## NON-INTRUSIVE FRP INSPECTION FOR AVOIDING PREMATURE ASSET RETIREMENT

GEOFF CLARKSON, *CEO and Founder at UTComp Inc.*

**VOLUME 23, ISSUE 6**

NOVEMBER | DECEMBER 2017

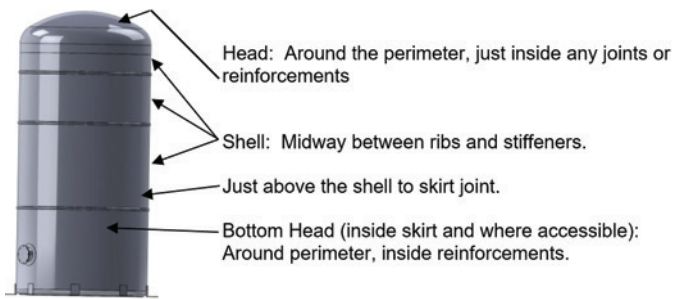
Figure 3. Recommended Inspection Plan

Inspection planning for FRP using this technology does require some assessment of damage sources expected. For the equipment considered here, **Figure 3** shows an example of the recommended inspections based on the operating condition. In addition, because reactions are expected in the packed bed, inspection of the shell in the packed bed areas is recommended to assess damage to the inner surface. This is from a Standard Practice that has been prepared as guidance for all inspectors.

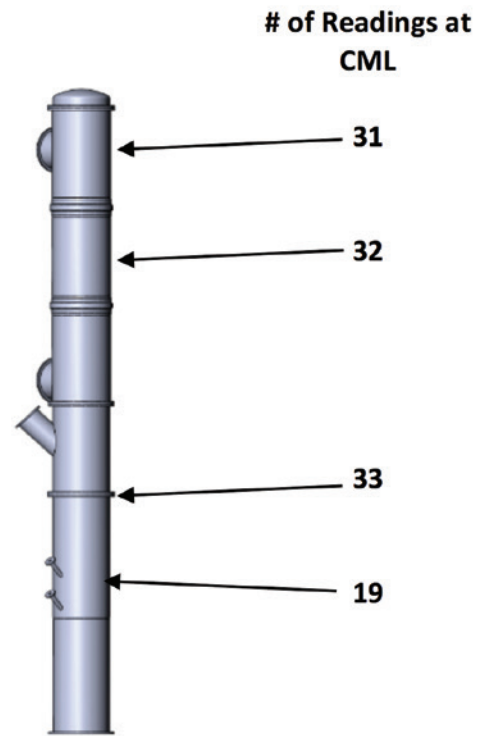
Figure 4. Ultrasonic Inspection Locations

In this case, the actual equipment was out of service. The owner covered any openings in the shell that would allow the inspector to see the inner surface, thus simulating a true non-intrusive condition. The packing was in place. The column was on its side and easily accessible to the inspector. The locations of actual inspections/scans completed and the number of readings that were taken are shown in **Figure 4**. For each of the locations, it is desirable to obtain at least 30 readings so that the variation in the

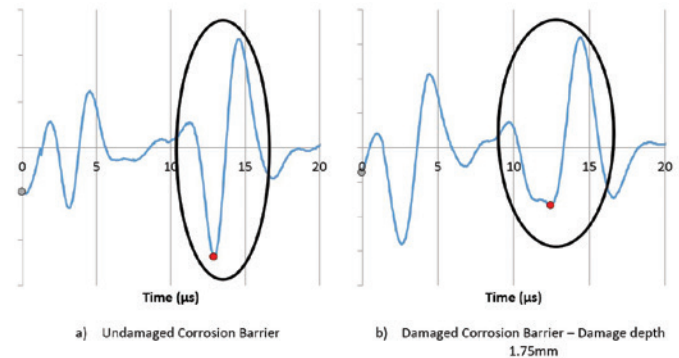
Figure 7. Typical Corrosion Barrier Analysis

Further evaluation was also used to determine the condition of the corrosion barrier surface. One of the methods used is illustrated in Figure 7.

From the same samples, condition of the corrosion barrier was also compared. Results for sample B are shown below in Figure 10. Also, the reading used as illustration in Figure 7b is from this sample.

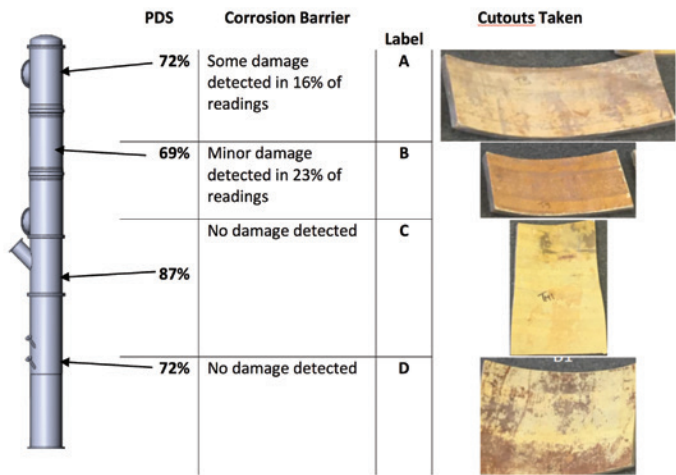
Figure 8. Inspection Results and Cutouts

The inspection results are summarized in Figure 8, at the end of this section.

As mentioned above, the client used this retired asset so that the results from this inspection could be verified by destructive tests. The inspection results and cut-outs that were removed to verify the inspection results are illustrated in Figure 8.

The cutouts were used to verify both the PDS results and the

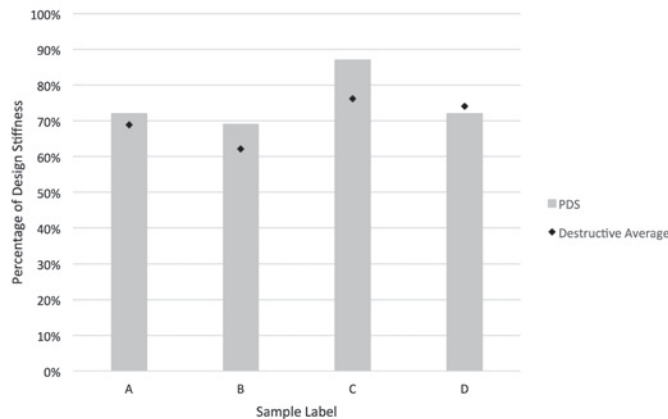
Figure 9. Comparison of Non-Destructive with Destructive Results

corrosion barrier results. To verify the PDS results, flexural modulus was determined for the samples in accordance with ASTM D790 and compared to the theoretical flexural modulus for the actual FRP construction. The testing method is detailed in [5]. Results of this testing are shown in Figure 9. Note that the values from the destructive test are all within 14% of the values from the non-destructive test.

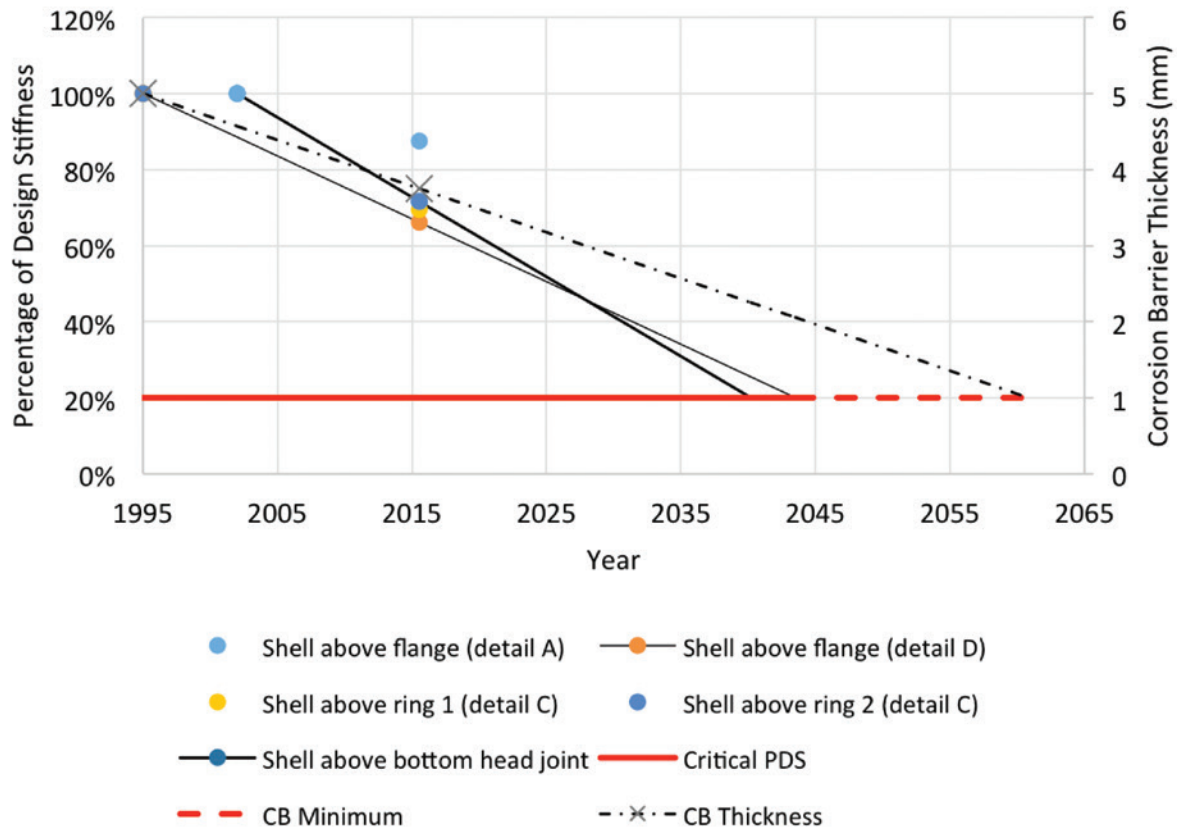
**Figure 11.** Chart Showing Remaining Service Life Calculations

The results of the calculations are given in Table 1 for a critical PDS of 20%, which represents a nominal safety factor of 2 based on the original design factor of 10.

Scrubber Section	Current Minimum PDS	Remaining Service Life (yrs)
Bottom Section	72%	25
Upper Shell and Head	66%	27

This remaining service life calculation for Percentage of Design Stiffness is illustrated graphically in Figure 11. The remaining service life could also be determined on the basis of the corrosion barrier (CB) damage detected in this case using the damage depth and criteria for end of corrosion barrier service life. In this case, the corrosion barrier has experienced thickness loss due to

oxidation from chemical reactions in the column. For the detected corrosion barrier damage depth of 1.25mm (leaving net corrosion barrier thickness of 3.75mm) and using a minimum allowable corrosion barrier thickness of 1mm, the remaining life is about 45 years. **Figure 11** also includes calculation of the remaining life based on corrosion barrier damage.
