FIBERGLASS REINFORCED PLASTIC ASSETS - CORROSION BARRIER CONDITION AND REMAINING SERVICE LIFE

Geoffrey E. Clarkson, P.Eng., ing., FEC
UTComp Inc.
Cambridge, Ontario, Canada
g.clarkson@utcomp.ca

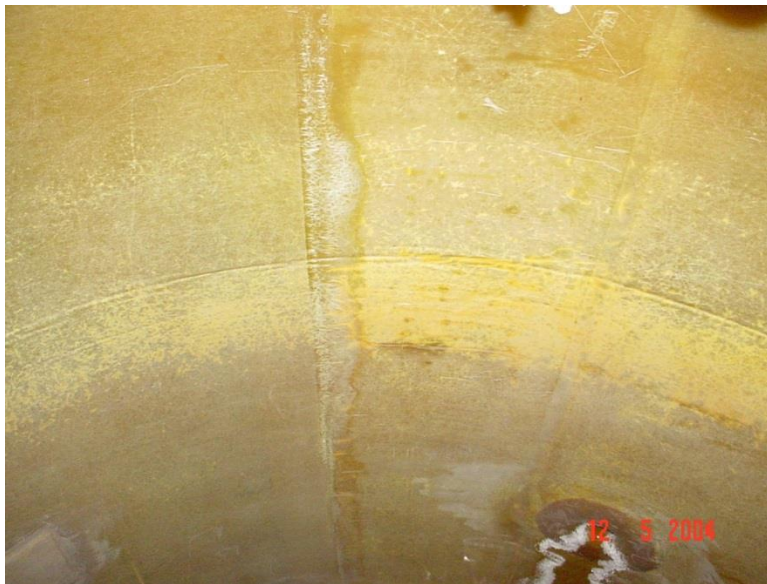
Figure 3

The resins used in FRP are all organic polymers, and therefore they can be oxidized. When oxidizing agents such as sodium hypochlorite (hypo), chlorine and chlorine dioxide are contained, oxidation of the resin will occur. This oxidation shows as direct loss of resin from the corrosion barrier. Where organic (polyester) veils are used, they will also be oxidized. When these substances are contained, an FRP corrosion barrier must be considered to be sacrificial. An example of extensive oxidation is shown in Figure 3. In general, glass fibers will not be oxidized and when released they may become tramp material in the process. If fluid is moving along the surface, such as in a stock line or upflow tube, the oxidized resin is often abraded off. This is normally found in any equipment that handles chlorine dioxide and hypo.

Oxidation is quite easy to detect visually. In Figure 3, the resin in the surface has been yellowed by exposure to chlorine dioxide and loss of material is evident. The oxidized resin on the surface is softened and can be abraded off with little effort.

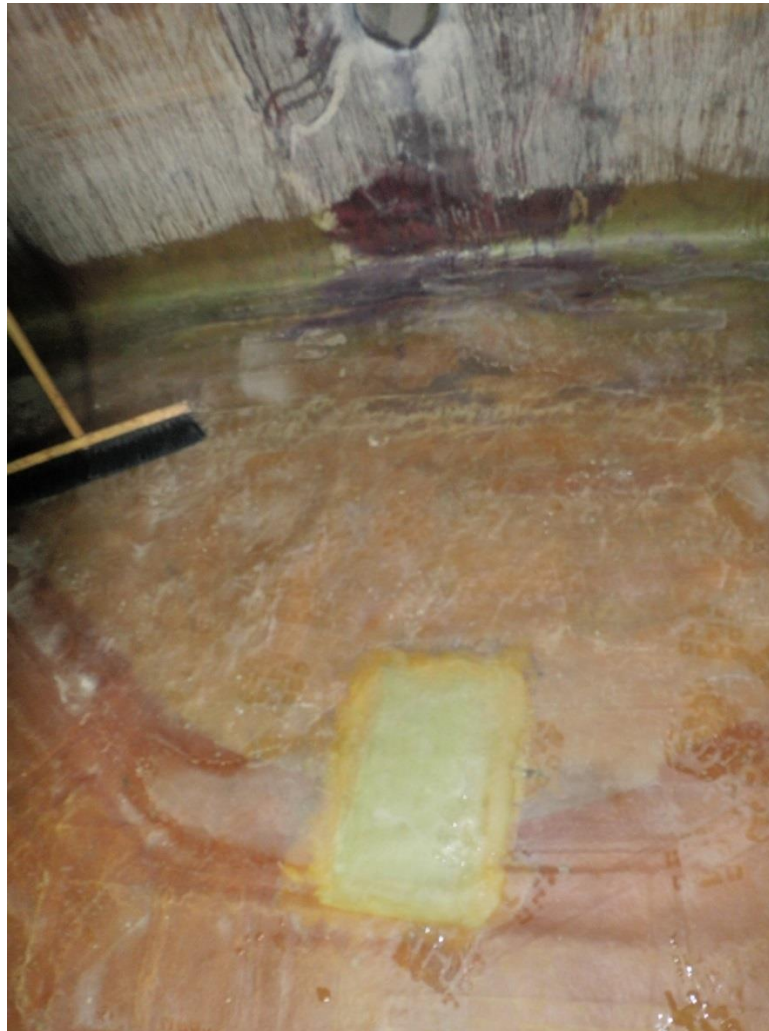
In this discussion, this is differentiated from oxidation in that the resin surface will appear to be intact, although some changes will be detected. The changes will appear as changes in the glossiness of the resin surface, changes in the hardness of the surface and changes in the colour (but not darkening). These changes occur as a result of chemical reactions taking place within some areas of the resin as a result of aggressive chemical reactions. Chemicals that are known to cause these changes include sodium hydroxide (caustic), hypo, solvents and some acids. Figure 4 shows an example of the inner surface of a chemical storage tank. All components shown were made using the same materials at about the same time. The different surface textures and colours reflect surface attack.

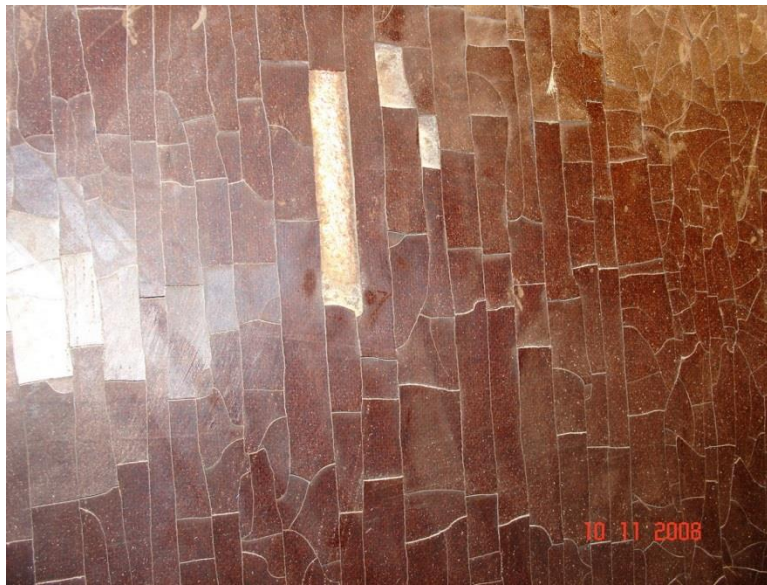
As mentioned above, the thermal expansion of resins and glass differ markedly. For this reason, process temperatures can cause significant changes in expansion. In the corrosion barrier, with a higher resin fraction than the structural layers, the difference can create cracks. When formed, these cracks allow process fluid to gain access deeper into the laminate and can form into inter-layer cracks that may result in separation. An example is shown in Figure 5 which is the inner surface of a scrubber. Note how sections of the corrosion barrier have actually come off of the vessel. Failure of the surface of the corrosion barrier has allowed the process fluids direct access to structural reinforcement.

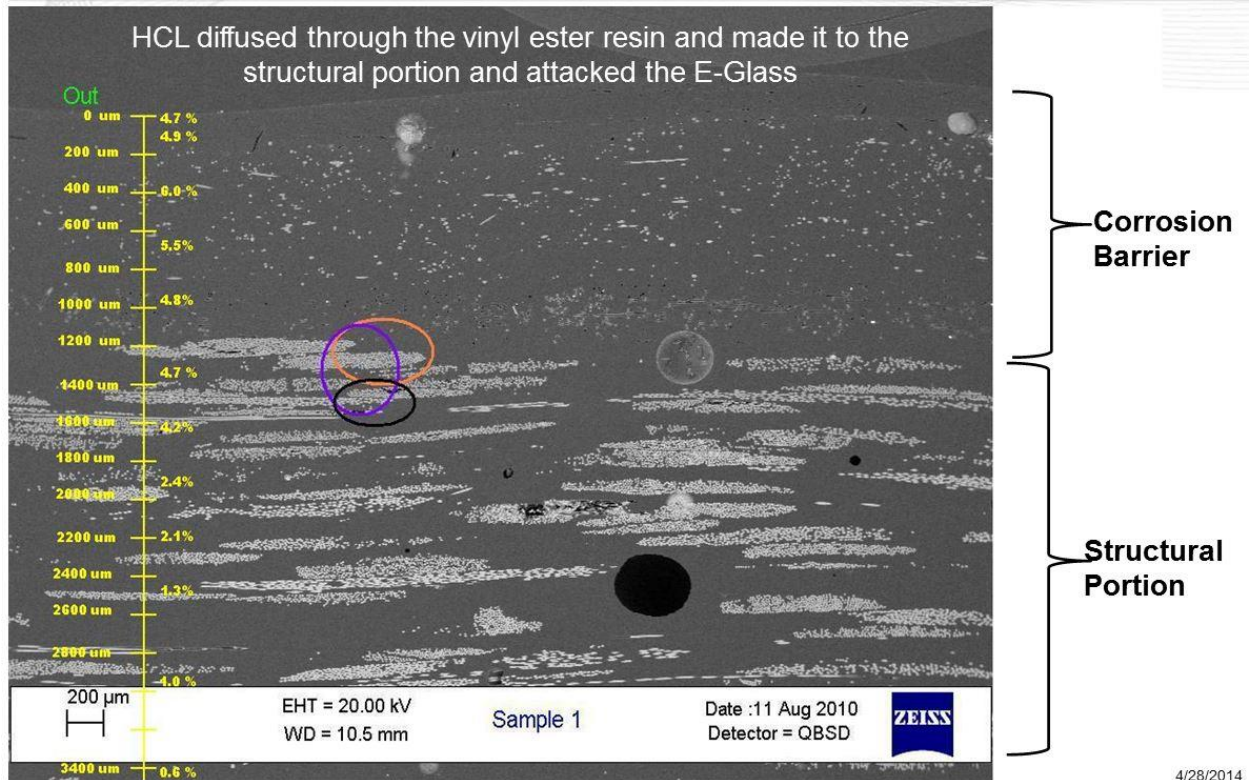
It is important to note that diffusion of process fluids into FRP occurs, whether blisters form or not. As an example, consider Figure 6 which shows an electron micrograph which has been surveyed using energy dispersive x-ray (EDX). The FRP is a specimen removed from a tank that contains hydrochloric acid (HCL). No blisters have been observed in the corrosion barrier, but chlorine concentration has been detected to the full depth of 3.4mm shown.

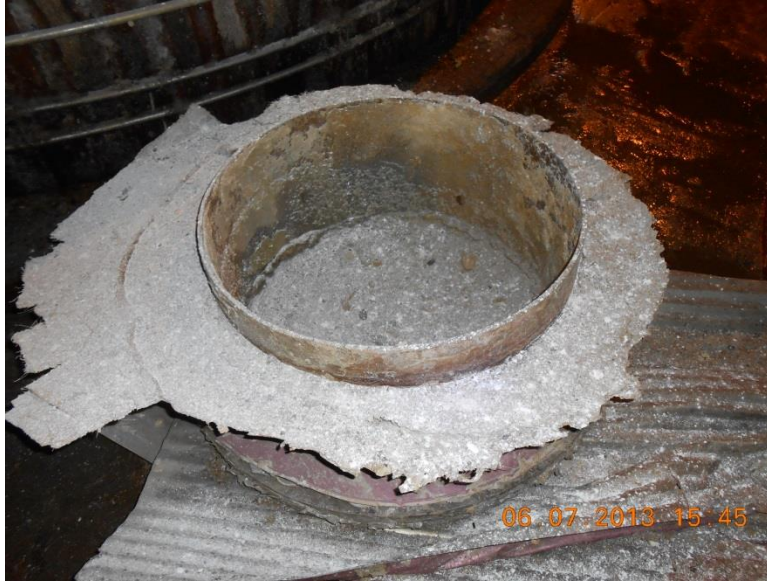
Attachments to FRP pipe and tanks, especially nozzles, are bonded to the parent structure. The bonds are known as “Secondary Bonds” because the resin in the parent structure is already cured and the crosslinking available for the new resin is negligible. The forces applied to these bonds resolve as two (2) distinct components – shear and peel. If the bonding practice follows accepted norms and the shear length of the bond is adequate, shear failures are rare. Peel describes forces that are normal to the bonded surface. These occur commonly with nozzles and stub-ins, where internal pressure applies a “peeling force” to the attachment where the attachment surfaces are normal to the loads. The peel resistance of a bond is low compared to its shear resistance. Peel failures are relatively common. When peel failures occur, there is usually loss of containment. Figure 7 shows a nozzle after peel failure that emptied a tank.

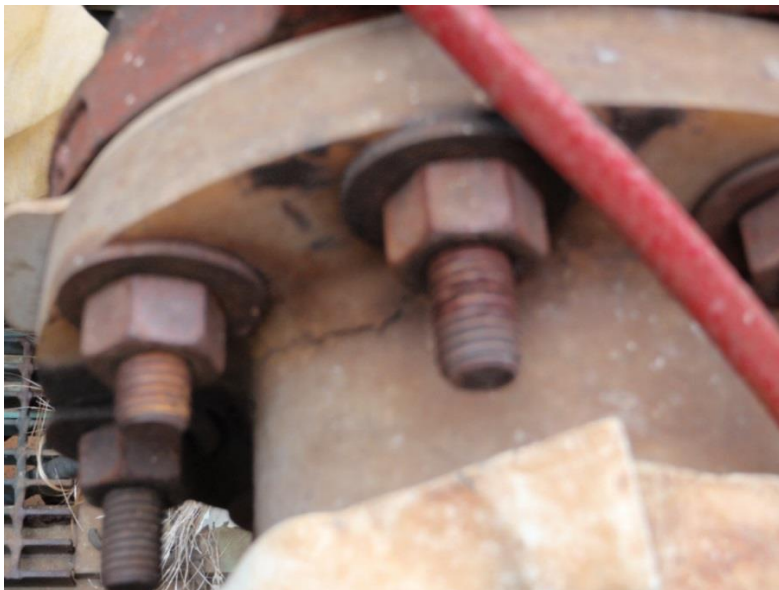
The most common flange type used in FRP manufacture is known as a flat face flange. These flanges are specifically designed to be bolted only to other flat face flanges, with gasket contact over the entire face. Any other mating configuration – raised face, typical wafer valves, Vanstone flanges, lap joint flanges, or using rope-type gaskets is not allowed for in the design of flat face flanges. Another arrangement that these flanges are not designed for is support of valves or piping. Where improper configurations are used, these flanges normally crack. This can lead to failure and loss of containment. Figure 8 shows an example. It is important to note that these cracks cannot be repaired.

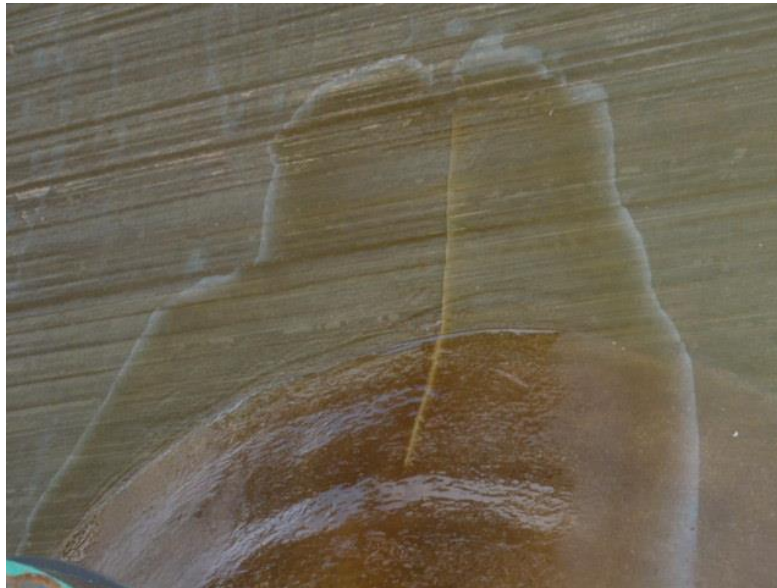
Corrosion of glass reinforcement is much more common than resin corrosion and more difficult to detect. In this case, the chemical composition of the glass is important. Glass is particularly vulnerable to acidic environments which can dissolve components from the fibers which reduces their strength and the strain at which the fiber will fail. Reinforcement fibers can be exposed to process fluids in a number of ways, including leaks at internal bonds and diffusion through an intact corrosion barrier. Stress corrosion cracking failures of FRP have been observed mostly where stresses are higher in the FRP, such as at nozzles or stub-ins where the additional reinforcement applied is not adequate. Figure 9 shows stress corrosion cracking at a 150mm nozzle. Note that the crack has resulted in a loss of containment.

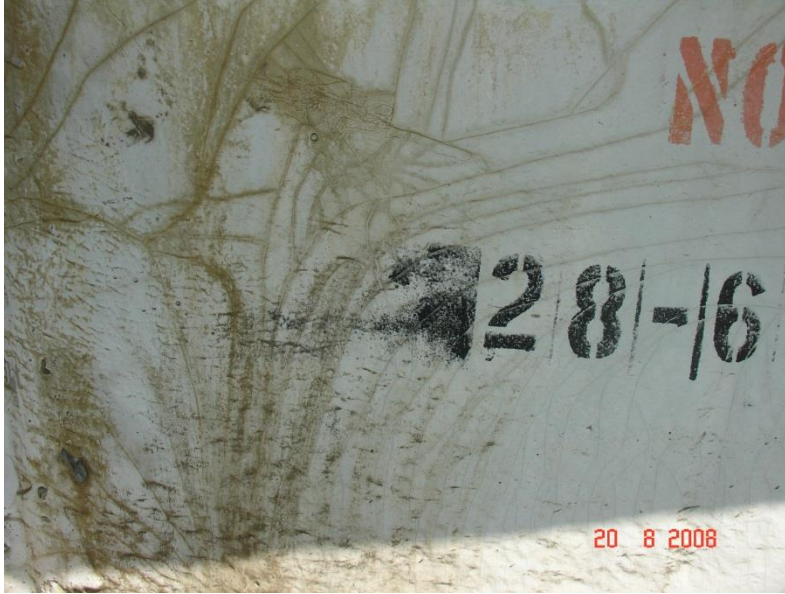
FRP is more fragile than most metals and will generally crack from impacts or excessive bending. The sites of these cracks are a common failure location. Sources of impact damage include dropped tools, mobile equipment impacts and handling damage. In general, they are immediately visible. A common term to describe their appearance is "star cracks". Figure 10 shows a common star crack appearance. When these occur, the FRP is weakened in the same way that cracks weaken steel. Immediate repairs are usually recommended.

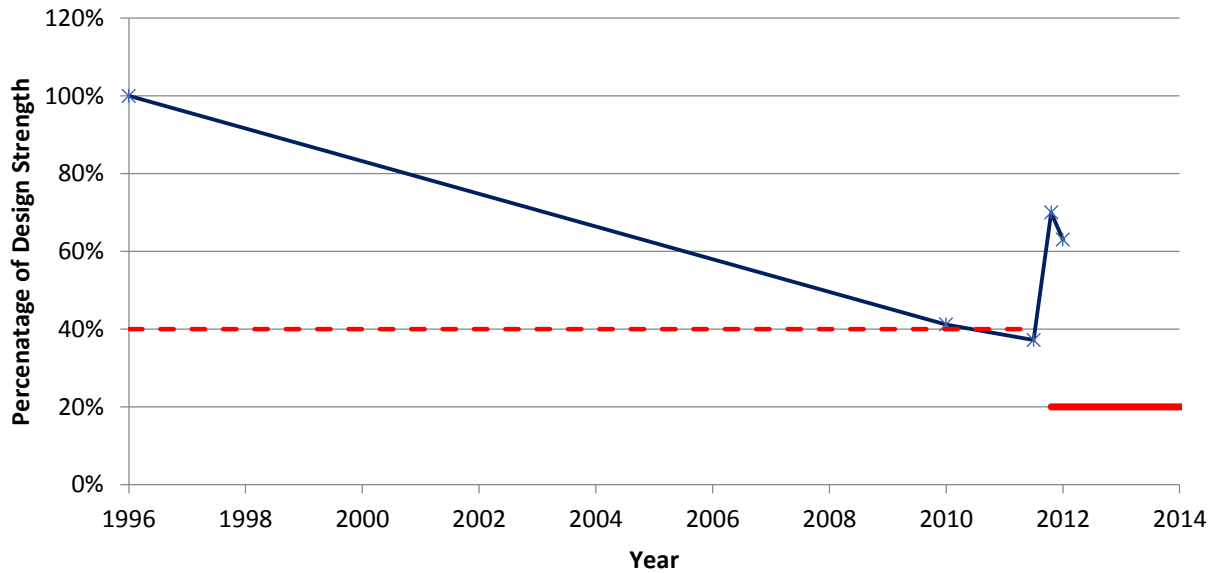
Figure 11 shows actual results for an FRP tank. Changes in strength of the shell are shown in the period from 1996 to 2011. Repairs with structural reinforcement were completed in 2011 and the increased structural capacity of the tank is shown by the increase in the 2012 inspection. The drop from 2012 to 2013 is the result of incomplete corrosion barrier cure.

In the chart, Percentage of Design Strength is the current percentage of the original design strength of the FRP. The Design Strength of the FRP is obtained from calculation or destructive tests of the new, fully cured laminate. Normally, FRP is designed with a safety factor of 10, which is used as 100% on the chart. As a result, a safety factor of 2 corresponds to 20%. The red lines show the levels at which RSL is calculated.
