# Non-Intrusive & Non-Destructive Inspection of FRP – Case Studies

Geoff Clarkson, P.Eng.  
Chief Engineer, UTComp

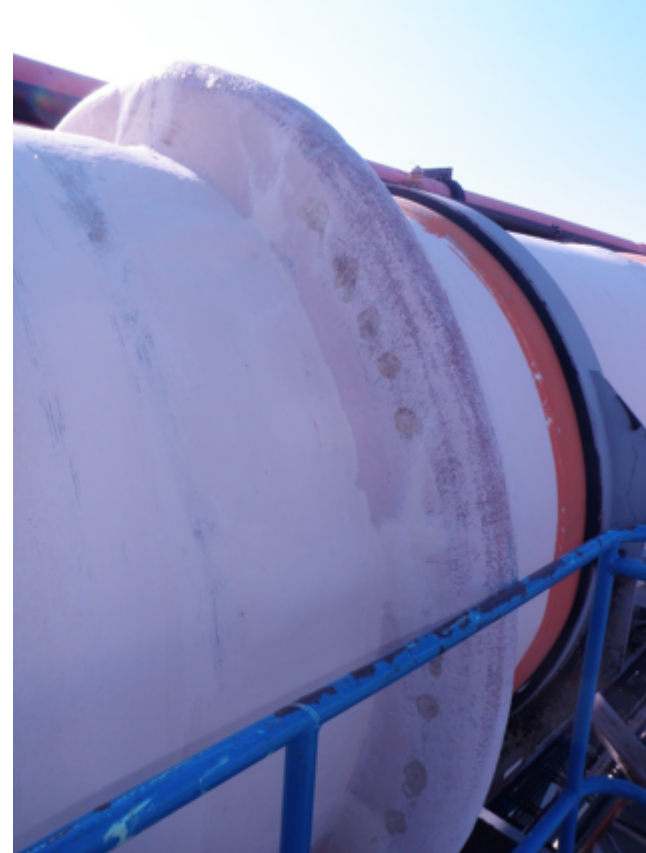
- ▶ Carrying corrosive humid SO<sub>2</sub> .
- ▶ Includes FRP expansion joints.
- ▶ Portions relined 2 years previously.
- ▶ Immediate replacement recommended at last internal inspection.
- ▶ “How soon do we need to replace?”

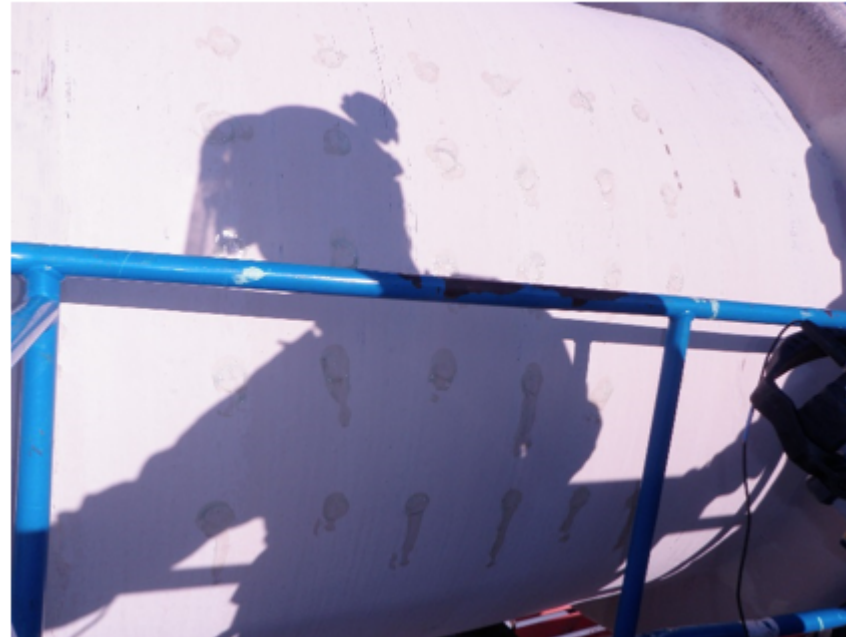
- ▶ Inspection:
  - Completed while facility was operating.
  - Duct outer surface temperature ~ 75C.
  - All inspection of 1,000m of duct completed in 3 days.

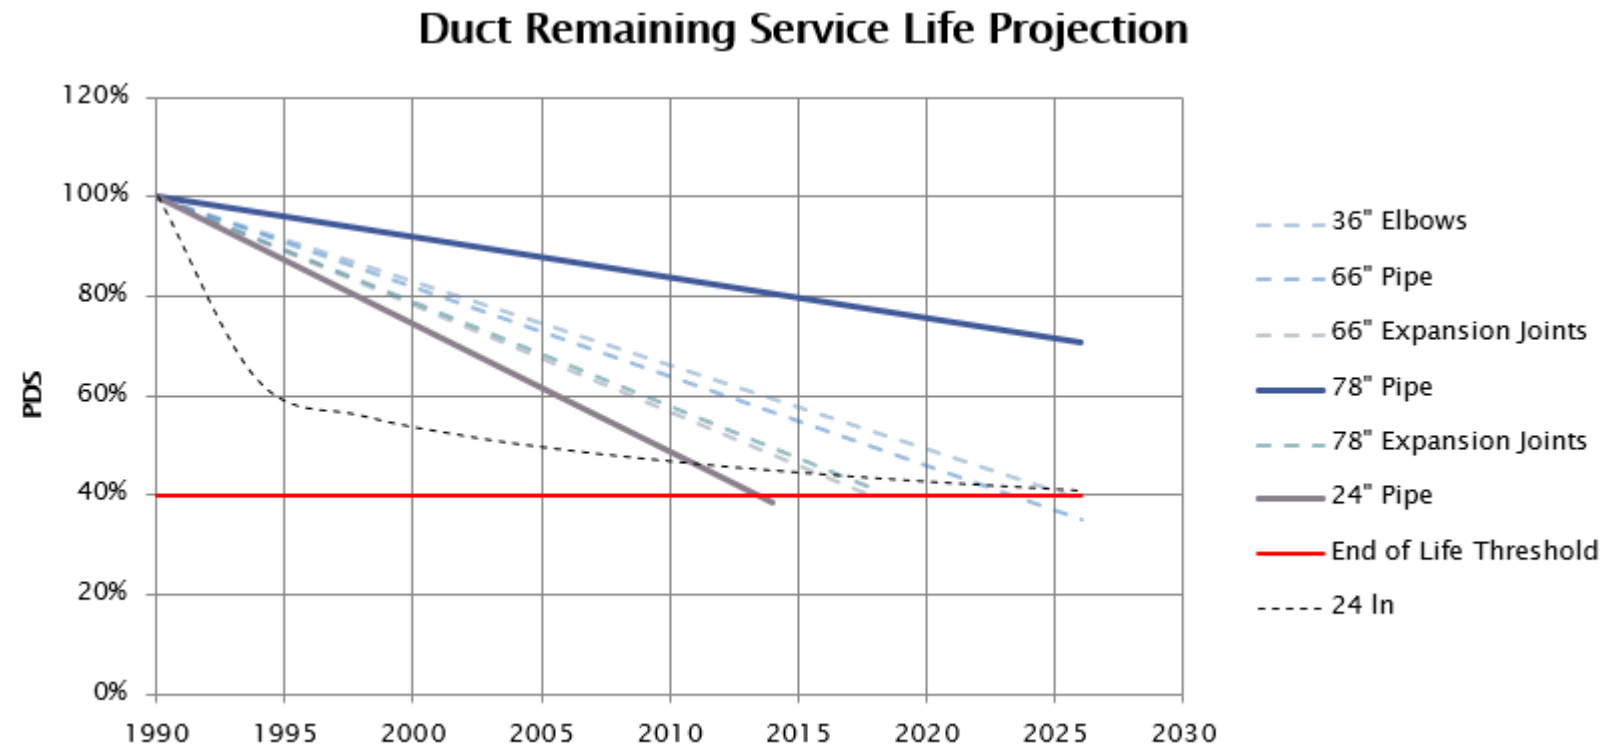
- No need to replace 78" duct for foreseeable future.
- Expansion joints show structural damage.
- No damage to corrosion barrier was detected.

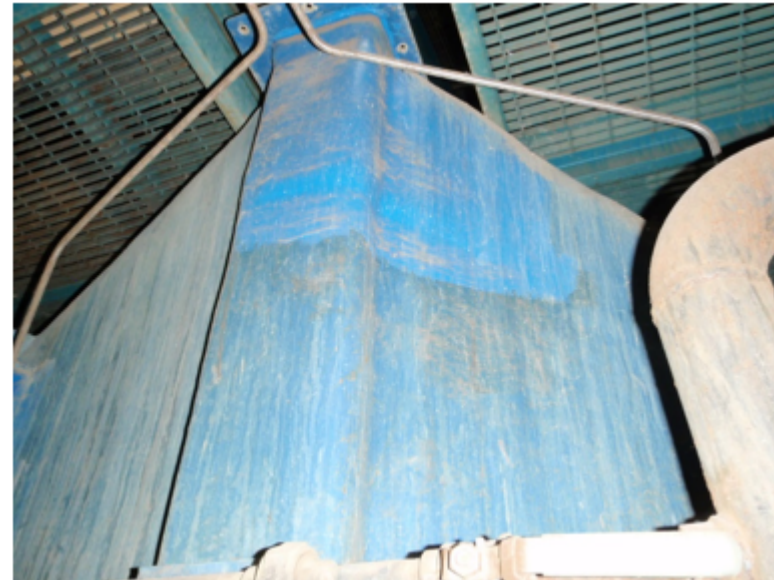
- ▶ First inspection in 2009.
- ▶ In 2010 low structural strength was noted.
- ▶ 2011 engineering analysis and repair recommended.

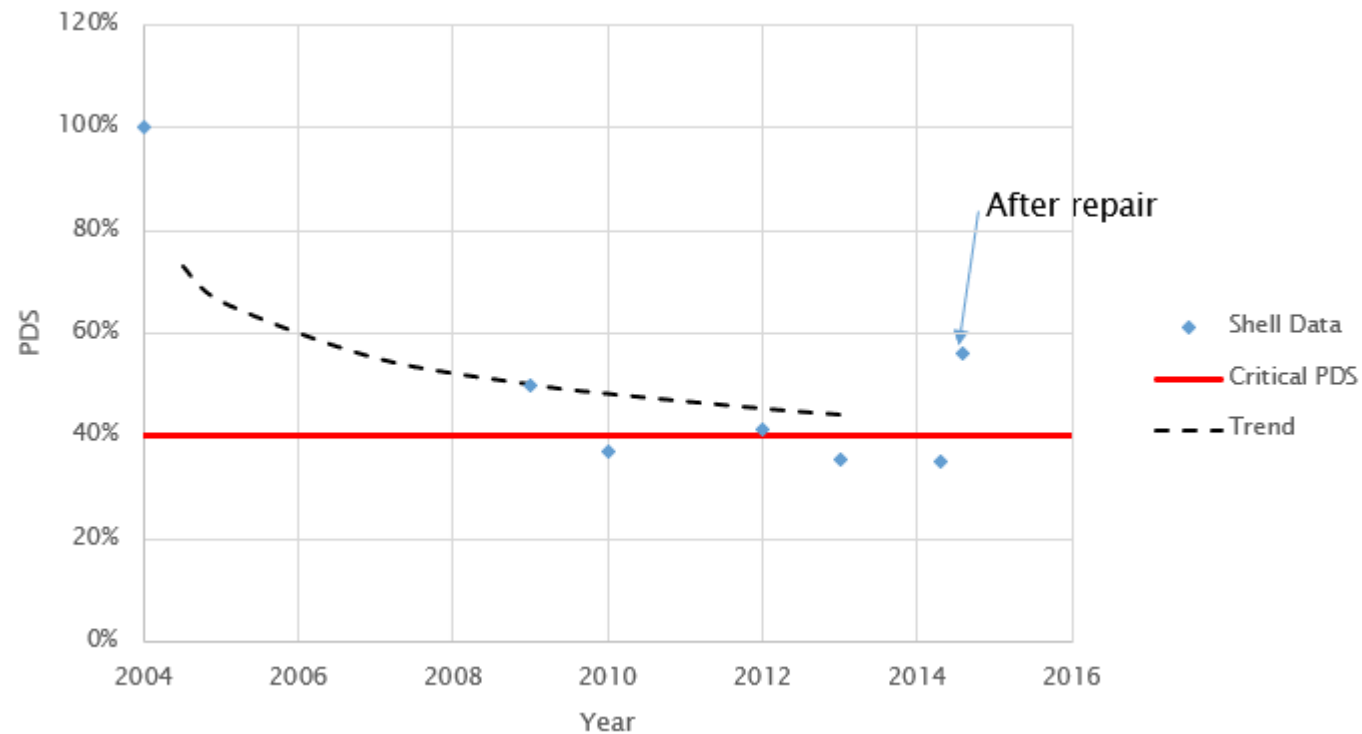
- ▶ Results;
  - Timely identification of need for repair.
  - When completed, re-start life prediction.

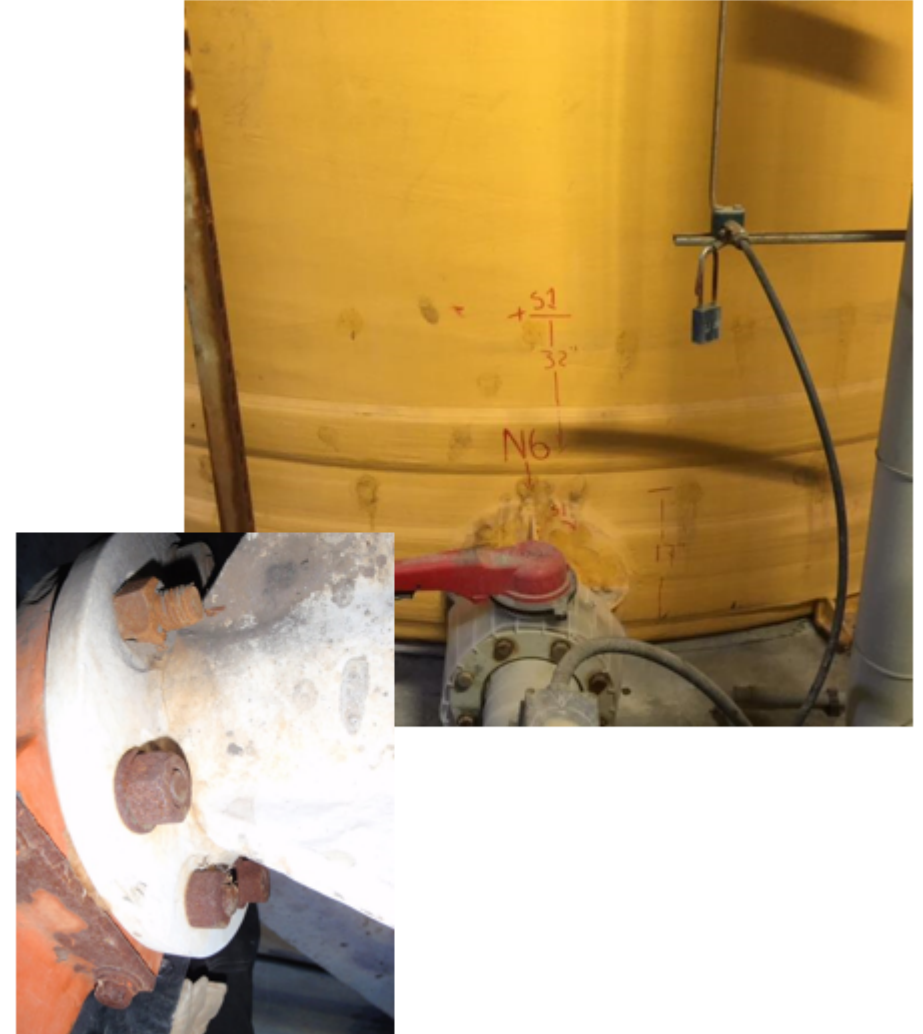
- ▶ Pickling Acid
- ▶ 7 years old
- ▶ First inspection 2015 – ultrasonic
- ▶ Results show blisters in corrosion barrier and good structural capacity (57%; Safety factor 5.7)
- ▶ No thickness loss, no CB damage
- ▶ Several nozzles with cracked flanges

- ▶ Replace damaged flanges
- ▶ Inspect again in 3 years

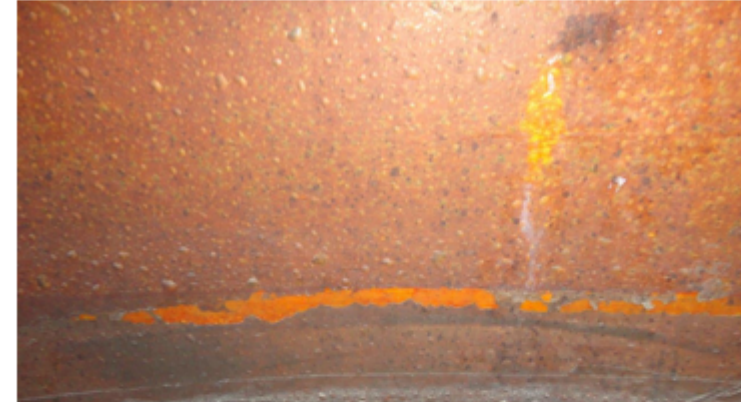
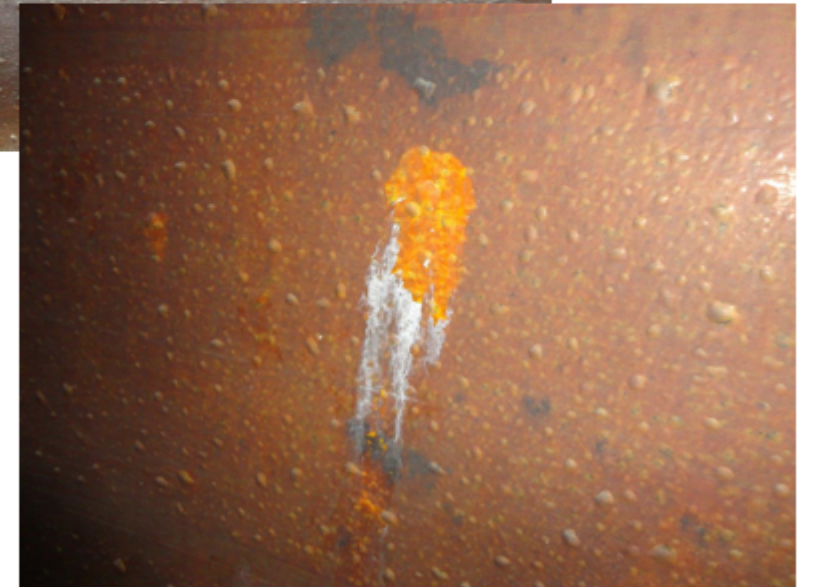
- ▶ Flanges were replaced.
- ▶ Corrosion barrier appearance:
  - Blisters as predicted
  - No significant softening
  - UT does not see color change but does see damage depth such as from softening, overheating
- ▶ Put back into service.

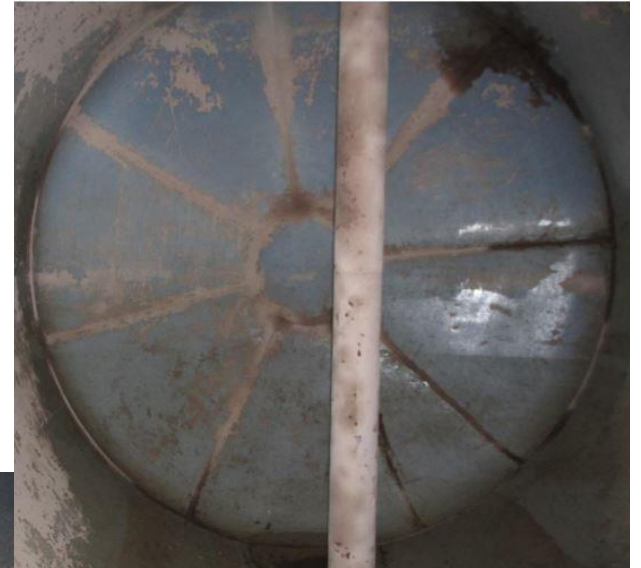
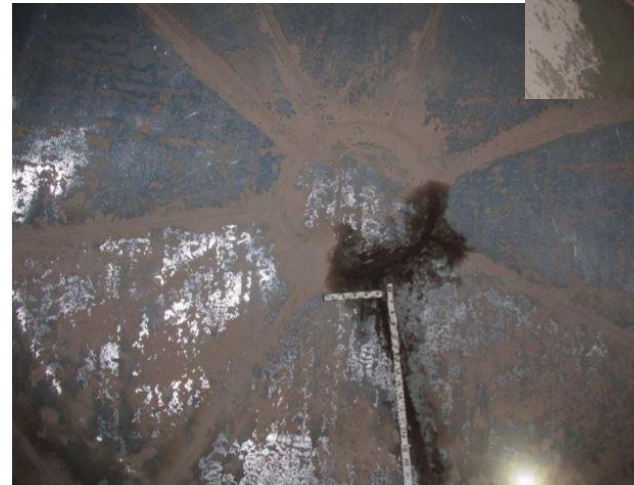
- ▶ Stains and “bleed out” at some lining welds
- ▶ \$\$ available to repair BUT.....
- ▶ Must assess for fitness for service.

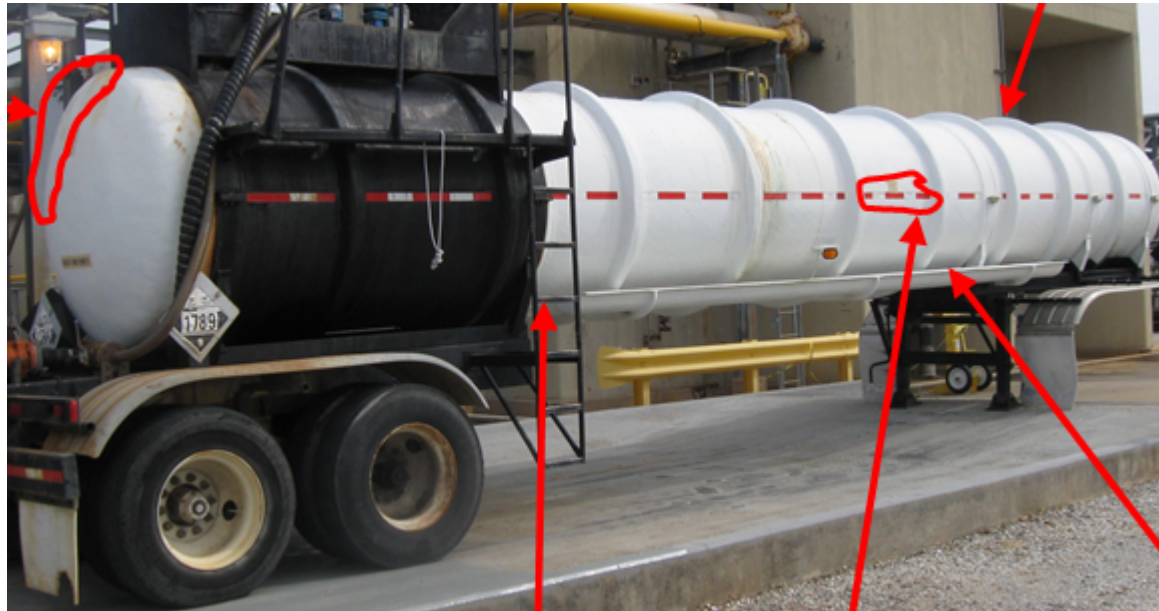
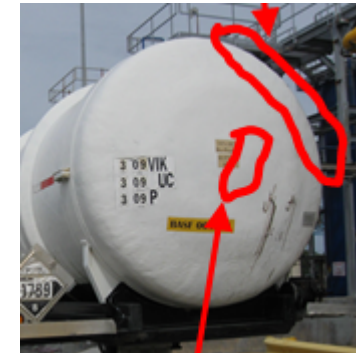
PDS = 60%

PDS = 50%

PDS = 80%

PDS = 82%

PDS = 84%

PDS = 48%

## ► No damage to inner surface was detected
