CASE STUDY
SEAL TANK 15

OWNER:
Pulp and Paper Mill

EQUIPMENT NAME:
Seal Tank 15

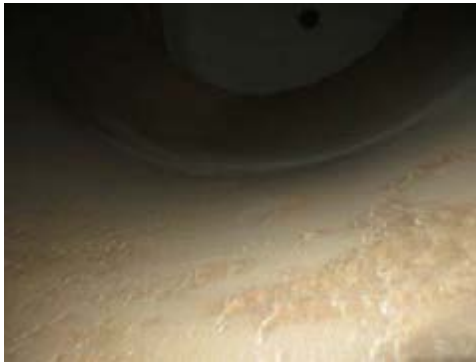
Condition of internal surface from previous Inspector's entry

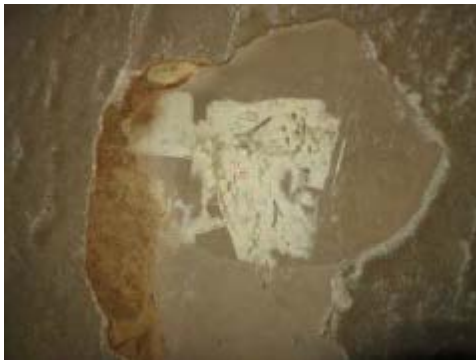
Condition of internal surface from previous Inspector's entry

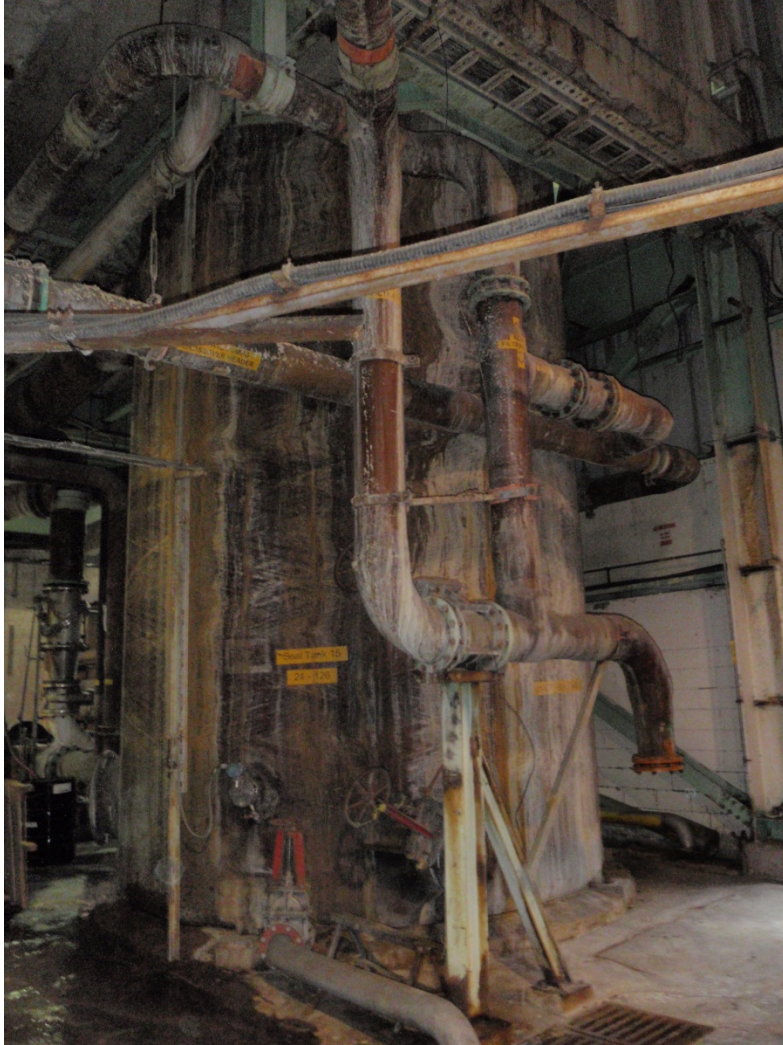
Overall view of Seal Tank
