## **Non-Destructive Condition Assessment of Fiberglass Reinforced Structures**

## Geoffrey E. Clarkson

UTComp Inc., Cambridge Ontario, Canada

The central case in this paper covers structural evaluation of an atmospheric storage tank used for ferric chloride at the wastewater treatment facility for the City of Ottawa in Canada. Ottawa is the capital city of Canada, with a population of about 1,000,000 people.

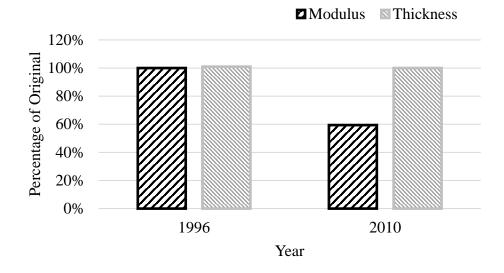
# Figure 2. Destructive Test Results from Samples Removed from Glass Fiber Reinforced Tank Shell

From Figure 2, it can be seen that during fourteen (14) years of service, the thickness of the laminate did not change appreciably but the modulus reduced by 40%. At some point in this decline, it is likely that the composite will no longer be able to support the required loads. The corrosion barrier as shown in Figure 1 also experiences changes from service conditions. Some of these are illustrated in Figure 3. In addition, blisters can form and the resin can be softened by chemical attack and corrosion.

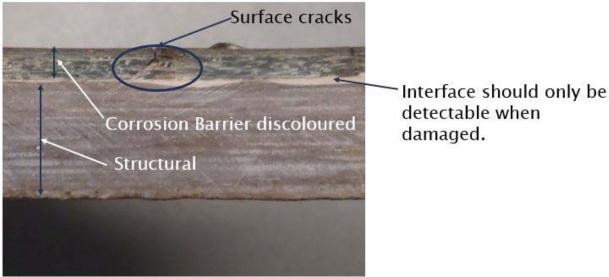
Figure 3. Illustration of effects on the corrosion barrier from service conditions. Note the different appearance of corrosion barrier and structural.

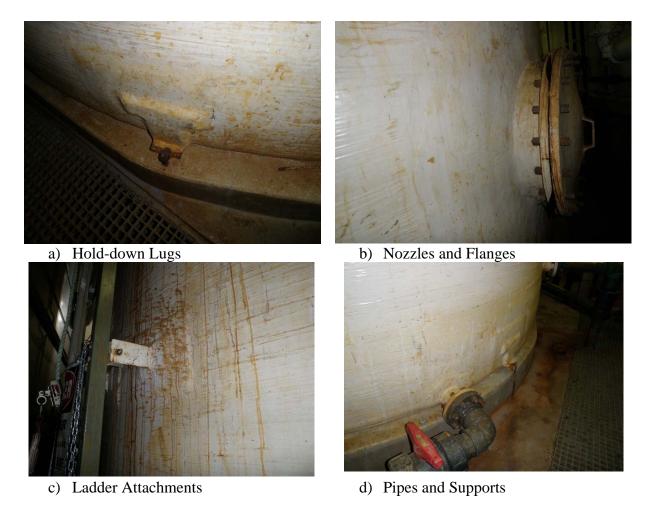
Figure 6. Examples of items inspected visually as part of the tank inspection.

Analysis of the external inspection revealed two defects.

Overflow leaks had occurred from the manway on the tank roof. Filling the tank to this level can pressurize the tank and cause damage at the hold-down lugs and tank floor. The best prevention of this problem is to place an overflow at the top of the tank cylinder which will direct excess fluid to a safe location. An alternative is to control the level with instrumentation, but this may not fully prevent overfilling.

The tank did not have a vent to allow air to move in and out of the tank with level changes. A "soft" vent at the roof manway existed, but if the manway was tightened with a gasket, this would no longer vent.

- Install overfill protection and venting on the tank.
- Repair the defective ladder attachments.
- Inspect the top head at next inspection.
- Inspect again in 3 years.

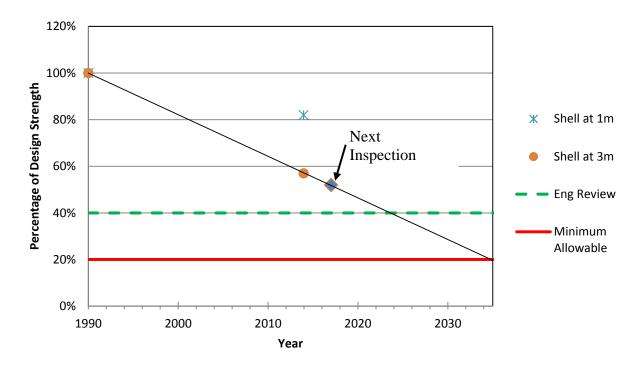
RSL is calculated as the time from the current inspection to the projected date when the FRP in the tank reaches a "Safety Factor" of 2. Using this method, the FRP equipment can be replaced or repaired proactively.

The engineer analyzing the inspection data has experience with the manufacturer of the tank and was confident that the tank was designed and built in accordance with recognized standards and used a safety factor of 10 at design. Based on this, the Safety Factor of 2 will be at 20% of the design, or new value.

Figure 8 presents a graphical illustration of this projection. Periodic inspections, normally at 3 year intervals, are recommended to monitor any developing changes. Note that this tank is expected to be serviceable for 20 years after the current inspection.

Figure 8. Graphical Remaining Service Life projection of the tank from 2013 inspection.
