## **Using Ultrasonic Technique to Determine Fitness for Service of FRP Equipment for Chemical Handling Applications**

Pradip Khaladkar  
PECT Consulting  
Hockessin,  
Delaware  
USA

Geoffrey Clarkson  
UTComp Inc.  
Cambridge, ON, N1R 8C8  
Canada

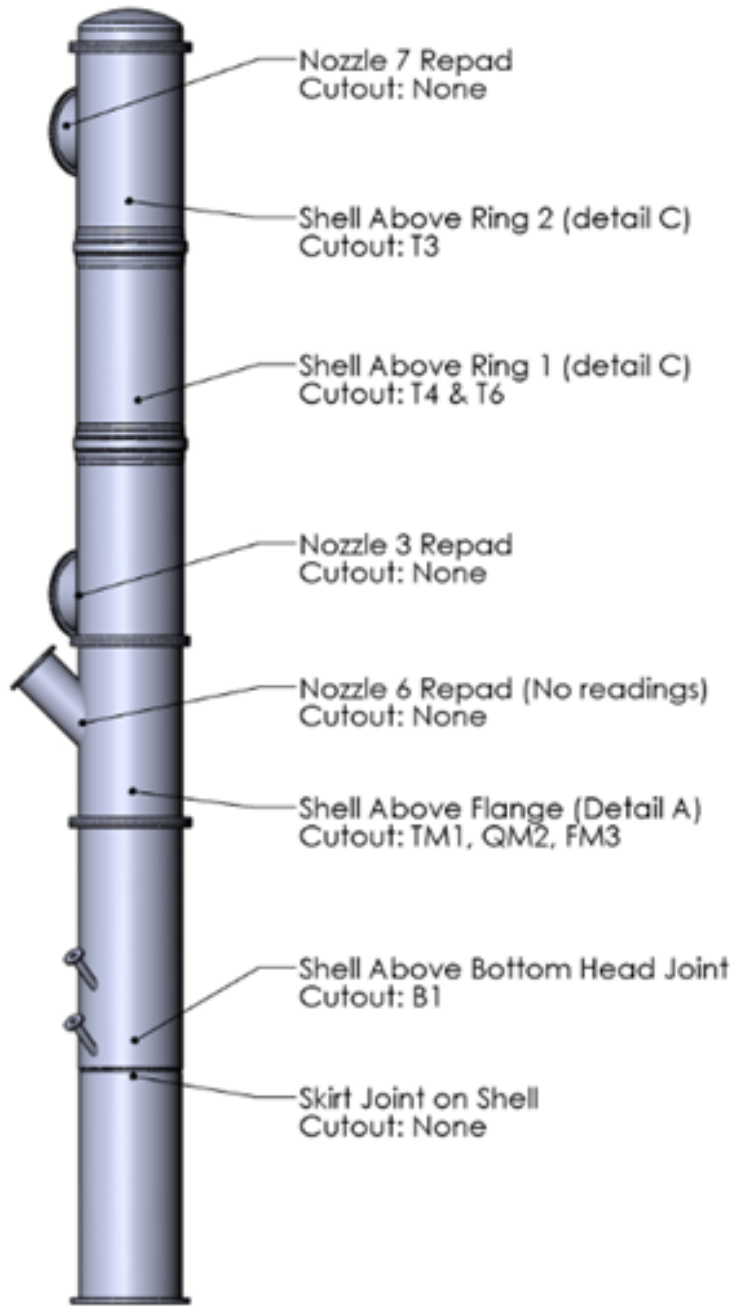
**Figure 2: Inspections**

Description of ultrasonic inspections and the locations of cutouts removed for verification is shown in Figure 2 along with details of inspection locations.

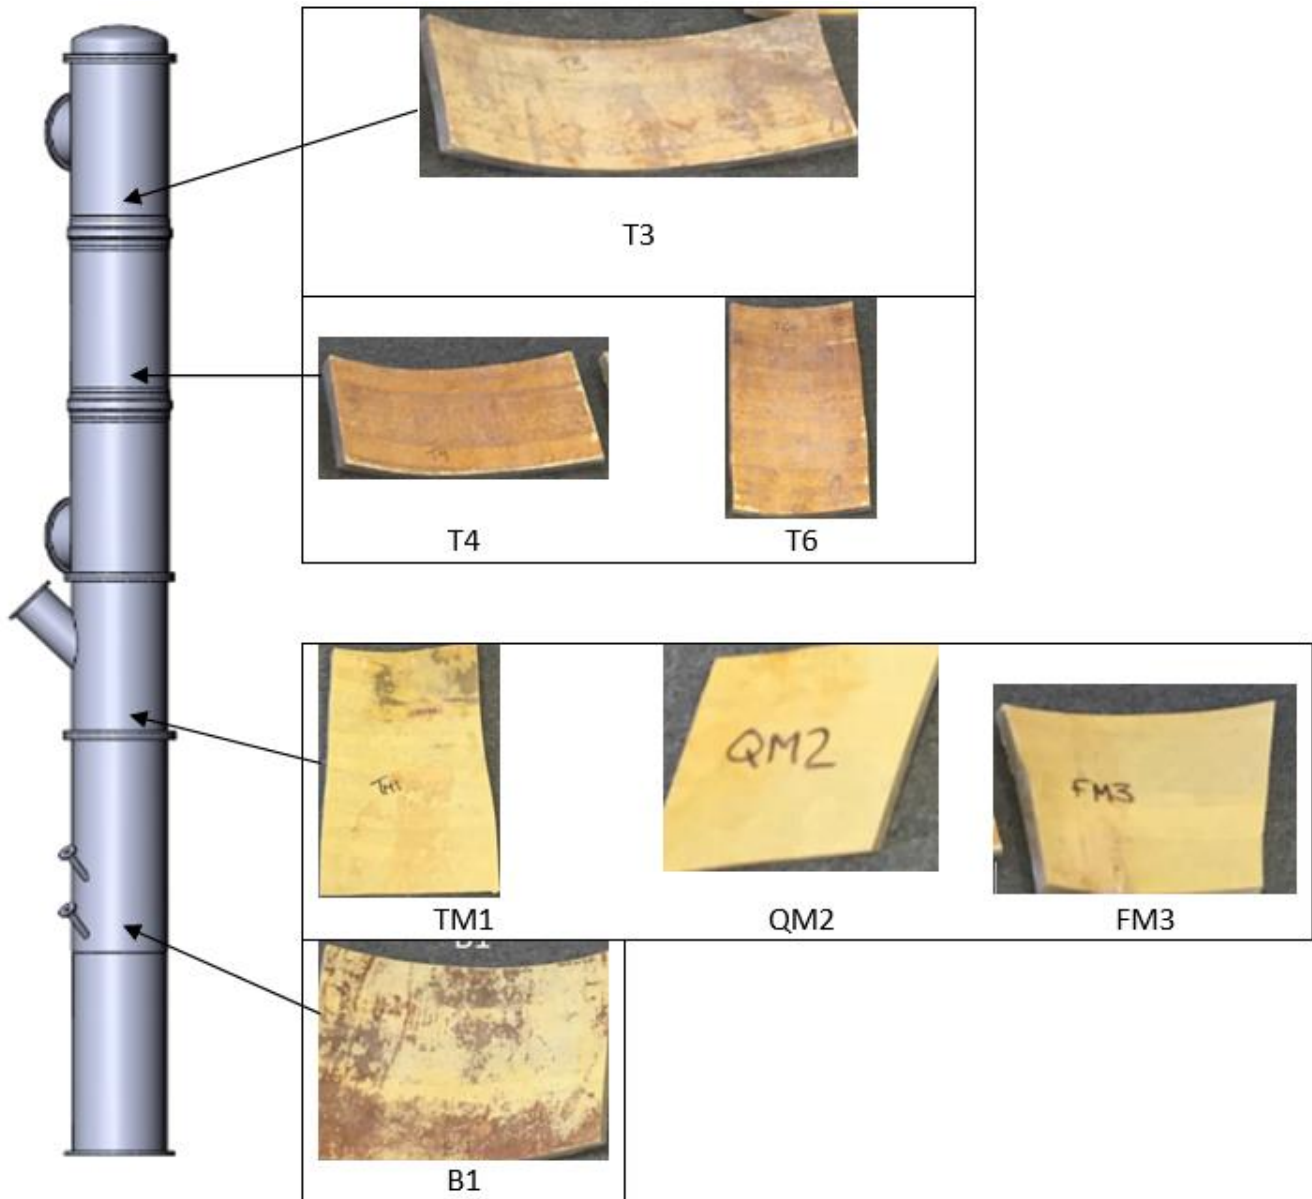
**Figure 3: Cutouts from Scrubber**

After the non-destructive readings were taken, portions of the FRP shell were removed for comparative evaluation. Figure 3 shows all of the cutouts removed from the vessel along with their locations. Cutouts QT1, FM3 and QM2 were not used for quantitative property verification because they were too small or did not have uniform thickness. The section of some of these samples were examined for verification of the condition of the corrosion barrier as reported from the ultrasonic analysis. This was the first time that the inspection contractor witnessed the internal condition of the FRP.

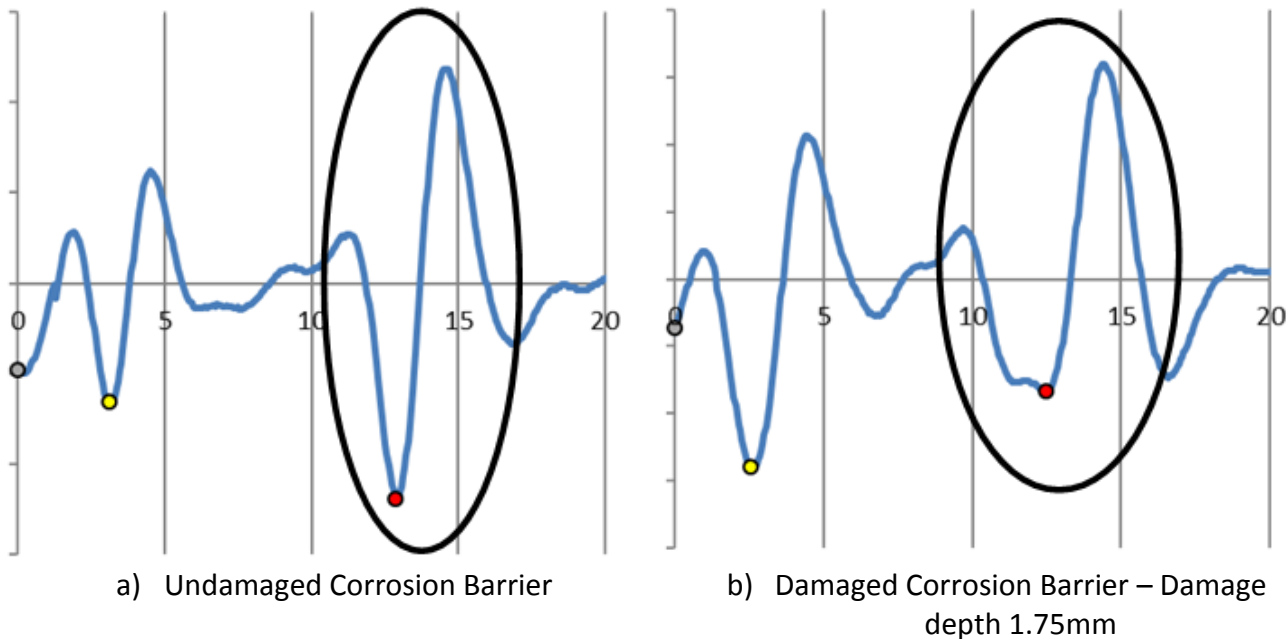
**Figure 4: Typical Corrosion Barrier Analysis**

Corrosion barrier assessment was completed by evaluating features within the opposite surface reflection of the ultrasonic reading. Figure 4 shows a typical comparison taken from different locations in the Shell Above Ring 1 (Detail C, Cutout T4). Common features used to determine if damage has occurred are the width of the main reflection lobe (circled area) and the presence of undulations in the reflection.

In table 3, the average depth of corrosion barrier damage detected for the shell sections above rings 1 and 2 was 1.25mm. Based on the shape of the reflected ultrasonic signal, the type of damage was assessed to be caused by oxidation of the resin.

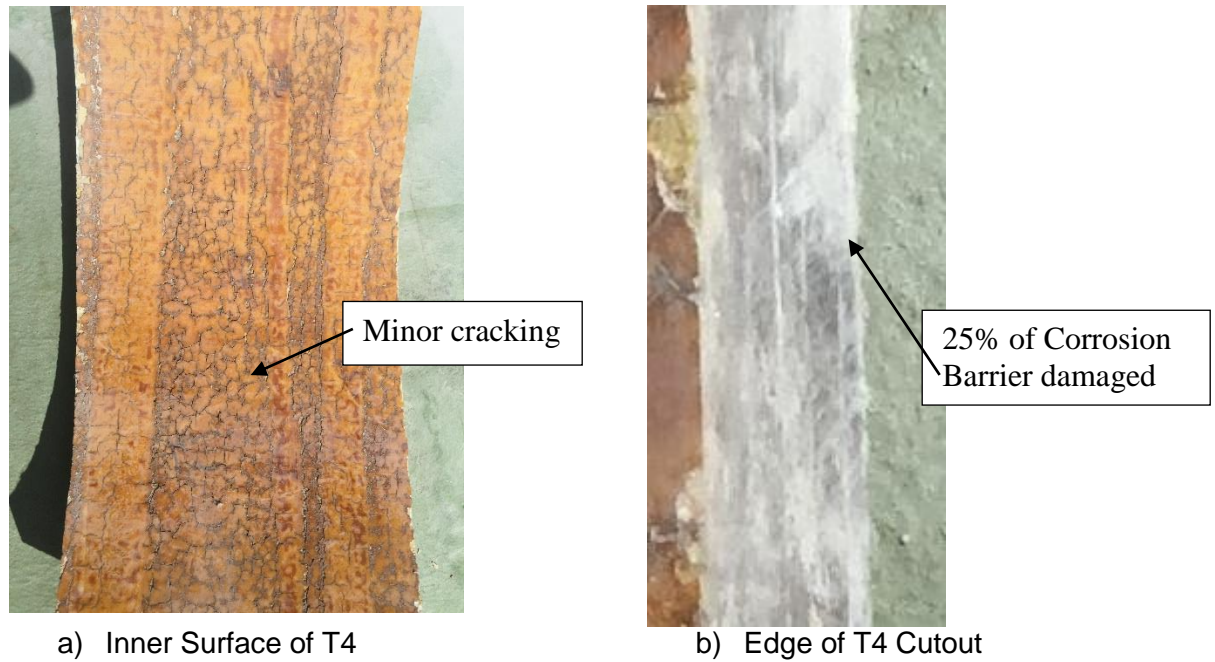
**Figure 6: Corrosion Barrier**

Several of the cutouts were examined to quantify the damage to the corrosion barrier. Figure 6 shows the T4 cutout. In Figure 6a, the inner surface of the corrosion barrier shows the damage and loss of material. Figure 6b shows the edge of the cutout.

Note that the ultrasonic assessment determined that the average depth of damage to this section of the corrosion barrier was 1.25mm. Evaluation of the cutout confirmed the ultrasonic results where the damage depth to the corrosion barrier was measured in the lab to correspond to the results in Table 3. Note also that the remainder of the shell thickness in Figure 6b does not show any signs of damage.
