CASE STUDY

Steam Train Car Roof

Steam Train Car

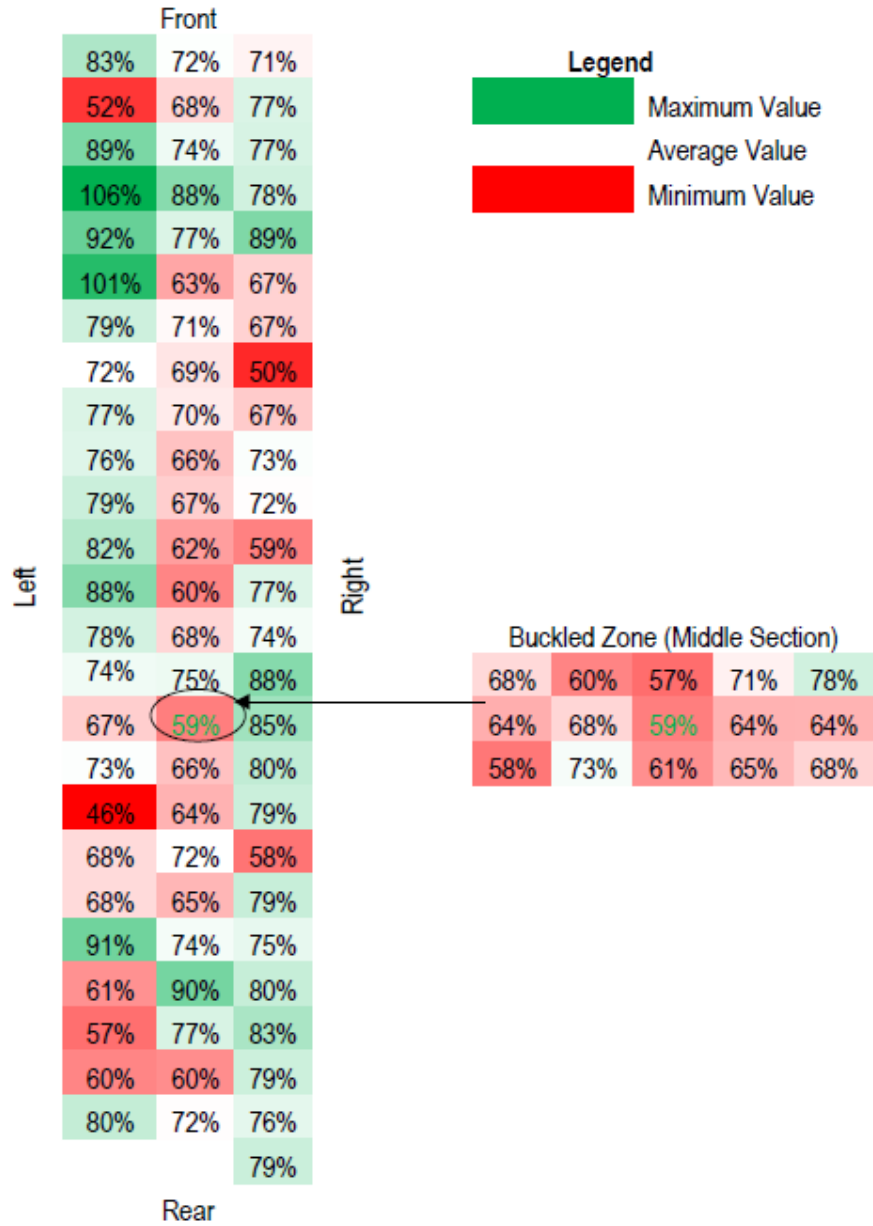
The collected data was then analyzed, and heat diagrams were produced for each reading to show thickness and the percentages of design stiffness (PDS) for each reading. The area of concern was shown in greater detail.

The analysis showed that the PDS was greater than the critical PDS and the engineering review threshold. This meant that despite the visible buckling, the structural integrity of the train car had not been compromised. Furthermore, the **UltraAnalytix™** analysis provided the client with valuable insights into the remaining service life of the train car.

Figure 1 - Sample heat chart for FRP Asset
