## NON-INTRUSIVE FRP INSPECTION FOR AVOIDING PREMATURE ASSET RETIREMENT

GEOFF CLARKSON, *CEO and Founder at UTComp Inc.*

**VOLUME 23, ISSUE 6**

NOVEMBER | DECEMBER 2017

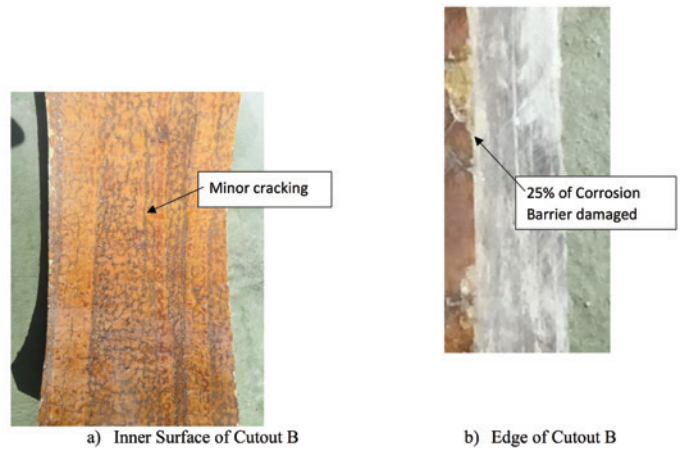
Figure 10. Corrosion Barrier Results

From the same samples, condition of the corrosion barrier was also compared. Results for sample B are shown below in Figure 10. Also, the reading used as illustration in Figure 7b is from this sample.
