Practical External Inspection of FRP Vessels

Geoff Clarkson, P.Eng., *Founder and CTO at UTComp Inc.*

VOLUME 27, ISSUE 1

JANUARY | FEBRUARY 2021

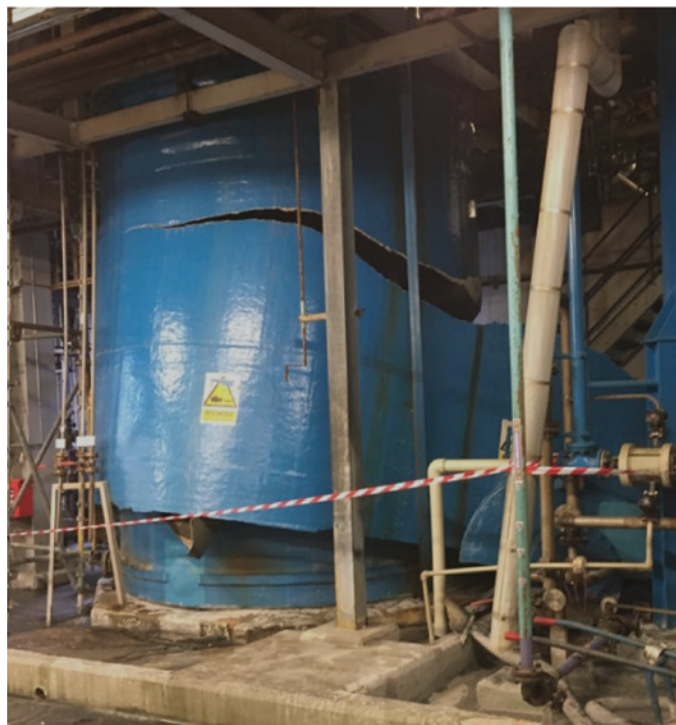
Figure 1. One consequence of over-filling

From the example of **Figure 1**, a very common item that causes loss is related to overflows, pressure relief and vacuum relief.

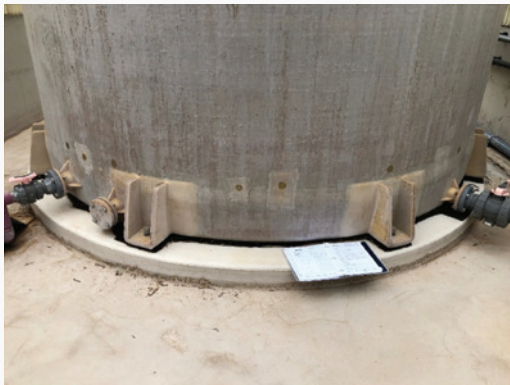
Figure 2. Support that does not require corrective action.

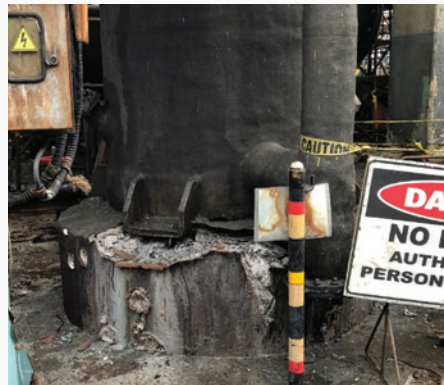
Figure 3. Support that requires corrective action.

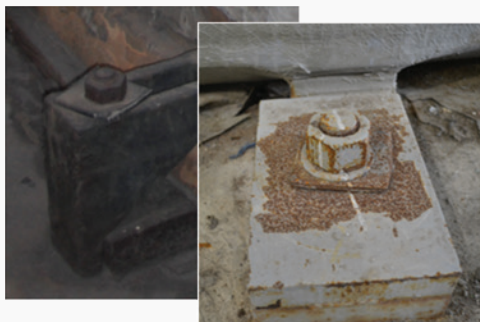
Figure 4. Anchors and hold-downs that do not require corrective action.

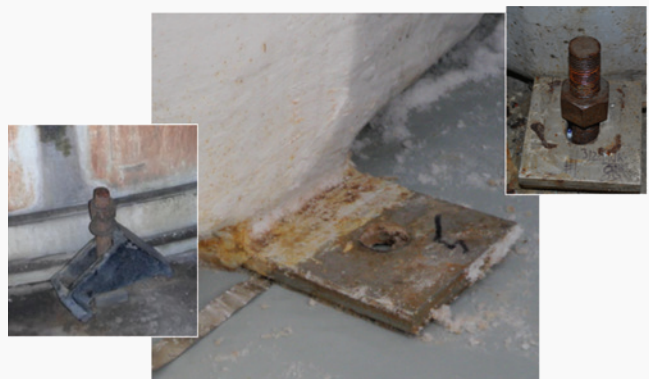
Figure 5. Anchors and hold-downs that require corrective action.

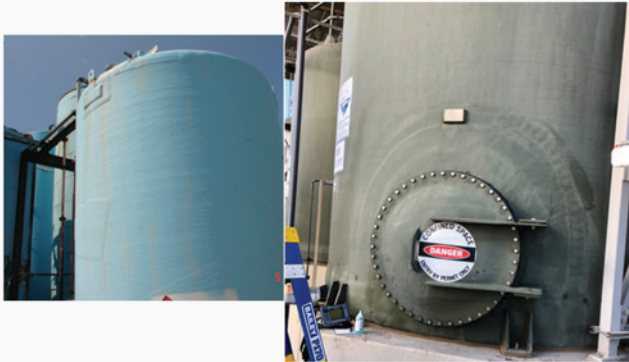
Figure 6. Intact FRP surfaces where no corrective action is required. Note that flaking of paint from the outer surface is normally considered to be superficial.

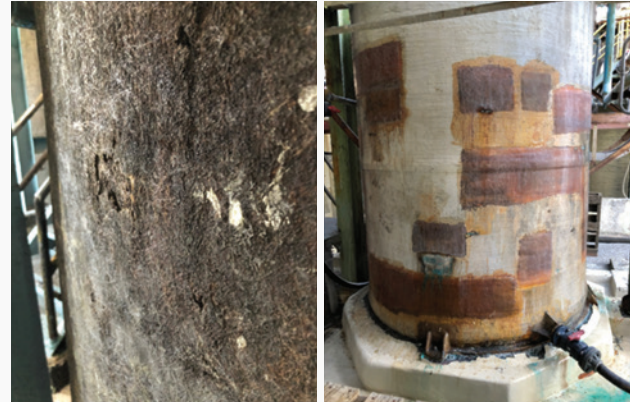
Figure 7. External surfaces that have been damaged; corrective action is required.

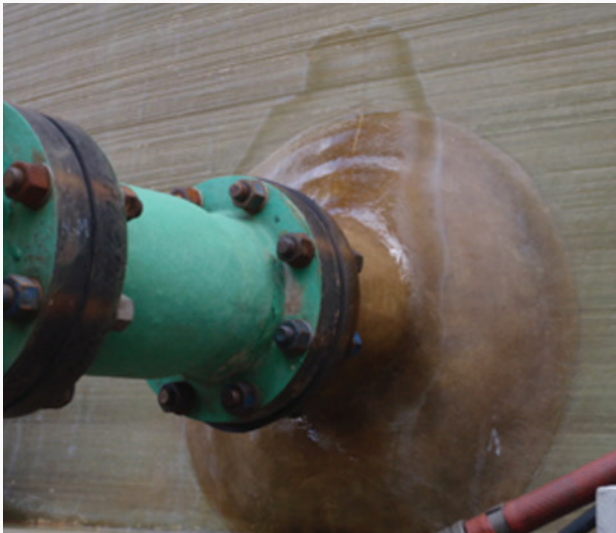
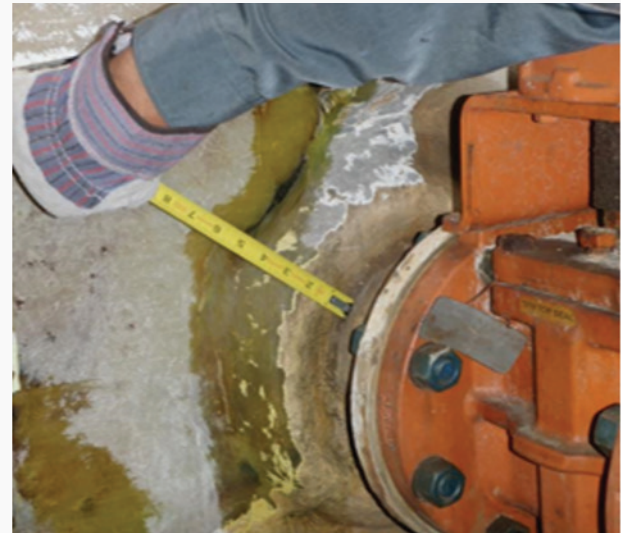
Figure 8. Cracks and leaks in the outer surface that require corrective action.

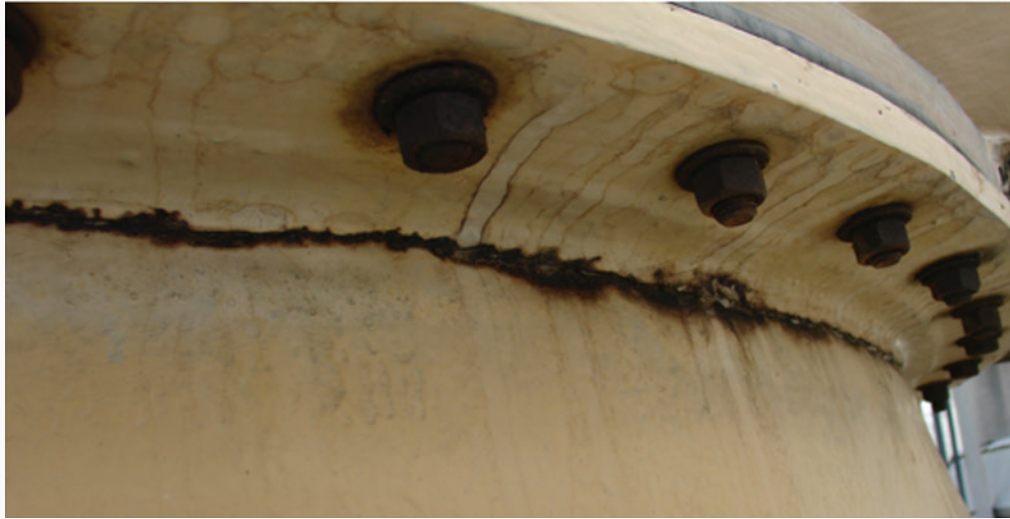
Figure 9. Body flange where corrective action is required.

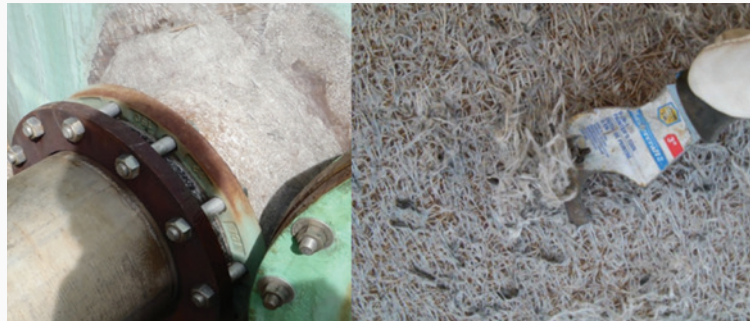
Figure 10. Reinforcement where no corrective action is required.

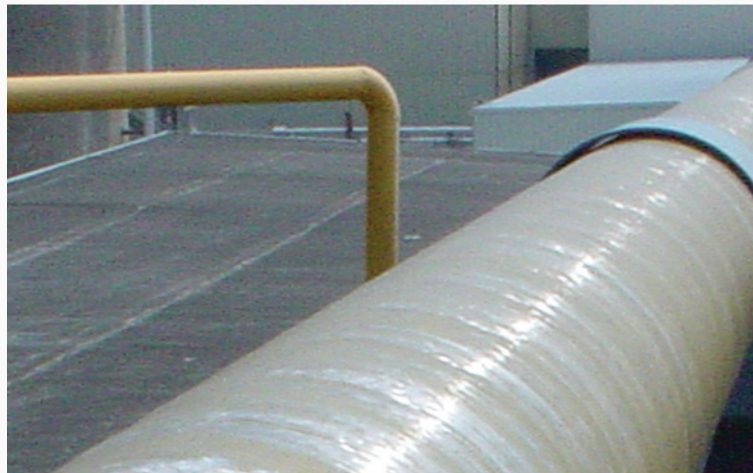
Figure 11. Exposed reinforcement where corrective action is required.

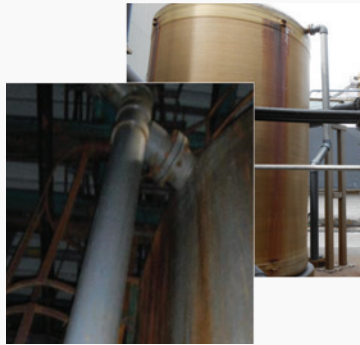
Figure 12. Overflows where no corrective action is required.

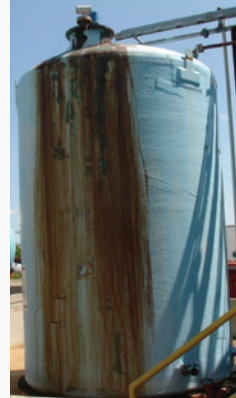
Figure 13. Tank with no overflow; corrective action is required. Note the staining from overfill spills out of the top nozzle. While this tank has not yet failed, every overfilling event creates a new risk of failure.

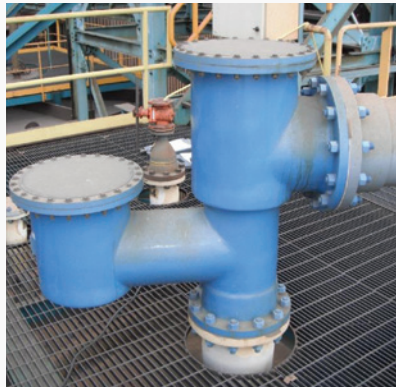
Figure 14. Combined vacuum breaker and pressure relief. Operation can be verified by confirming that the internal disks lift.

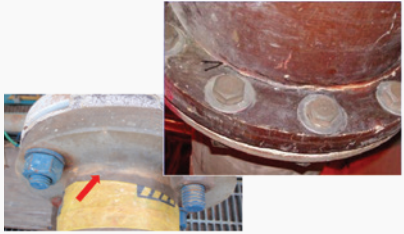
<p>Figure 16. Flange cracks where corrective action is required.</p>
