**PVP2026-183517**

## VERIFYING ALLOWABLE REMAINING STRENGTH FACTOR IN FITNESS FOR SERVICE ASSESSMENT OF FIBER REINFORCED POLYMER PRESSURE EQUIPMENT

<sup>1</sup>UTComp, Inc., Cambridge, ON, Canada

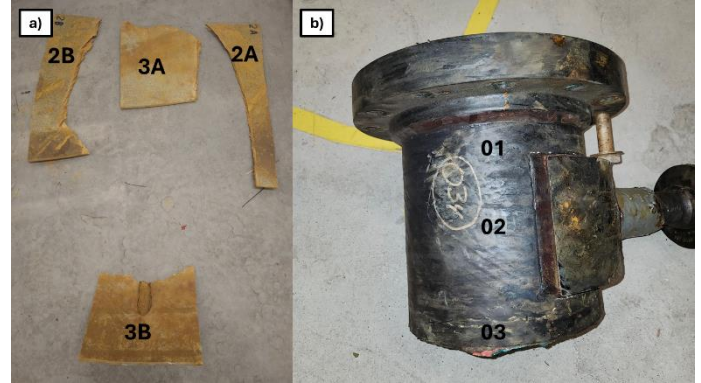
Non-destructive ultrasonic readings were taken on the failed samples using an ultrasonic flaw detector, a 0.5 MHz transducer, and couplant. A standard delay line was used for the failed tank FRP samples, while a reduced-aperture delay (RAD) line was used for the failed FRP spool sample. A RAD line is a delay line with a narrow, rectangular face such that, when held parallel to the axis of a piping component, the face can be completely in contact with the part. Fig. 1a labels each of the samples from the failed tank as it is laid out based on the approximate location of each sample on the tank bottom and Fig. 1b labels each of the Condition Monitoring Locations (CMLs) along the failed spool sample. Readings of the failed bottom head were taken along the failed edge of each sample. Readings of the failed spool sample were taken circumferentially at the highlighted CMLs, avoiding

any extra thickness due to secondary bonding. Readings taken at CML01 and CML02 are further away from the failure interface, while readings from CML03 were taken trying to maximize data from as close to the fracture as achievable.

**FIGURE 1: A) SAMPLES OF THE FAILED BOTTOM HEAD OF A TANK AND B) THE SAMPLE OF THE FAILED PIPING STUB.**

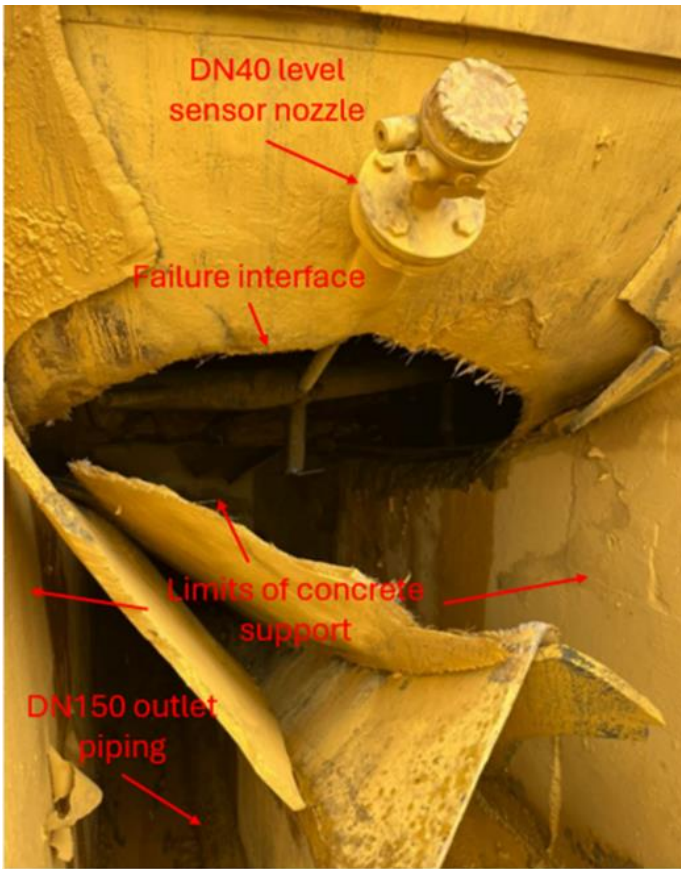
Fig. 2 shows the failure of the atmospheric tank where an unsupported section of the elliptical bottom head collapsed near a nozzle. The bottom of this atmospheric tank was approximately 87% supported by concrete and compacted sand fill.

**FIGURE 2: FAILURE OF THE PARTIALLY SUPPORTED ELLIPTICAL BOTTOM HEAD.**

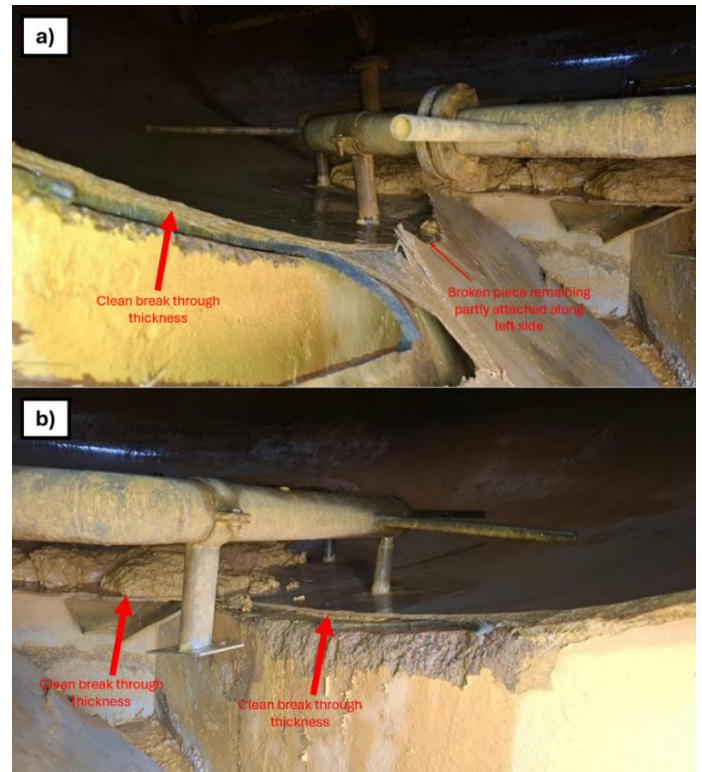
A closer look at the failure interfaces on both the left and right concrete supports are illustrated in Fig. 3. In the figure, there are several areas of clean fracture through the FRP thickness directly where the concrete support ends, with no glass fiber pull-out through the failure line. Contrastingly, in Fig. 2, glass fiber pull-out can be observed on the failure interface near the nozzle. The two interfaces display differing failure modes – the straight fracture along the concrete supports is indicative of long-term brittle fracture, while the inconsistent fracture near the nozzle is indicative of sudden tensile failure of FRP.

The samples of the bottom head measured an LCL thickness of 11.2 mm (0.44 in) and an average thickness of 11.5 mm (0.45 in). UAX results of each sample are summarized in **Error! Reference source not found.** The PDS results of each sample were high and approximately within the same range. There was nothing of note to suggest that the polymer was heavily damaged at the inspected locations.

**FIGURE 3: FRP FAILURE INTERFACE NEAR THE A) LEFT SUPPORT AND B) RIGHT SUPPORT.**

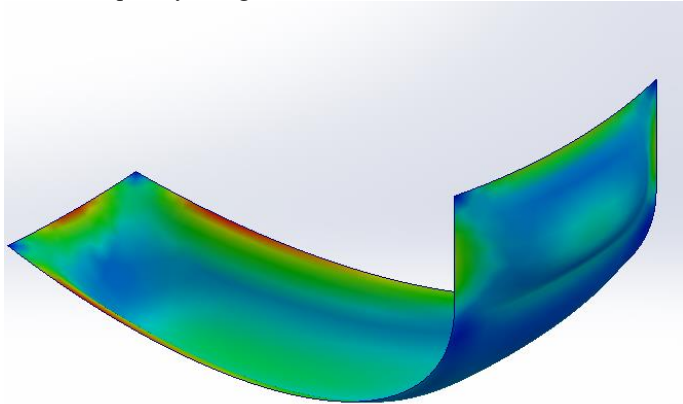
To account for bending stress, the unsupported section of the bottom head was modeled, in Fig. 4, with its theoretical curvature using SolidWorks and the hydrostatic pressure head introduced by vessel contents and the fixed edges from the

support configuration was applied. The nozzle above the failed bottom head section was not modeled since the failure interface at that location, discussed previously, indicated that failure did not initiate from there. For the average measured thickness, the maximum stress was 85.8 MPa (12.4 kpsi), located at the fixed edges. The determined maximum bending stress of the bottom head is significantly greater than the allowable bending stress of 15 MPa (2.2 kpsi) provided in ASTM D3299 [10]. The location of maximum stress areas in the model corresponds well with where brittle fracture was observed in Fig. 3, along the end of the concrete supports. These results indicate that the bottom head was inadequately designed.

**FIGURE 4: FEA MODEL OF THE UNSUPPORTED BOTTOM HEAD SECTION.**

Given that the bottom head of the tank was improperly designed, the FEA model was adjusted and used to determine the pressure for which operating stresses fall within the allowable range of the design standard based on its known thickness. The pressure at which the allowable bending stress is reached was 27.7 kPa (4.0 psi). Meanwhile, the operating hydrostatic head of the tank was determined to be 158.3 kPa (23.0 psi). The influence of the disparity between design and operation on the FRP can be reflected by RSF. Using Equation (2) and the lowest LCL PDS measured in **Error! Reference source not found.**, RSF was determined to be 0.064, which is lower than  $RSF_{FRPa}$  [1]. Despite failing to comply with the standard it was designed to; the bottom head was in service until RSF reduced to point of failure twenty years later.

Since the bottom head at failure measured less than  $RSF_{FRPa}$ , this indicates that had the bottom head been assessed prior to failure, it would have been determined as not Fit for Service. The FFS criterion for  $RSF_{FRPa}$  serves as a conservative limit that could have seen the equipment repaired, replaced or re-rated at a realistic point before failure.

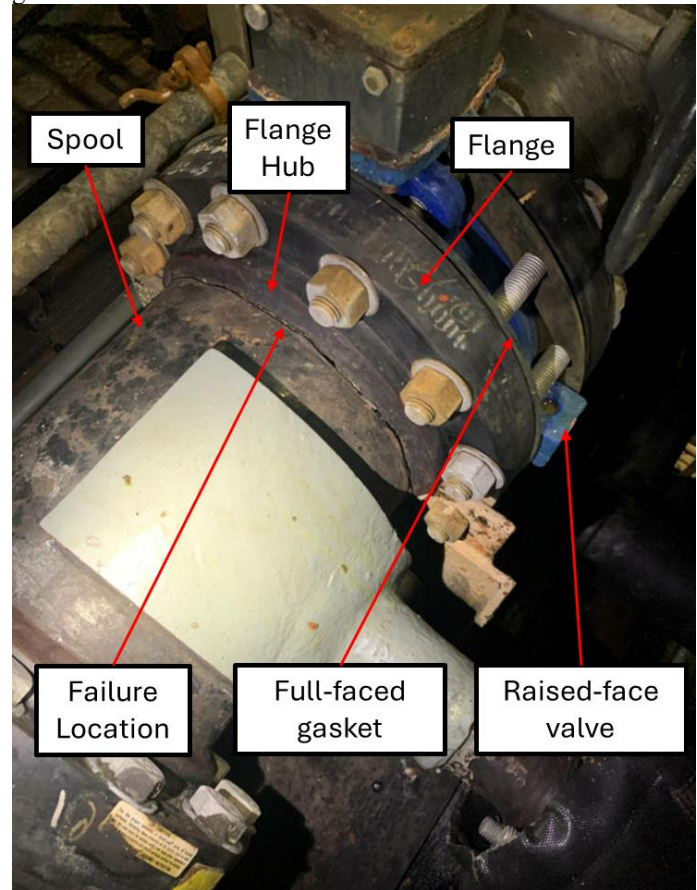
The failed spool component was attached to a flange which was connected to a butterfly valve, as shown in Fig. 5. The failure location on the spool was immediately located next to the reinforcement hub of the flange. It is important to note that while a full-faced gasket was used at the flange connection to the valve, the effective gasket area is equivalent to that of a non-full-faced

gasket because of its connection to the raised face flange of the butterfly valve. The raised face flange only partially supports the full-faced gasket. All standards pertaining to FRP flanged connections required full-faced connections with full-faced gaskets.

**FIGURE 5: FAILURE OF THE PIPING STUB.**

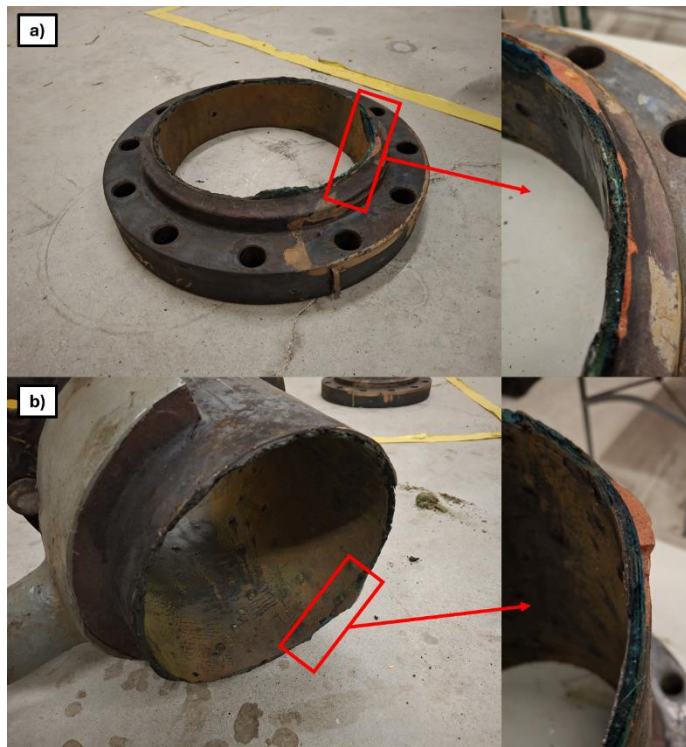
The failure interfaces on the flange and spool components are presented in Fig. **Error! Reference source not found.a** and Fig. **Error! Reference source not found.b**, respectively. On both interfaces, blue discoloration can be found. The source of the resin discoloration is unclear. The failure interfaces on the two components are notably very flat with little fiber pullout, indicating near-simultaneous circumferential brittle fracture of the spool.

The failed spool measured a thickness of 7.4mm (0.3 in). Ultrasonic readings were also taken along the spool according to Fig. 1b and the PDS results are presented in Table 4. The PDS for CML03 is significantly reduced compared to the PDS for both CML01 and CML02. This reduction in strength indicates that the resin at the failure location was experiencing more chemical and/or physical damage compared to other sections of the same spool further away from the flange. To determine whether this reduction in strength was enough to cause failure during service, RSF was calculated for the failure location using LCL PDS values from CML03. The attenuation of the moment at the flange through its hub was considered and the RSF of the

spool immediately adjacent to the hub was determined to be 0.097 using Equation (2), which is less than the  $RSF_{FRPa}$  of 0.125 stated by WRC601 [1]. In the RSF calculation, for service conditions, it was assumed that the bolting for the flange connection was installed using the bolt load required for a full-faced gasket as required by ASME NM.2 [12]. However, the over-torquing of the bolts past this load was also likely due to poor installation practices.

**FIGURE 6:** THE FAILURE INTERFACE OF THE A) FLANGE AND B) SPOOL.

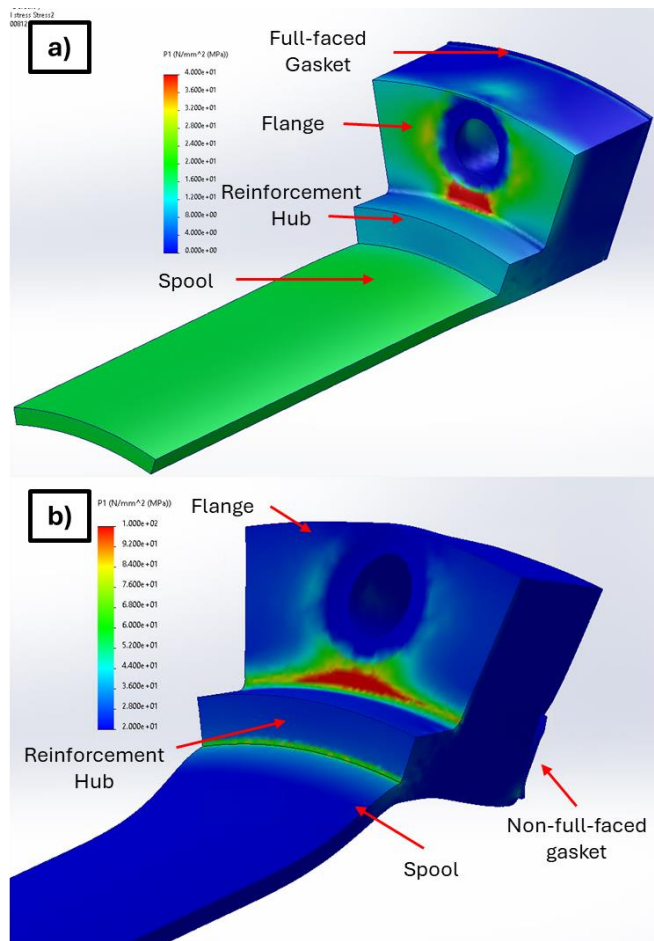
The mechanical behaviour of the piping stub was also modeled in Fig. 7a and 7b for the design and operating conditions, respectively, to further illustrate the RSF findings. If the flange was installed properly with a full-faced gasket connection, the spool would experience a stress of approximately 20 MPa (2.9 kpsi) immediately adjacent to the reinforcement hub. Instead, because of its connection to a raised-face butterfly valve, the spool near the flange hub was estimated to experience a bending stress between 60-80 MPa (8.7-11.6 kpsi). The raised-face condition significantly increases the amount of stress within

the spool. Markedly, the model shows that the location of highest stress is between the flange bolt hole and the reinforcement hub in both cases. However, the flange did not fail in this location. The location of failure experienced different service conditions compared to the area above the reinforcement hub. While the amount of stress it sustained was lower, the spool was constantly exposed to hydrochloric acid during service. The presence of chemical attack is assumed in the application of  $f_{sp}$  in Equation (2) for the RSF calculations for the spool. For the area near the bolt, the true value of  $f_{sp}$  is likely higher which explains the absence of cracking around that area.

The stress concentration at the spool to hub transition in the model also reveals that the flange reinforcement hub is not sufficiently long to accommodate for the bending moment at the flange. The attenuation of the bending moment through the length of the reinforcement hub using Timoshenko's method highlights that there is still localized bending moment remaining and it has not yet decayed at the end of the hub for both design and operating conditions [15]. This behaviour is reflected in the determined RSF value. ASME NM.2 mandates that the hub length is equal to or greater than three times the flange thickness which aids to prevent this issue [12]. From Table 2, the reinforcement hub length for the piping stub was only 26 mm (1.0 in) and the flange thickness was 50 mm (2.0 in), and as such, the residual bending moment created bending in the thin wall of the pipe.

**FIGURE 7: SOLIDWORKS MODEL OF THE PIPING STUB FOR A) DESIGN AND B) OPERATING CONDITIONS.**

High bolt loads, in addition to the improper flange connection and insufficient reinforcement hub length, imparted a bending moment on the spool for which it was not designed to handle. The bending moment introduced by in-service configuration of the stub resulted in sustained stresses in a spool already undergoing chemical attack, leading to the weakening and ultimate failure of the FRP. Notably, the spool was able to withstand these operating conditions for more than twenty years. However, at the end of its service life, the determined RSF of the spool ultimately did not meet  $RSF_{FRPa}$ , showing that the spool would have been deemed not Fit for Service had it been inspected and assessed to WRC601 procedures prior to failure. The application of  $RSF_{FRPa}$  as a means to determine FFS in this case would have provided a conservative end of life with a reasonable margin to allow repair.
