FIN FAN BLADE CASE STUDY

OWNER:
Global Oil & Gas Company

FACILITY LOCATION:
Ontario, Canada

EQUIPMENT NAME:
Fin Fan Blade

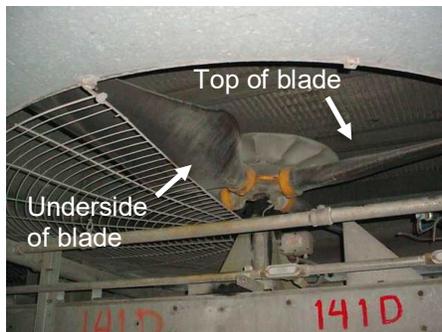
Figure 1 - Fin Fan Blade (In Service)

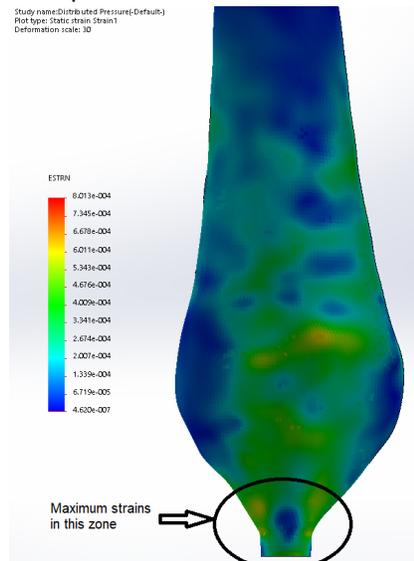
Figure 2: SolidWorks model

UTComp utilized 4 fan blades supplied by the Owner, constructed a computer simulation model of the blade using SolidWorks and verified and refined the model by measuring deflections of the blade under known load conditions. The SolidWorks Model predicted that the area with the highest strains are closest to the hub and can be accessed as seen in Figure 2.

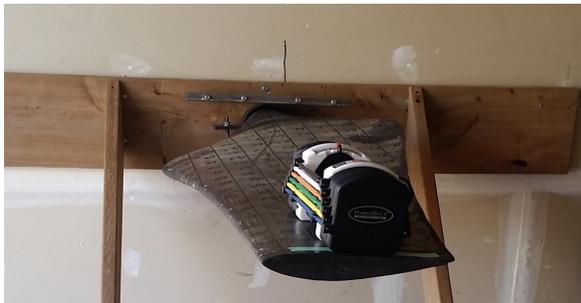
Figure 3: Load testing

The load that an individual fan blade will experience when in operation was then determined using the Fin-Fan specification sheet. The loads the blade experienced when attached at the hub were calculated. The maximum moment in the hub was determined using the uniformly distributed load or static pressure.

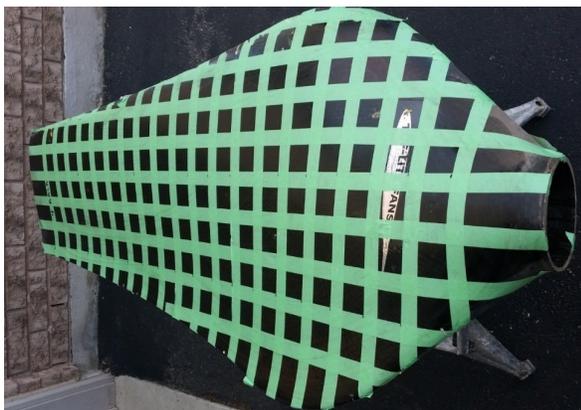
The surfaces of the blades were marked out with a 64x64mm (2.5x2.5in) grid. Measurements were taken to each gridline intersection. The blade was then rotated 180 degrees and measurements repeated on the other side.

Figure 4: Grid pattern on blade the blades with cut-away hubs. This was analyzed to determine nominal ultrasonic velocity through the
