UTComp[®] System Used in Preventing Failure

This case study describes how UTComp[®] System analysis of a Fiberglass Reinforced Plastic (FRP) tank identified risks to the vessels and detected damage that could result in failure. From this work, other recommendations are made to increase the reliability of FRP fabrications.

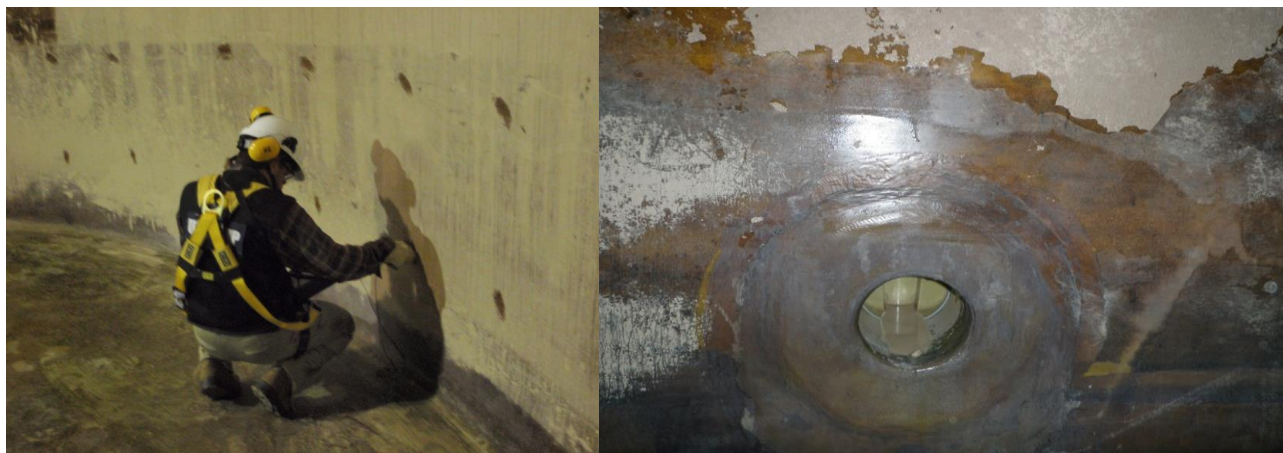
Figure 1 - Data Collection and CB Appearance

Structural evaluation by the UTComp® System of the FRP in the vessel shells has revealed that the average strength of the FRP has declined to an average of 60% of the original values. In some locations, such as near the nozzle shown in the right photo of Figure 1, the strength is at 50% of the original value. As part of the ongoing verification process of the UTComp® System, the cutout from a new access placed in the tank shell has been destructively tested to verify the UTComp® results.

Although darkened by process temperatures, the corrosion barriers have maintained excellent hardness, gloss and thickness with no visible evidence of permeation of vessel contents to the structural layers. Dynamic Mechanical Analysis (DMA) of the shell has shown almost no change to the resin properties. Barcol hardness of the inner surface is higher than the manufacturer's published value. There were no visible indications of damage to the vessel.

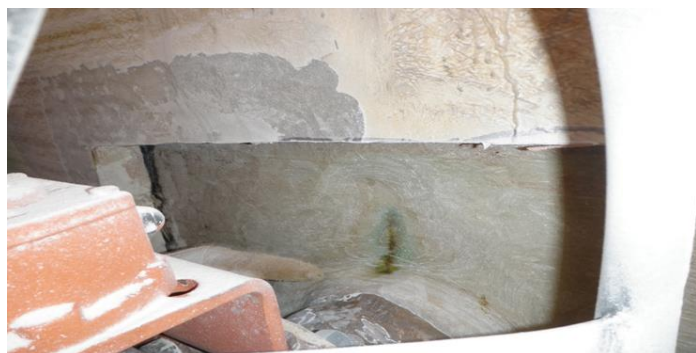
Figure 2 - Crack

As a result of experience with several failures that have occurred at nozzles - where the shell stresses are increased by the presence of the hole - it is Standard Practice for UTComp to take ultrasonic readings through nozzle reinforcing pads (repads) to determine whether the repad is attached all around. At the nozzle shown in Figure 1, several significant anomalies were identified where the repad was not bonded. At these anomalies, the strain in the shell was determined to exceed 0.2%.

External inspection at the nozzle found a vertical crack that extended from under the repad, but was hidden by the cladding. The crack had HCL from the vessel in it, showing that there was a leak in the tank. Further investigation found that the leak started from the internal seal bond in the nozzle and found its way into the structural layers and under the reinforcing pad for the nozzle. A crack developed in the shell along the axial direction starting at the top of the nozzle penetration. The crack had not progressed through the shell thickness. There was no sign of the crack in the corrosion barrier. The appearance of the crack in the outer surface, after removal of the cladding layers and some of the repad is shown in Figure 2.

The vessel was repaired and returned to service. The section of shell with the crack was removed for analysis. Only the structural laminate was affected by the crack and the depth of the crack was about 25% of the shell thickness. Chemical and microscopic analysis was completed by Owens-Corning. The analysis concluded that SCC had occurred to the glass fibers and they failed at the operating strains. Undetected, this could have led to failure of the tank and significant losses for the Owner.

- Wherever possible, all nozzles of size DN200 (8 inch) and smaller should use penetrating-type installation to improve bonding,
- Use UTComp® System for structural evaluation of all key sections of FRP equipment to optimize reliability.
