Using Ultrasonic Technique to Determine Fitness for Service of FRP Equipment for Chemical Handling Applications

Pradip Khaladkar,

Geoffrey E. Clarkson,

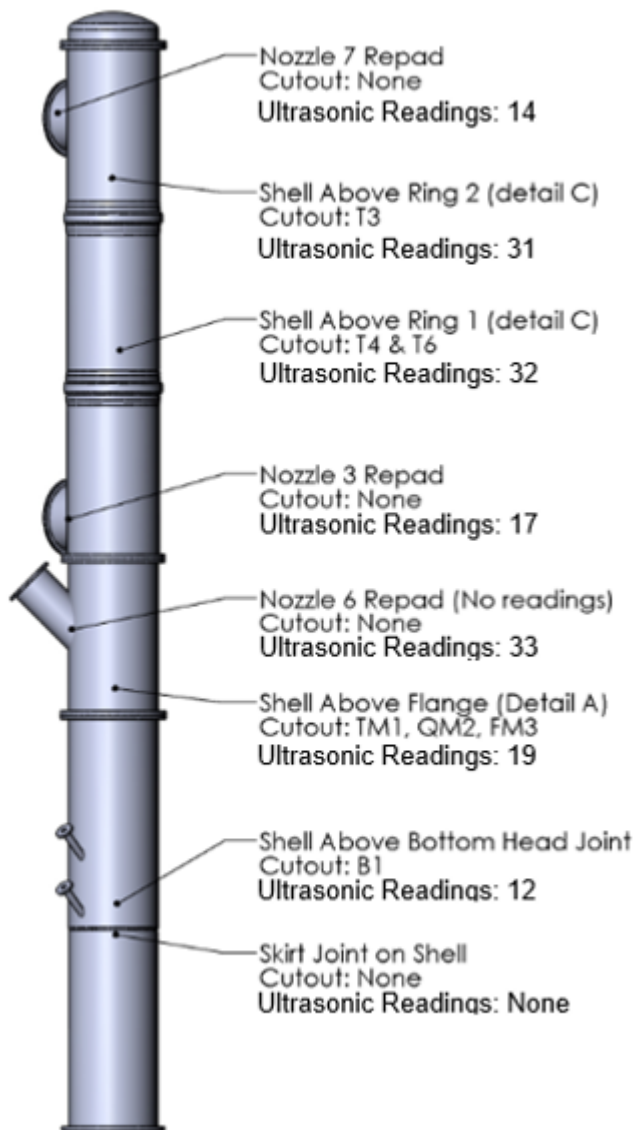
Figure 3 - Inspections

Description of ultrasonic inspections and the locations of cutouts removed for verification is shown in Figure 3 along with details of inspection locations.

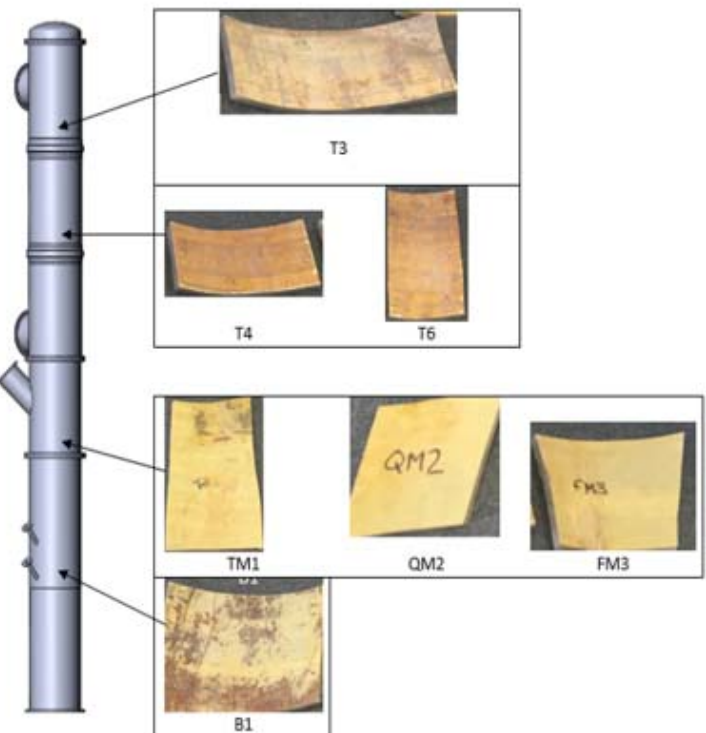
Figure 4 – Cut-outs from Scrubber

After the non-destructive readings were taken, portions of the FRP shell were removed for comparative evaluation. Figure 4 shows all of the cutouts removed from the vessel along with their locations. Cutouts FM3 and QM2 were not used for quantitative property verification because they were too small or did not have uniform thickness. The cross-section of some of these samples were examined for verification of the condition of the corrosion barrier as reported from the ultrasonic analysis. This was the first time that the inspector witnessed the internal condition of the FRP.

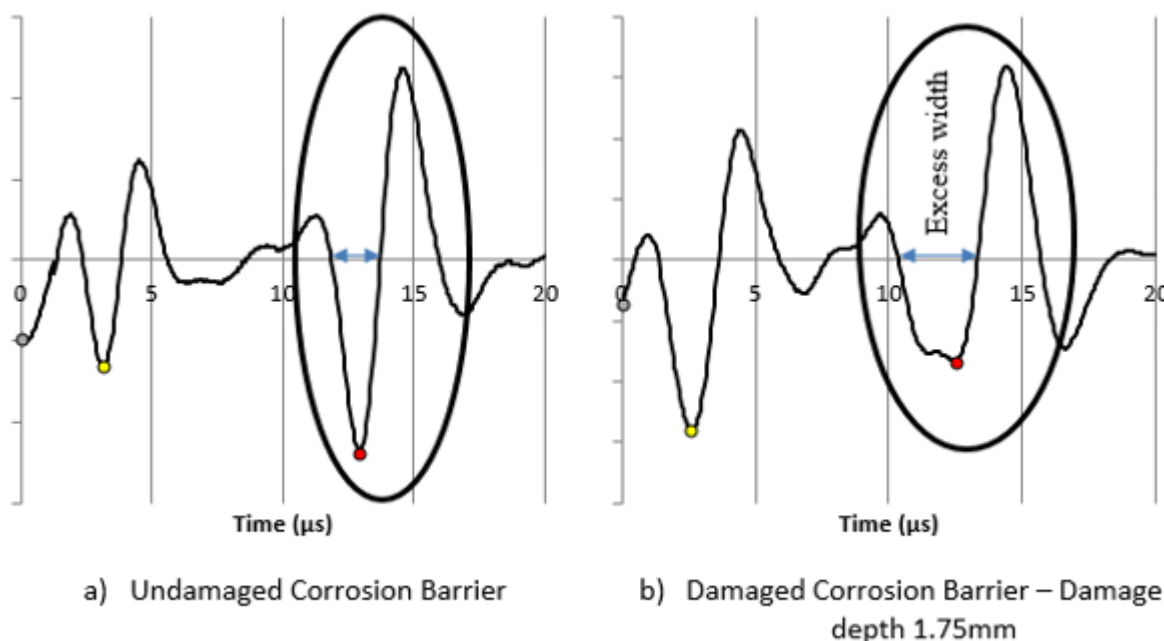
Figure 6. Typical Corrosion Barrier Analysis

Corrosion barrier assessment was completed by evaluating features within the opposite surface reflection of the ultrasonic reading. Figure 6 shows a typical comparison taken from different locations in the Shell above Ring 1 (Detail C, Cutout T4). Common features used to determine if damage had occurred are the width of the main reflection lobe (circled area) and the presence of undulations in the reflection.

In Table 3, the average depth of corrosion barrier damage detected for the shell sections above rings 1 and 2 was 1.25mm. Based on the shape of the reflected ultrasonic signal, the type of damage was assessed to be caused by oxidation of the resin. Several of the cutouts were examined to quantify the damage to the corrosion barrier.

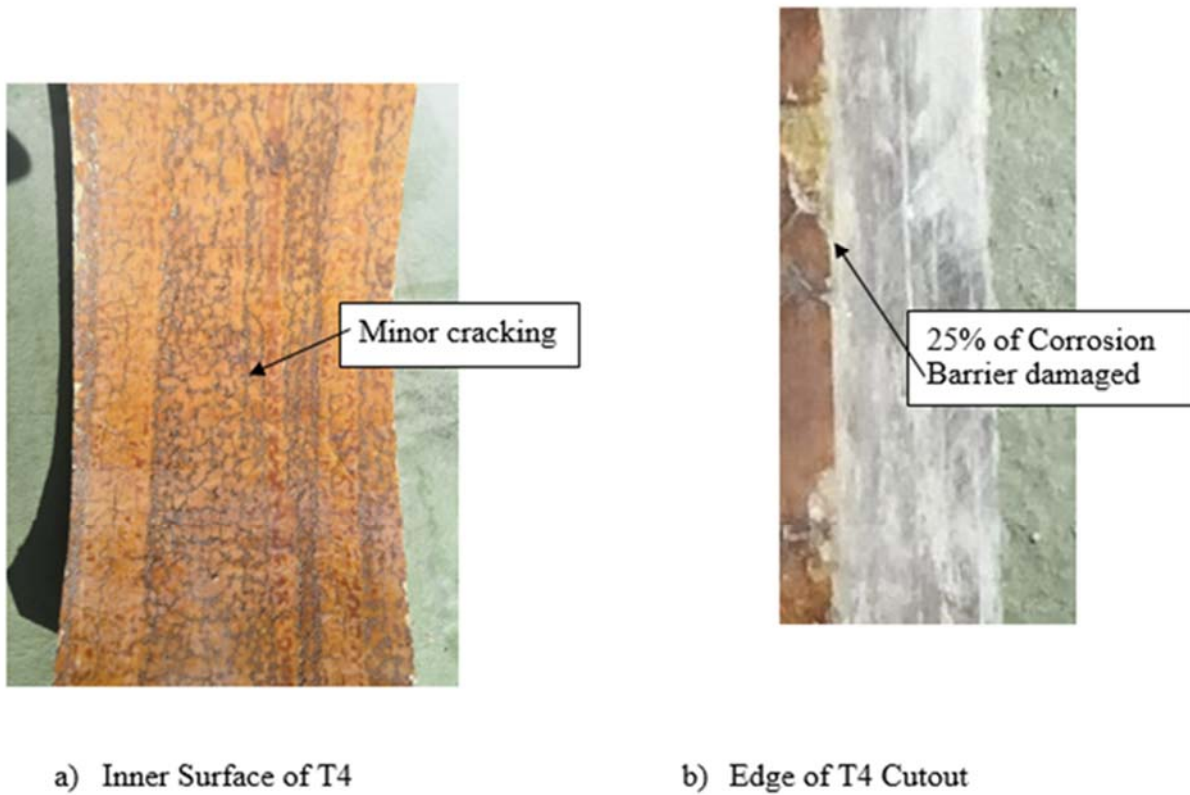
Figure 8 – Corrosion Barrier

Evaluation of the cutouts confirmed the ultrasonic results where the damage depth to the corrosion barrier was measured in the lab to corresponded to the results in Table 3.

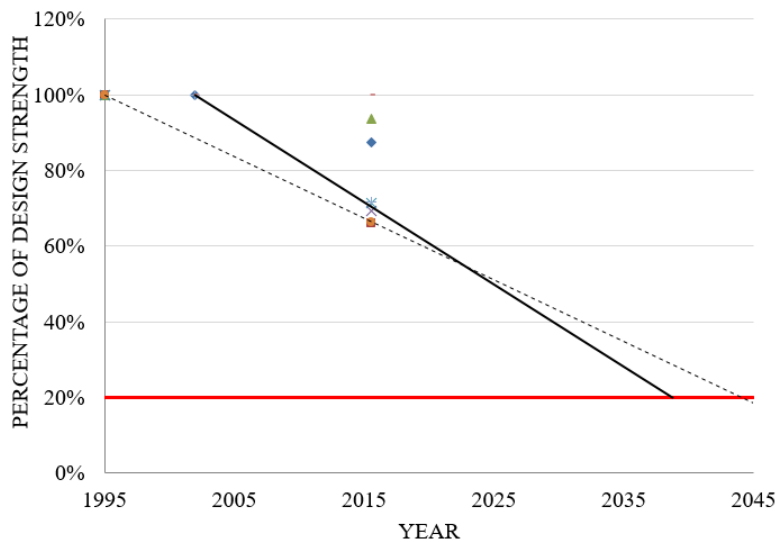
Figure 9 – Chart Showing Remaining Service Life

The principal output of this novel ultrasonic analysis is PDS. PDS can be used to provide a prediction of the remaining time when the FRP will have sufficient structural capacity. Graphical illustration of remaining service life prediction where the minimum allowable PDS is set to 20% is shown in Figure 9.

For this scrubber, this was the first evaluation using this method and no previous data was available. When this occurs, it is conservative to assume that the new FRP had 100% of its theoretical strength when new. Also, note from above that the upper sections and lower section were different ages.
