MODEL TO OPTIMIZE THE DESIGN OF FIBERGLASS REINFORCED PLASTIC IN CHLORINE DIOXIDE SERVICE

Geoff Clarkson, P.Eng, FEC
Principal Engineer: UTComp Inc.

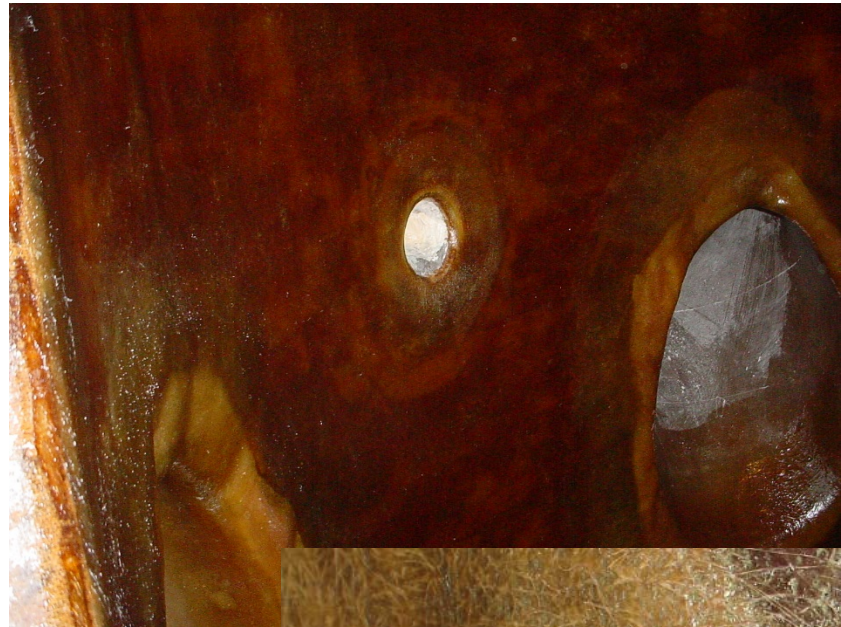
- ▶ Relining

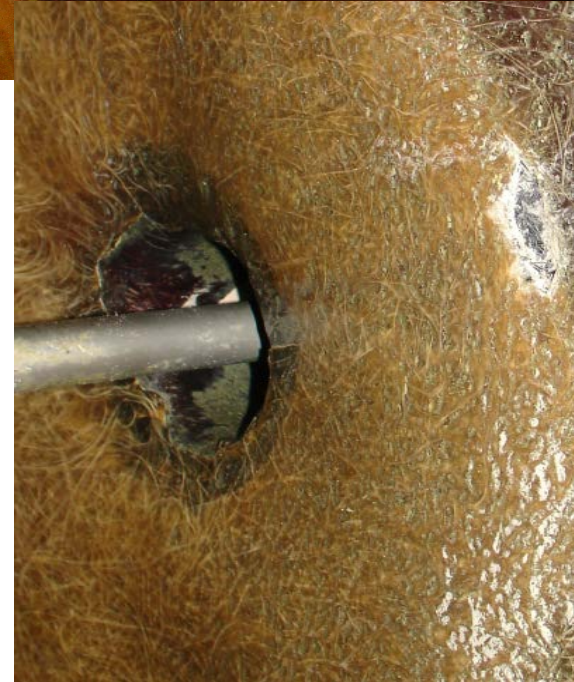
- ▶ Misses inside of small nozzles

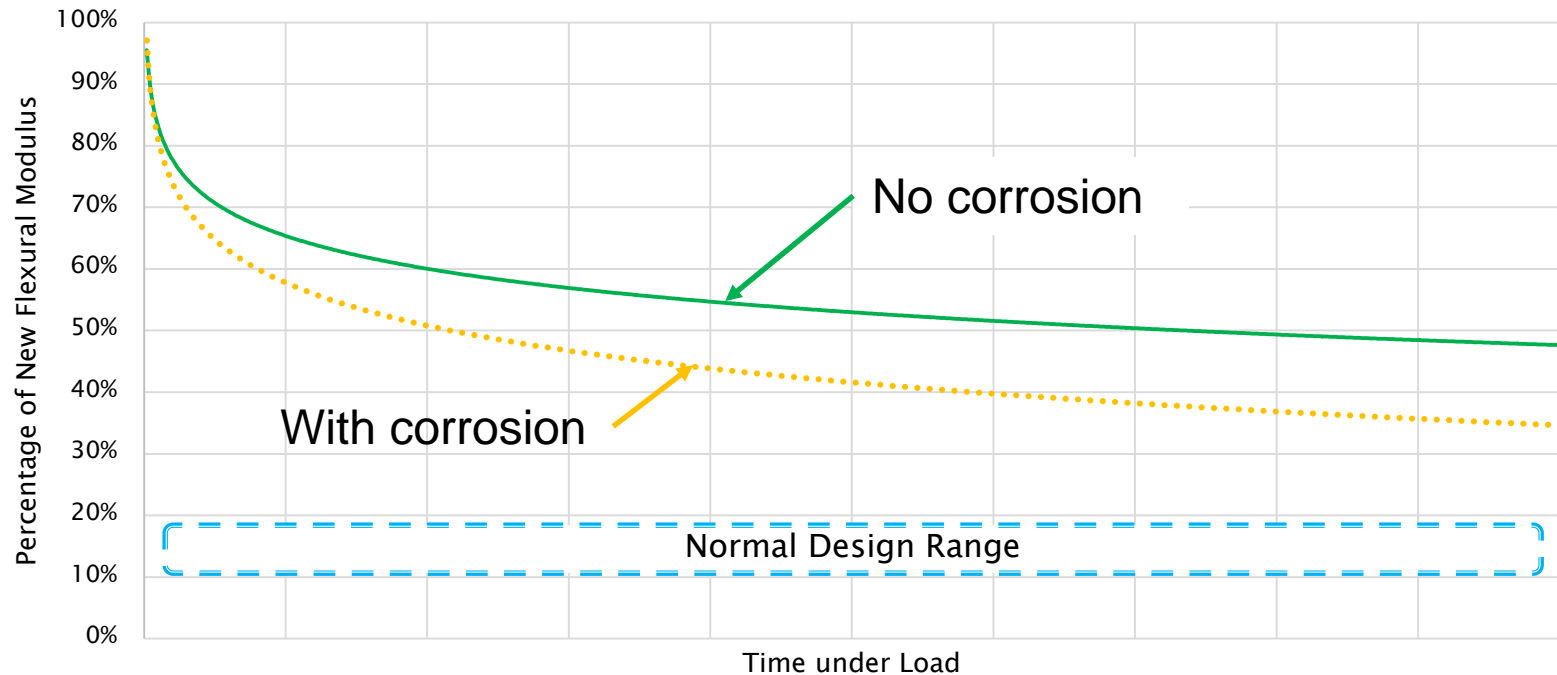
Creep in Service

Occurs in any chemical service
Damage to CB will depress the curve

- ▶ Ensure that adequate design factors are used.
 - Factors in most standards are adequate.

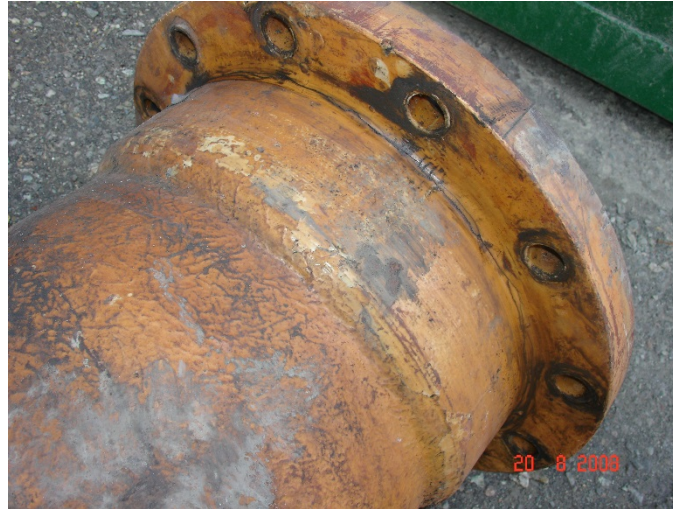
- ▶ Avoid Flat Face

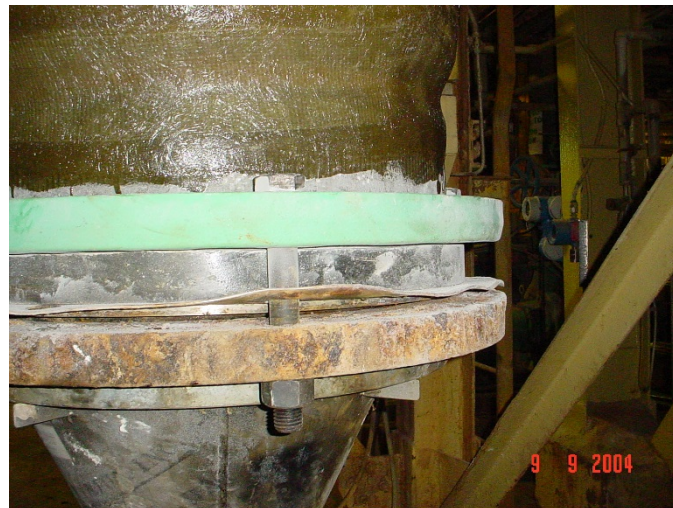
- ▶ Use Lap-Joint (Vanstone) Type

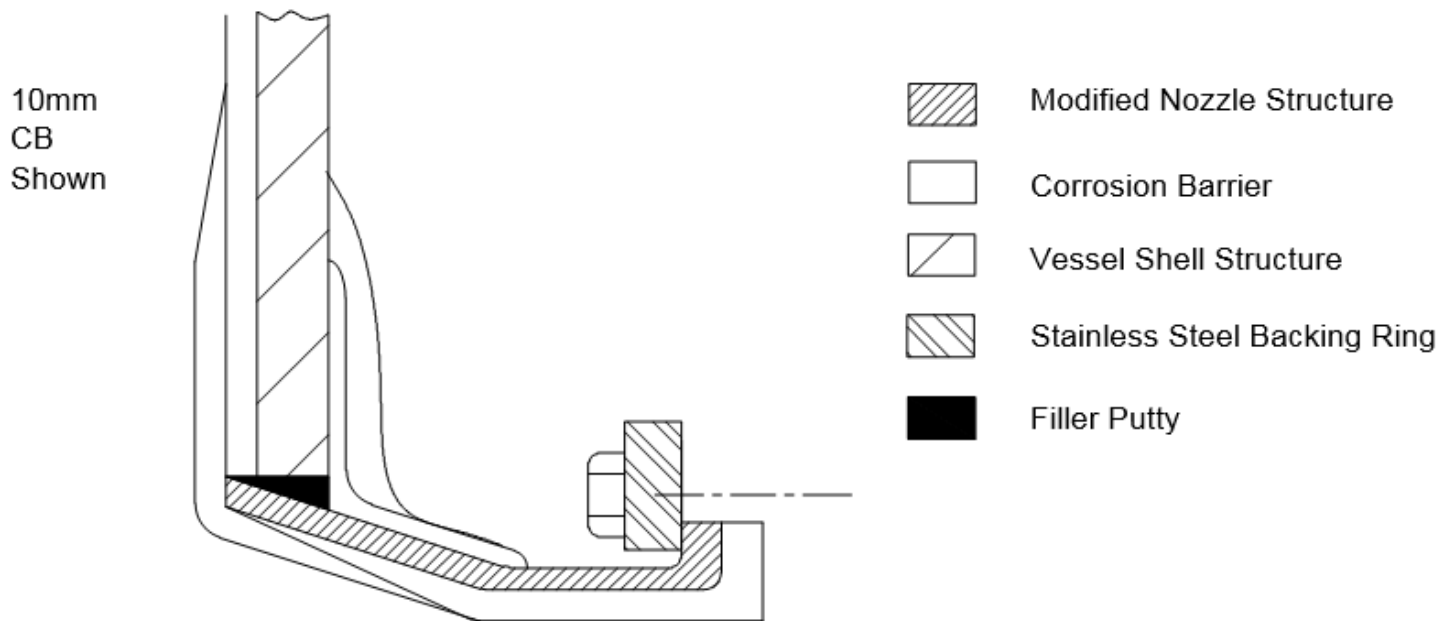
► Typical 4" Engineered Nozzle

1. Use the best resin available.
2. Get the best resin cure possible. Specify post curing.
3. Increase corrosion barrier thickness.
 - Improve nozzle design to suit....

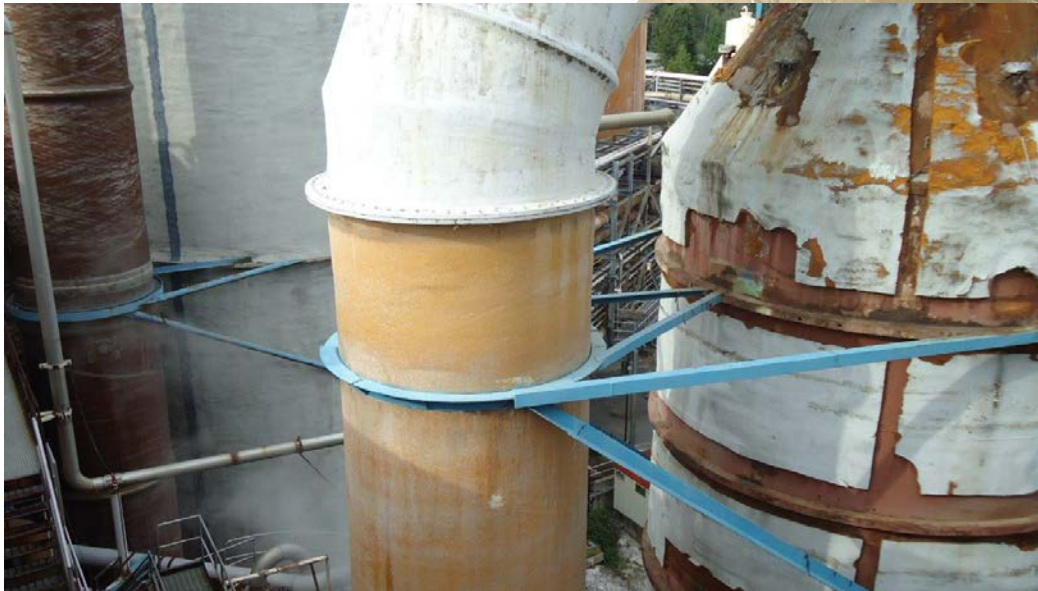
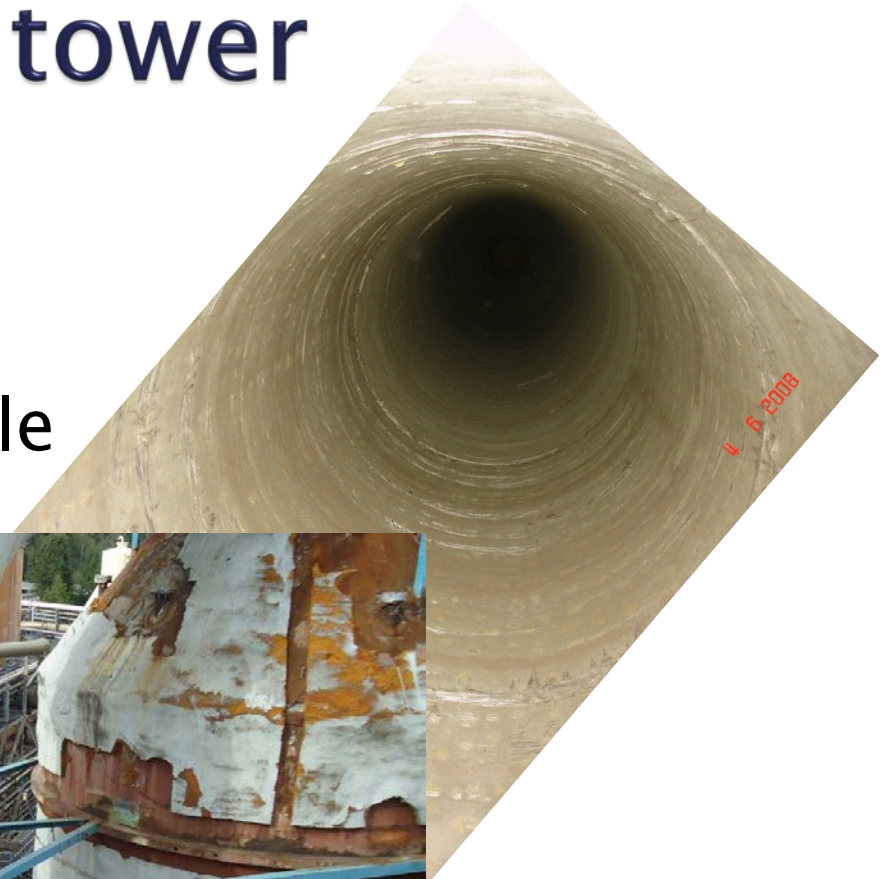
D stage upflow tower

- ▶ Outdoors
- ▶ New in 1970's
- ▶ Structural fibers visible

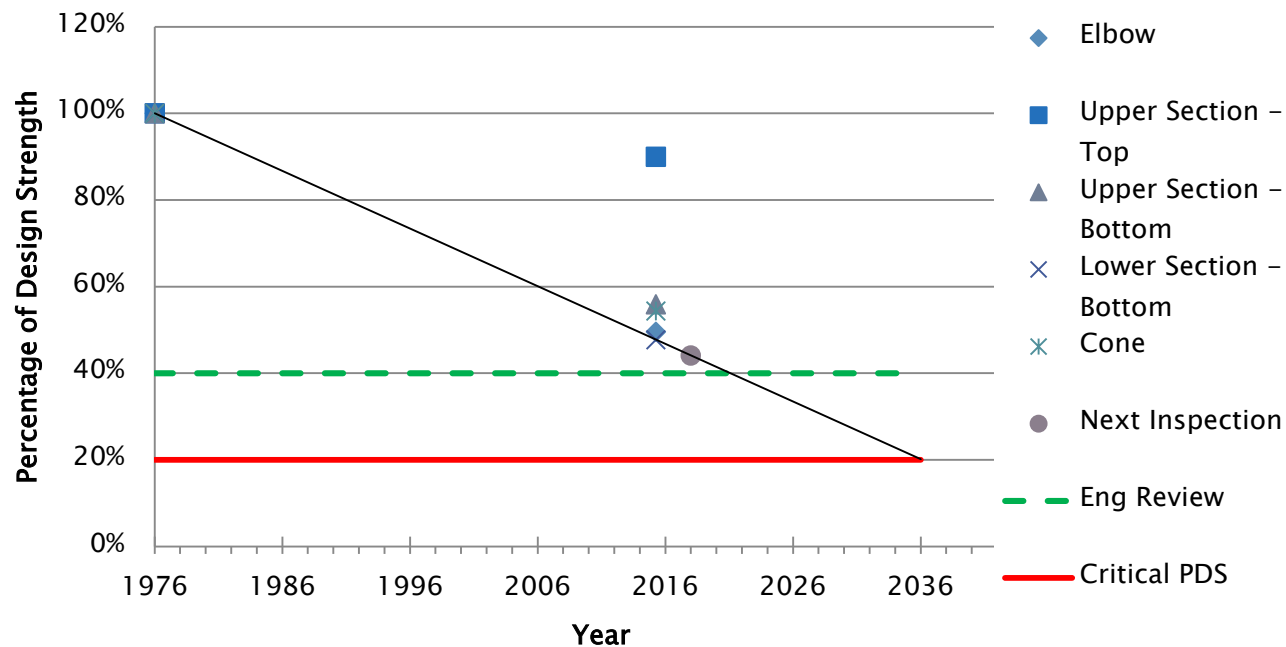
D stage upflow tower

- ▶ Current inspection results:
 - Tower has 50% of original capacity.
 - Expected remaining life is 20 years.

- ▶ Plans to reline next year
- ▶ Based on structural evaluation, the tower will be 60 years old at the end of its life. Why not plan to replace in 10 to 15 years rather than undertake a repair that is almost as costly?
