Predicting FRP Remaining Service Life:
What if you could know?

Provide meaningful Fitness for Service (FFS) and condition assessment of FRP.

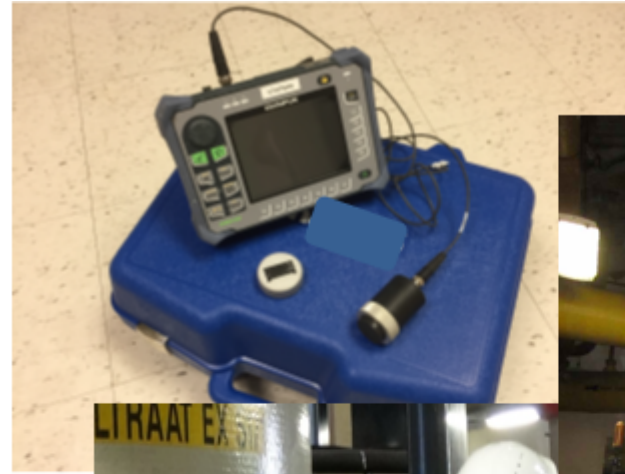
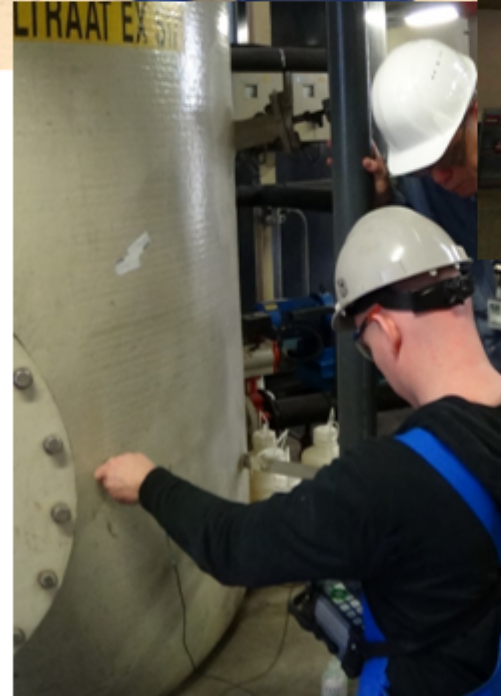
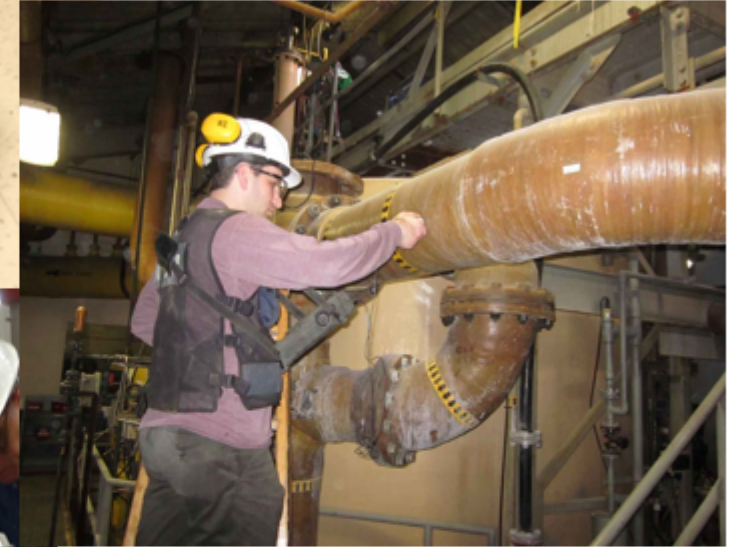
Inspection

- ▶ Uses off-the-shelf UT hardware
- ▶ Proprietary software
- ▶ Off-site analysis
- ▶ Non-destructive
- ▶ Non-intrusive
- ▶ Creep, Thickness and CB Damage Depth come from A-Scan.

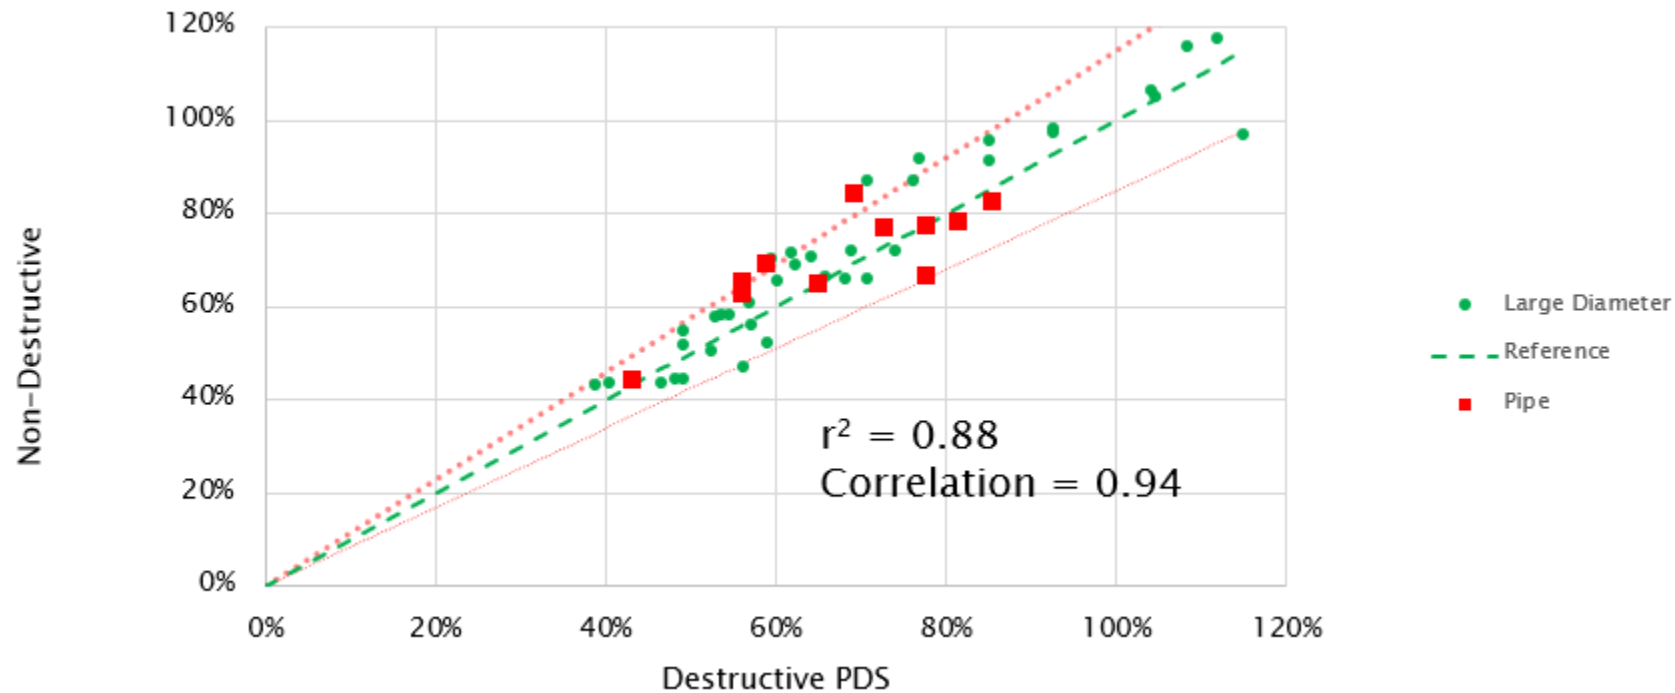
- ▶ Testing creep results against destructive testing

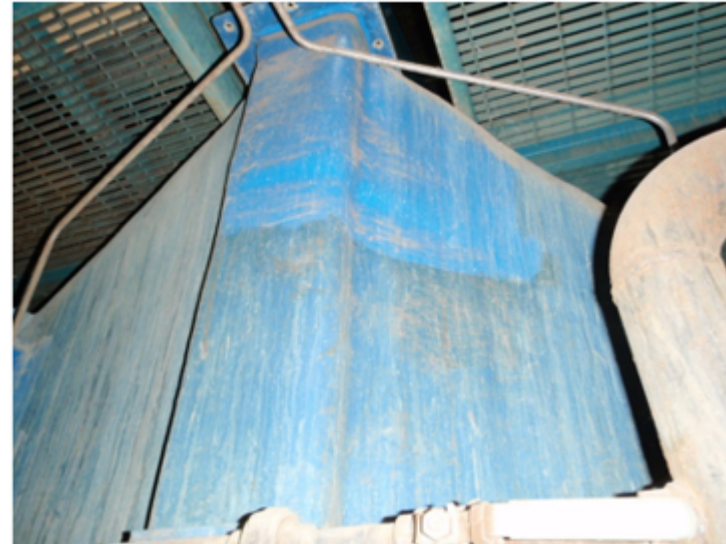
- ▶ First inspection in 2009.
- ▶ In 2010 creep was noted.
- ▶ 2011 engineering analysis and repair recommended.

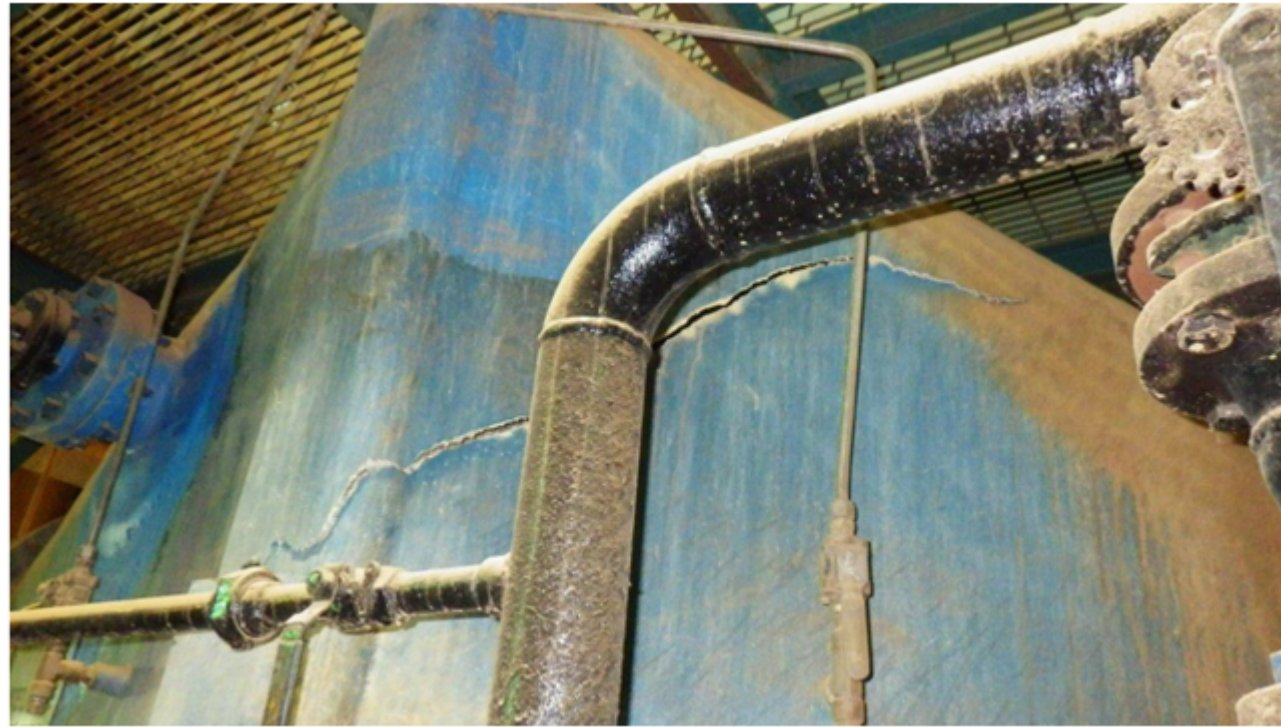
Case Study – Vacuum Vessel

- ▶ March 2014: Design of repairs complete and planned for May
