CASE STUDY: SCRUBBER DEMONSTRATION

UTComp[®] data was collected from sections of a retired FRP Scrubber that had been used to clean vented vapours. The scrubber used caustic liquor to remove chlorides. This is the 1st time that UTComp[®] Evaluation has been completed for this equipment. The vessel was insulated and insulation was removed from the areas to be inspected.

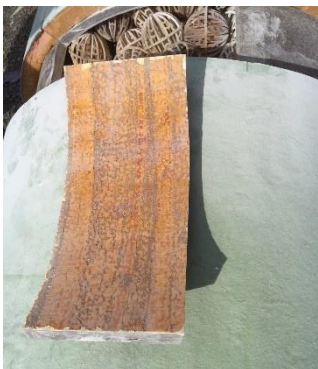
Photo 2: Cut Section with Corrosion Barrier Damage

The photo to the left shows the cut out section of concern by the customer. As can be seen, the interior of the scrubber shows significant visual corrosion barrier damage. However, this is a surface concern only and the shell shows good condition and remaining strength. This was validated by the UTComp System, which did not require confined space entry or destructive testing or holes to be cut in the equipment.

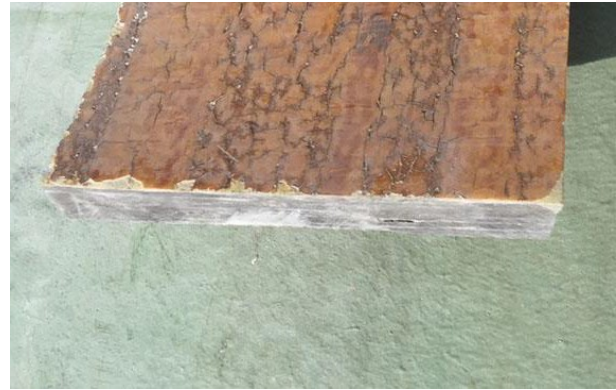
To the right is a close up of the corrosion barrier damage and the shell. It can be seen that the damage to the scrubber is limited to the surface of the interior. Using the UTComp Analysis a 1.25mm corrosion barrier damage was detected and confirmed using measurements.

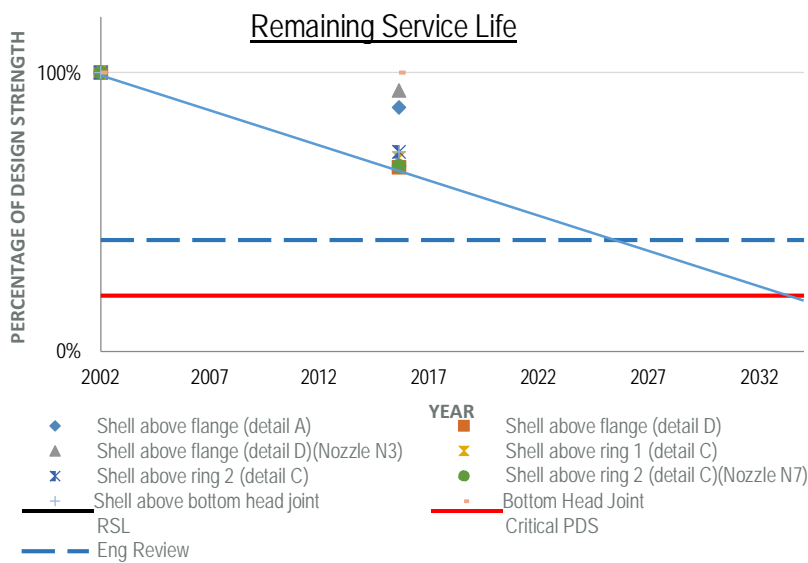
UTComp completed the analysis of the files collected and the results are in the graph (right).

UTComp recommended that the next inspection be completed in 2018, and estimated the year this equipment will reach its critical Percentage of Design Strength (20%) will be 2034, 19 years from the date of the inspection.
