## FRP CORROSION BARRIER INSPECTION: NON-DESTRUCTIVE AND NON-INTRUSIVE TECHNIQUE

GEOFF CLARKSON, P.ENG., *Founder and CTO at UTComp Inc.*

**VOLUME 26, ISSUE 2**

MARCH | APRIL 2020

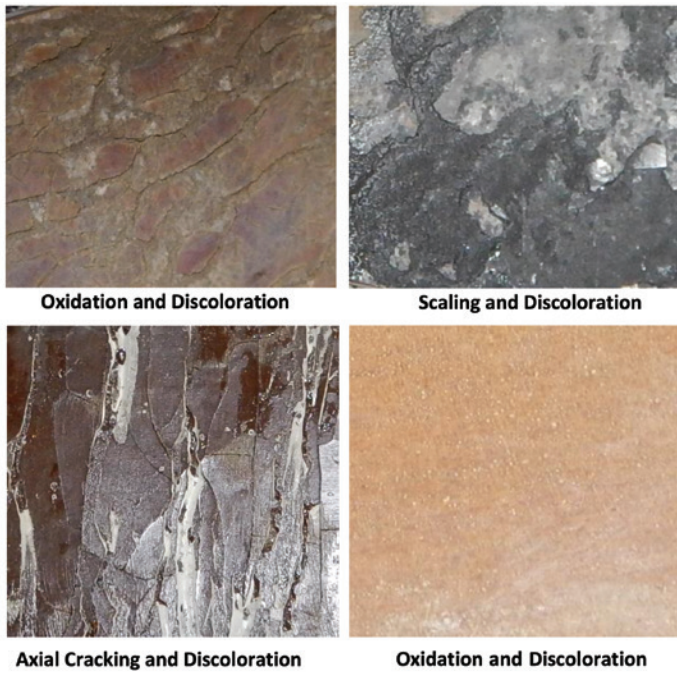
Figure 2. Examples of Corrosion Barrier Appearance

Inspection practices started with visual assessment of the corrosion barrier surface inside FRP containers or pipes. The images in **Figure 2** show surface appearance that may result from a sample of different service conditions. The examples show oxidation, discoloration, scaling, and axial cracking. Note that in all cases, the polymer is opaque and nothing can be seen beneath the surface. These examples come from a wide variety of service conditions and chemical exposures.

In the case of the cracking and the oxidation, it may be possible to estimate the depth of damage without damaging the intact FRP, but the other visible features offer little information about the depth of damage or diffusion of chemicals into the FRP.

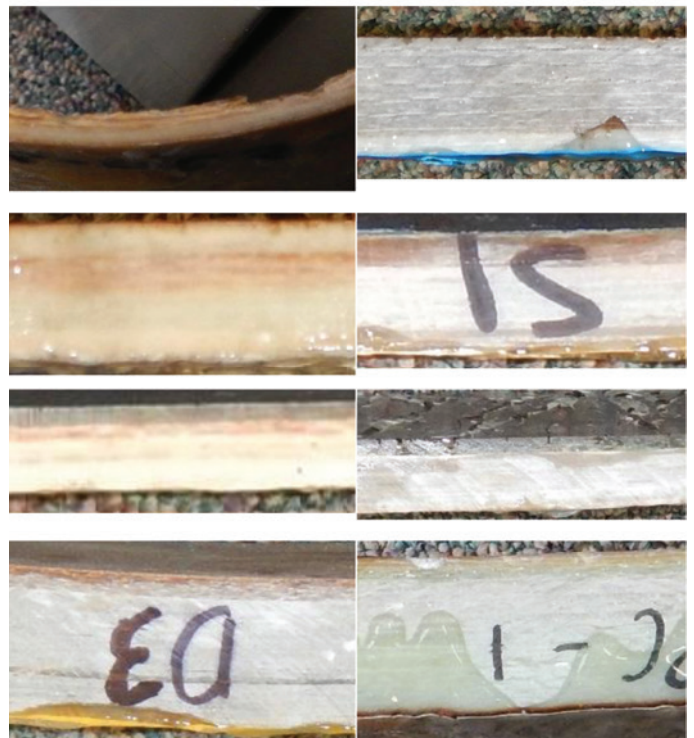
**Figure 5.** Some of the samples investigated

The example above can serve as an illustration, but further evidence is required. For the investigation, we took 30 samples of FRP that have been exposed to a wide variety of service conditions from no exposure to several decades of exposure. The chemical environments included chlorine; chlorine dioxide; hydrochloric acid; sulphuric acid; brines; sulphur dioxide; and others. **Figure 5** shows a sample of the sections through the thickness of the samples used. For all photos, the surface with the corrosion barrier is at the top of the image. During the ultrasonic testing, no information regarding service conditions was used to complete the analysis.

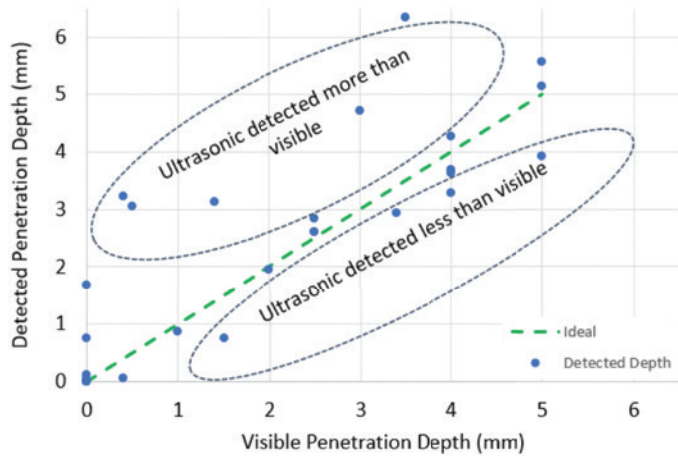
Figure 6. Comparison of visible and detected depth

Figure 6 shows a comparison between the visible, measured depth of penetration in the corrosion barrier and the depth detected using ultrasound. Figure 6 also includes a dotted line that shows where an ideal match would occur. Note that several of the readings found deeper penetration than was visible.

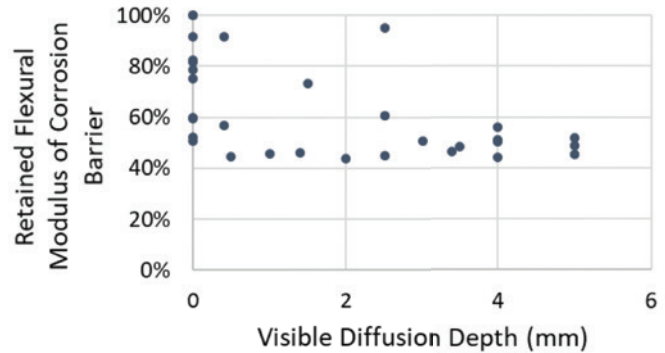
Figure 7. Retained properties of penetrated corrosion barriers

As mentioned above, the ultrasonic data after post-processing can be used to determine the retained flexural stiffness. This allows evaluation of the amount of damage to the corrosion barrier by a subject matter expert. Figure 7 shows a graph of the retained flexural modulus calculated for the samples in the study. Note that there is no correlation between the visible depth of penetration and the retained modulus of the penetrated material.
