# FITNESS FOR SERVICE OF FRP: MOVING TOWARDS BEST PRACTICES

BY: GEOFF CLARKSON, P.Eng., Founder and CEO at UTComp Inc.

## CASE STUDY - ASSESSMENT OF HYDROCHLORIC **ACID STORAGE TANK**

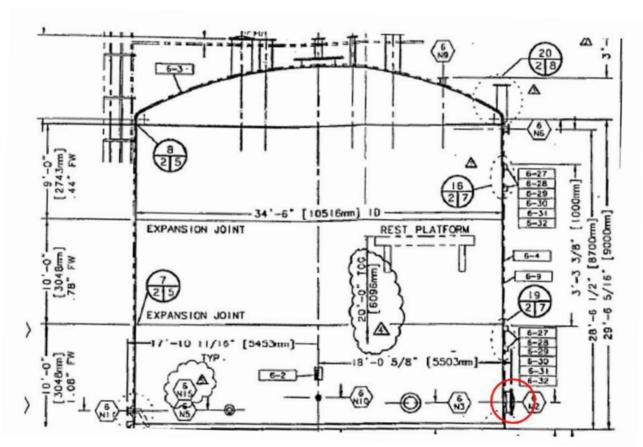
Figure 2. FRP Storage Tank.

This case study will examine two sets of data on a FRP storage tank that has been in service since 1996. Contents of the tank have been 20% hydrochloric acid at about 90°C (194°F) and the pressure in the tank has ranged from atmospheric (with hydrostatic fluid head) to-4 kPa (0.6 psi). The tank is 10.5 meters (34.4 feet) in diameter with 8.7 (28.5 feet) meters overflow level. The tank is shown in **Figure 2**. In the figure, the manway in the lower shell is circled.

The tank was installed in 1996. Design and construction were completed in accordance with ASTM RTP-1 [4], although the tank was not certified with an ASME stamp. In accordance with the inspection and testing requirements in Part 6 of ASME RTP-1, the design physical properties of the FRP in the tank were verified by destructive tests. In particular for this case, the hoop direction bending stiffness of the shell was verified from the cut-out from the circled manway. The bending stiffness matched the design values used for the tank.

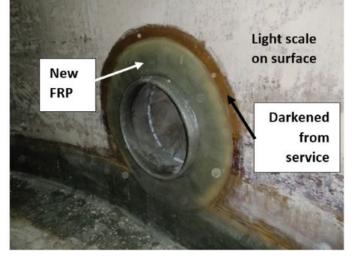
Figure 3. New Manway Added.

Two measurements of bending stiffness are required from cutouts that have been taken at known times. For this tank, a manway cut-out taken from the new tank is used as the starting point. In 2010, the owner decided to add a new manway at the same tank elevation as the circled manway. The installation of the new manway is shown in Figure 3. Note that testing of a cut-out will always require repairs to FRP.

Note from Figure 3 that the cut-out was removed from the tank shell after it had been in service for 14 years, about 123,000 hours. The inner surface was darkened and some absorption of hydrochloric acid had occurred. From the sample, the opportunity was taken for microscopic and energy dispersive x-ray spectroscopy (EDX) to examine the glass and resin after service. **Figure 4** shows a section of the corrosion barrier. EDX identifies chemical elements that are found in the material. The yellow strip on the left of the photo shows the percentage of the area at each depth that has chlorine from the hydrochloric acid in the tank. Note that the chlorine is shown to a depth of 3.4mm (0.13 inches). The original corrosion barrier thickness was 4.5mm (0.18 inches).

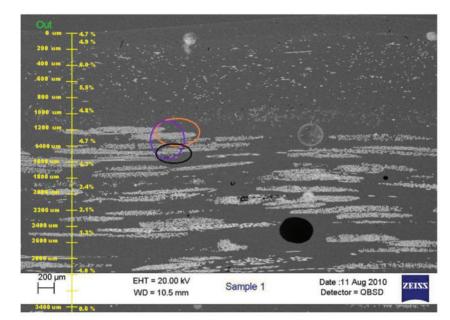
Figure 4. Chlorine from HCl in the cutout.

The inner surface of the tank, having a 4.7% chlorine content, was considered to be in good condition and suitable for continued service before EDX. At full depth of the corrosion barrier, chlorine penetration is modest and no changes were made after EDX results were available.

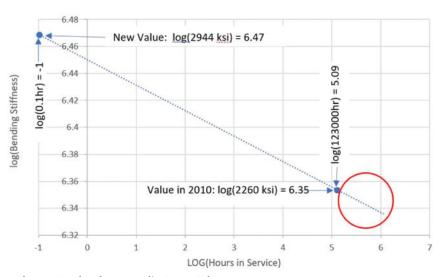
**Figure 5.** Log-log chart to Predict Future Values.

One way to make the prediction is to plot the stiffness value and its time in service on a log-log chart, then use a straight line to predict future values. This is illustrated in **Figure 5**. The line connecting the measurements has been extended into the circled area. The extended line can be used to predict future values.

The straight line in **Figure 5** can be used to predict future values of stiffness for the FRP. Using the straight line, a value of stiffness has been predicted for 2013 (149,000 hrs), 2017 (184,000 hours), and for 200,000 hours of time in service (late 2018). The predicted values and the corresponding PDS values using EN 13121 calculations are listed in **Table 2**.

Now consider the charts shown in **Figures 5** and **6** but not using logarithmic scales. The chart for Figure 6 becomes Figure 7.

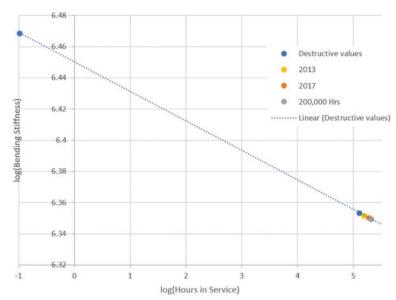
Figure 6. log-log Chart with predicted stiffness.

Figure 6 shows the log-log chart of the original destructive values and the predicted values.

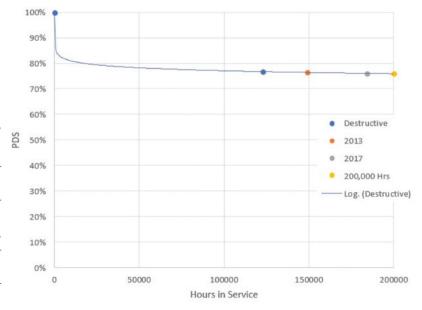
Figure 8. Destructive and Predicted Values using PDS

Note that we have not used the PDS value in **Tables 1** and 2 on the charts. Figure 8 shows the same curve as **Figure 7**, but using PDS instead of the actual stiffness value.

The PDS values from the non-destructive technique are also shown in **Figure 9**, plotted on the same curve as Figure 8. There is good agreement of the non-destructive values. The values determined by the technique in my previous articles in Inspectioneering Journal provide similar predictions.[2,3]
