Fitness for Service of FRP & Composite Assets

Composite FFS and Assessment

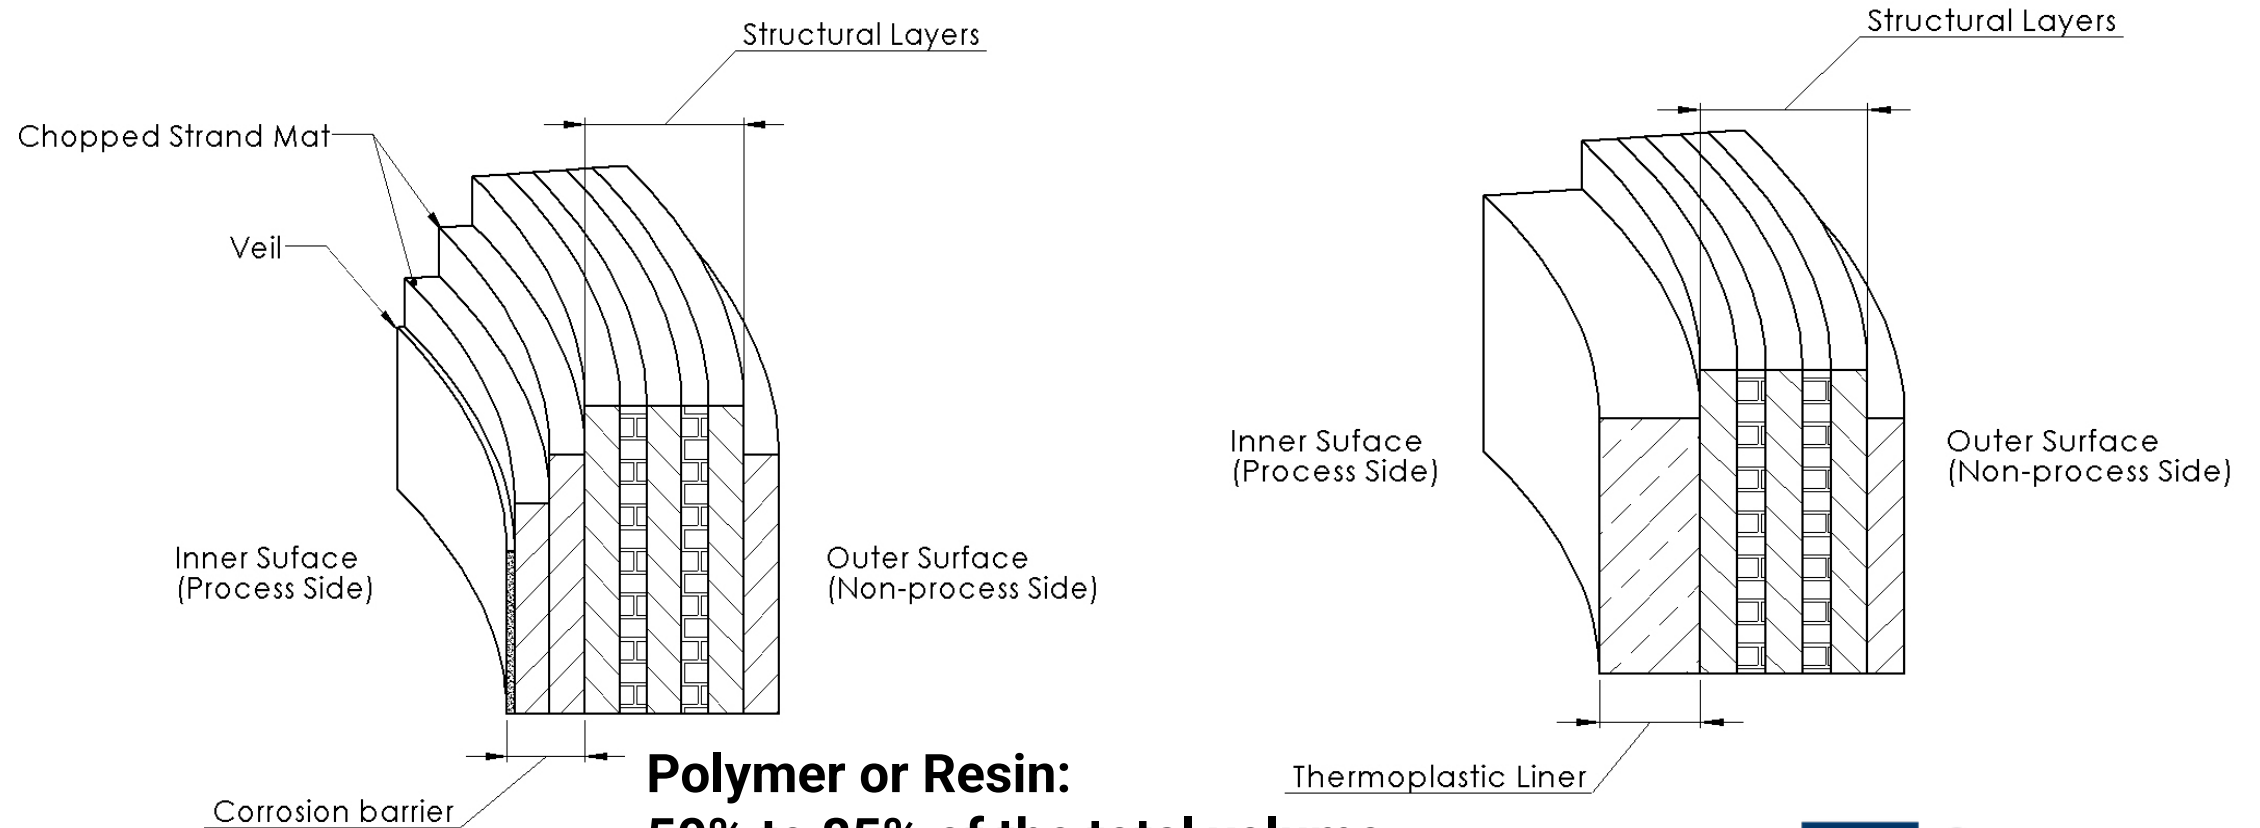
Proven Construction for Reliability

Polymer or Resin:
50% to 85% of the total volume
Provides 100% of corrosion resistance

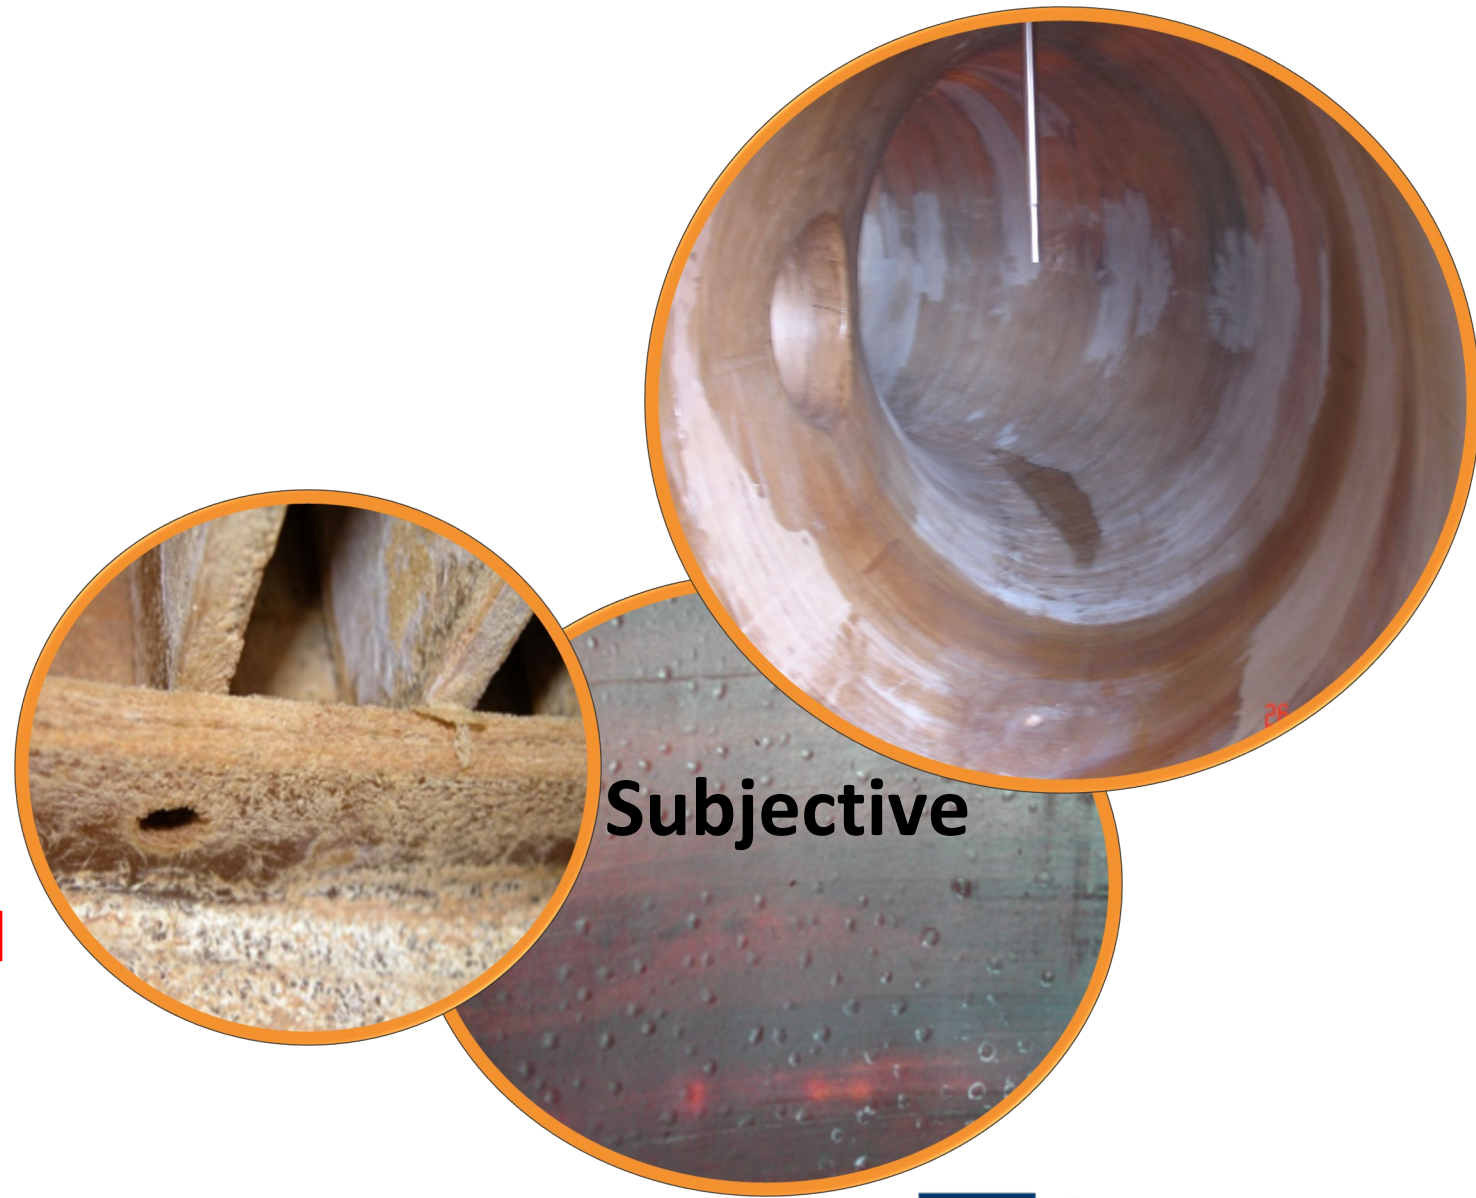
Conventional FRP Inspection

Intrusive Visual Internal Inspection

- Confined Space Entry Required
- Shutdown Required
- NBIC Supplement.

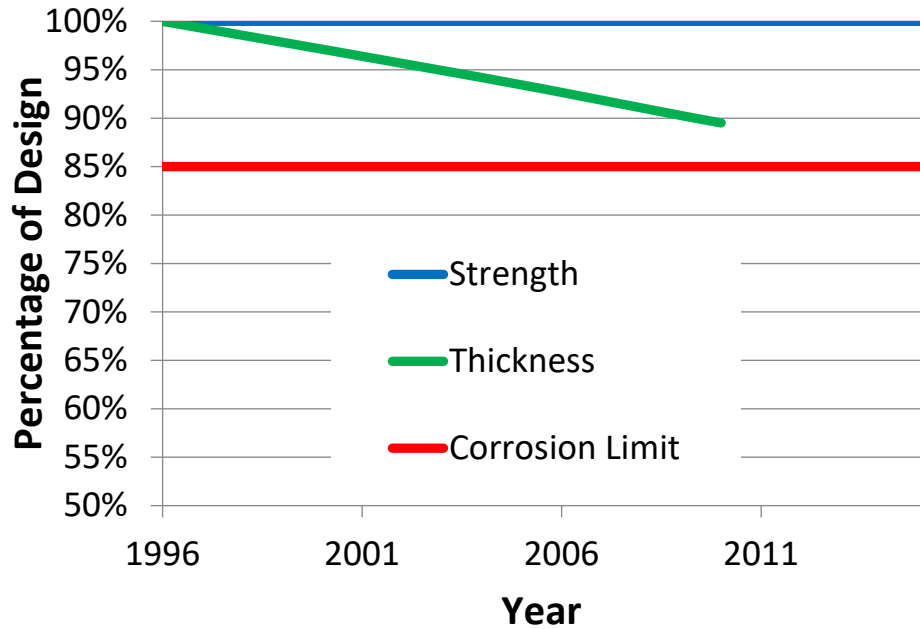
Steel

Thickness is part of the design and on the drawings.
Nameplate includes thickness and corrosion allowance.

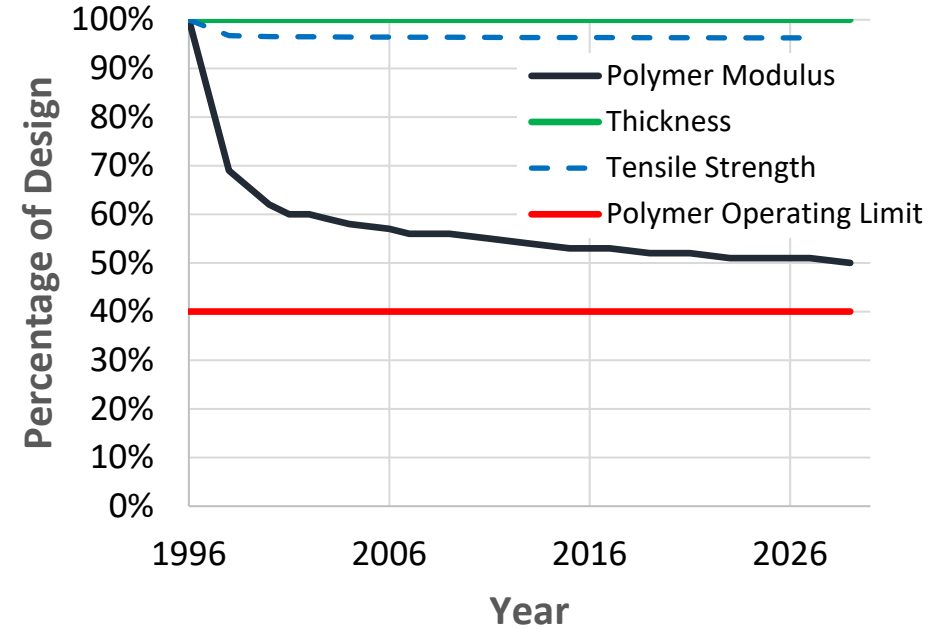
FRP & Polymers

Resin and polymer condition limits the life.
Damage indicators are not used in the design nor on the drawings or nameplate.
Occurs with OR without corrosion

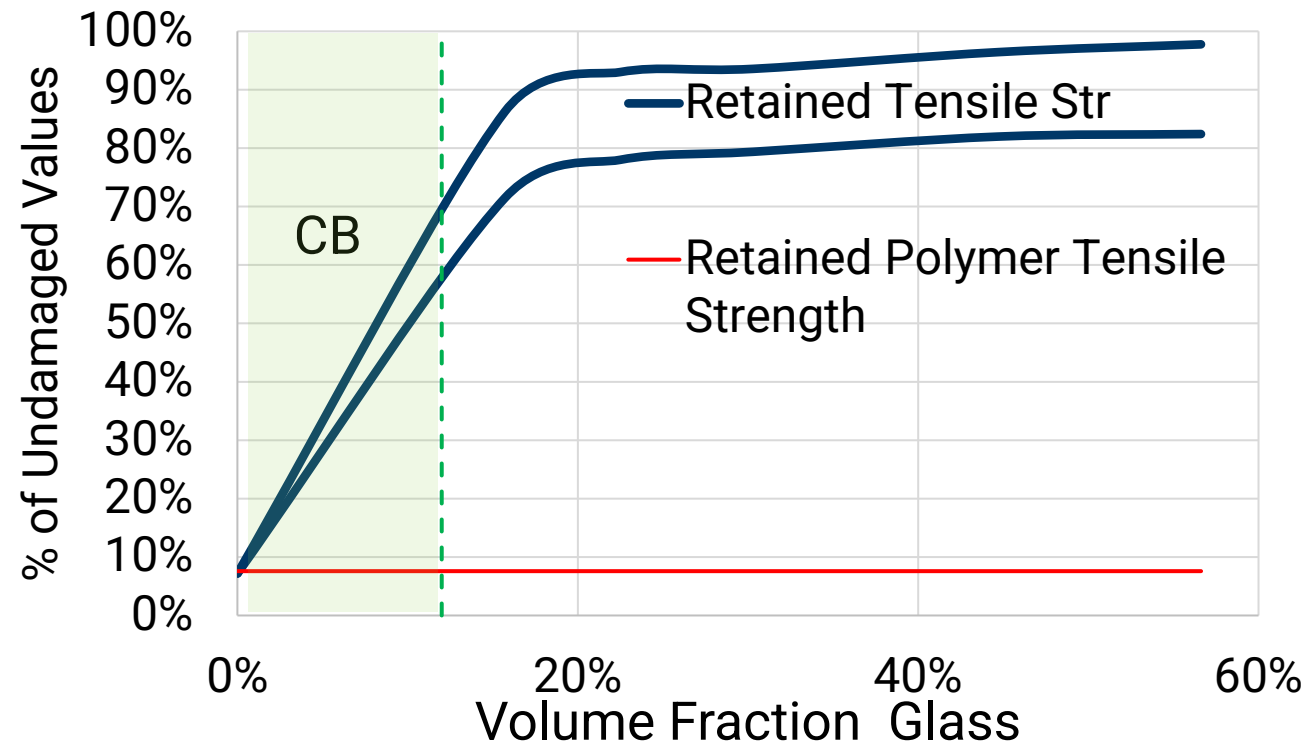
Retention of Code Properties

- Tensile is dominated by reinforcement.
- Bending is most sensitive to polymer or resin
- Damage to reinforcement follows damage to polymer

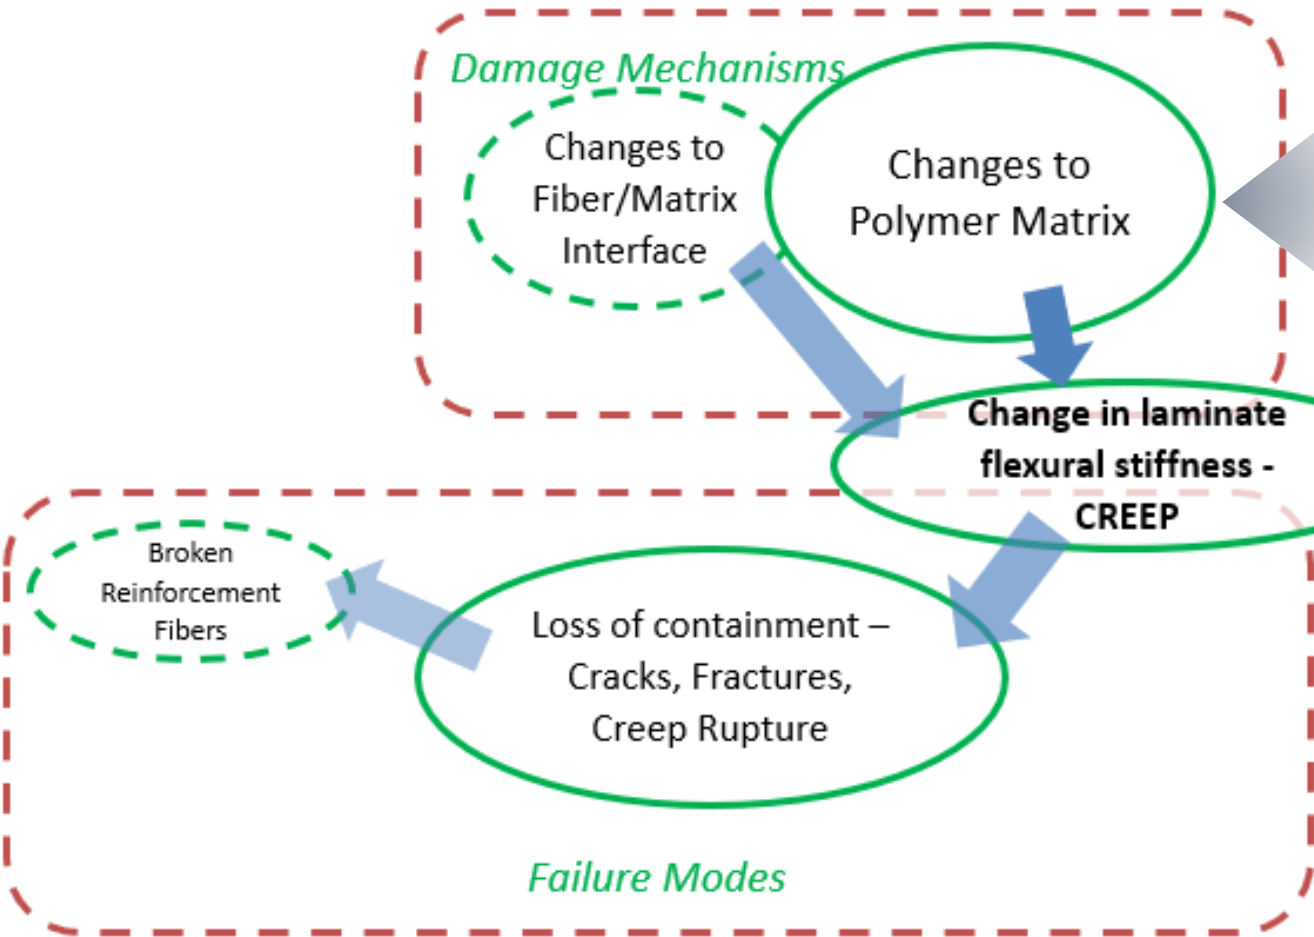
Damage & Failure

Contributions from: Curing, chemical attack, voids & porosity, stress, foreign substances

Used for Manufacturer Corrosion Resin Recommendations: ASTM C581

CREEP is the Dominant Failure Path

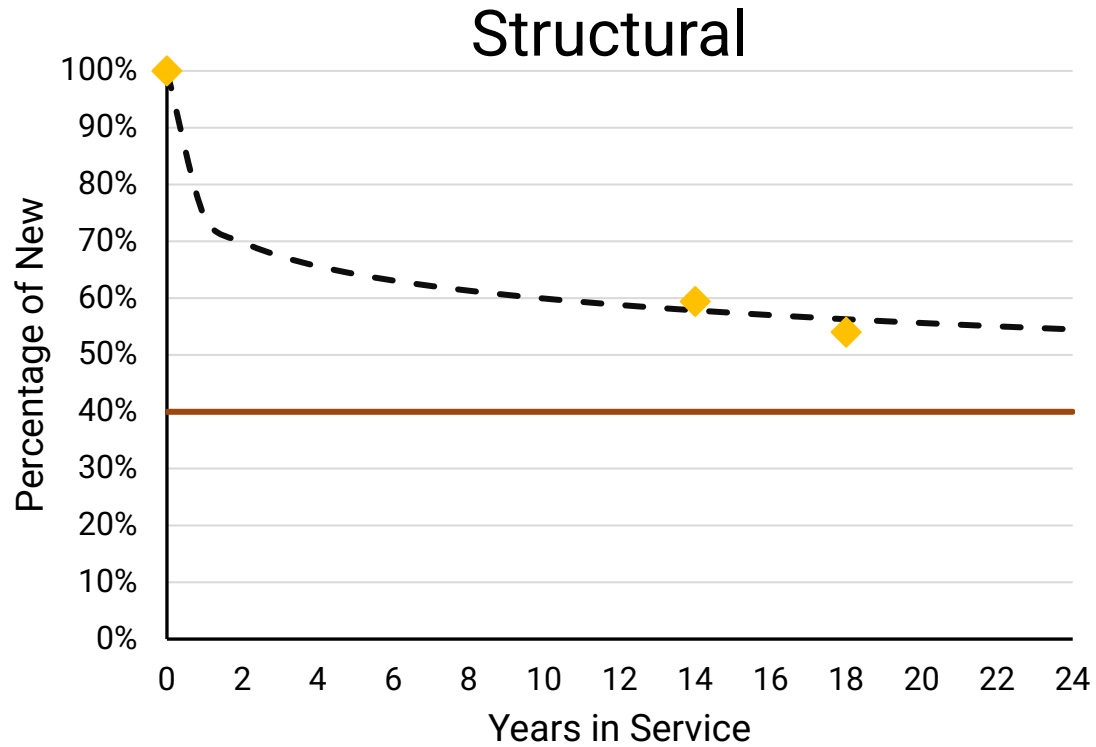
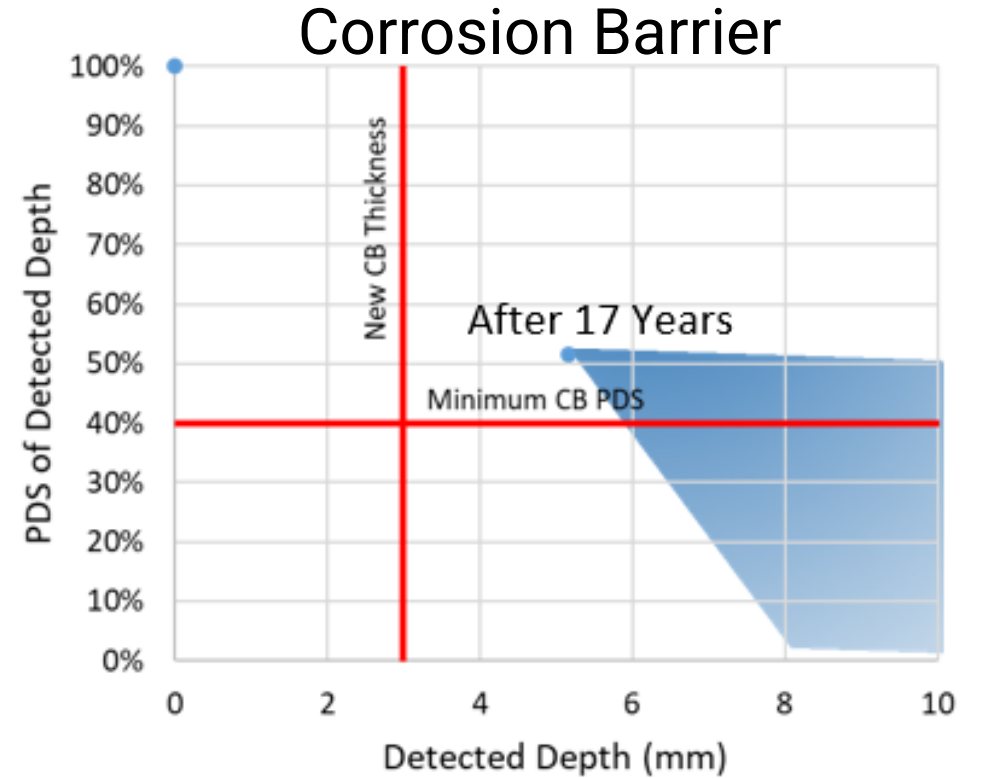
Full Thickness & Corrosion Barrier

End of Service Life when the polymer elastic modulus is 40% to 50% of new value.

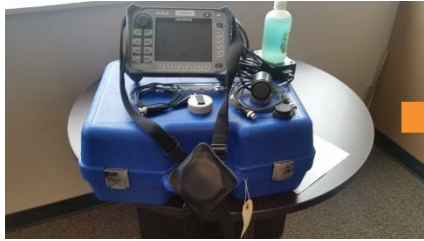
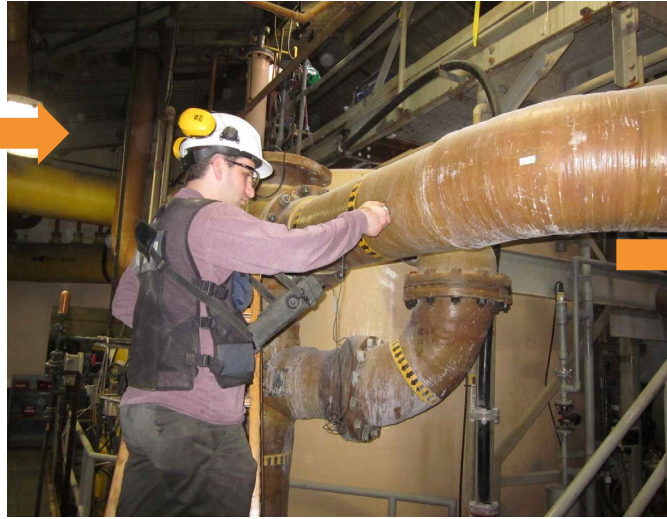
UltraAnalytix® – In Field

Data Analysis is post-processed and completed remotely

- Standard Procedure
- Non Destructive Ultrasonic
- Non Intrusive
- Complies with ASNT SNT-TC-1A

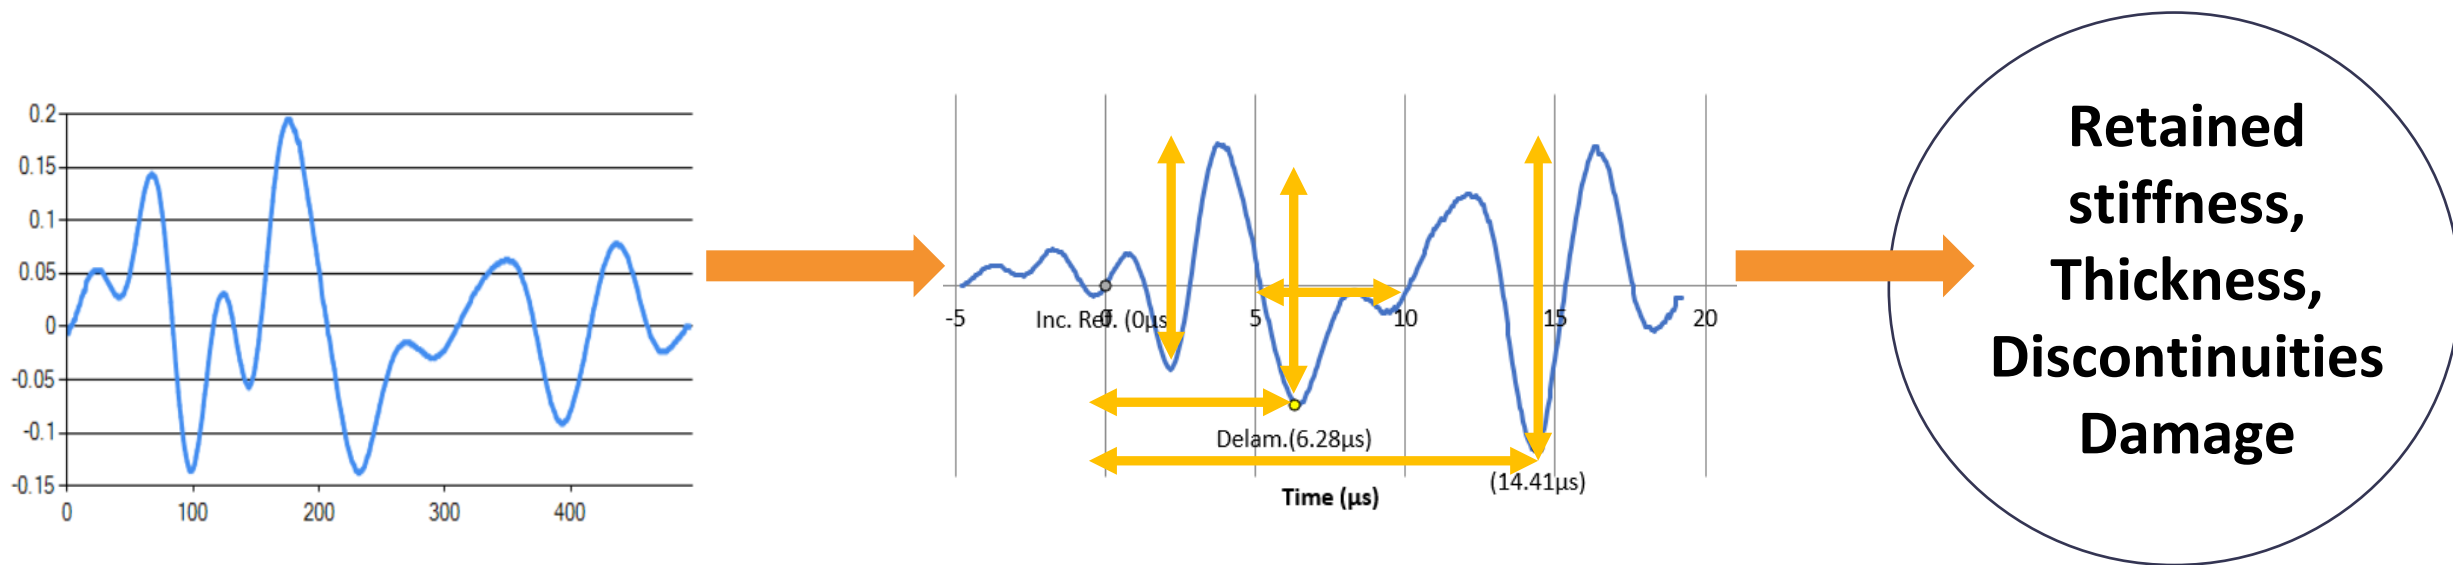
UltraAnalytix®- Analysis

- Damage to the corrosion barrier is isolated at this stage.

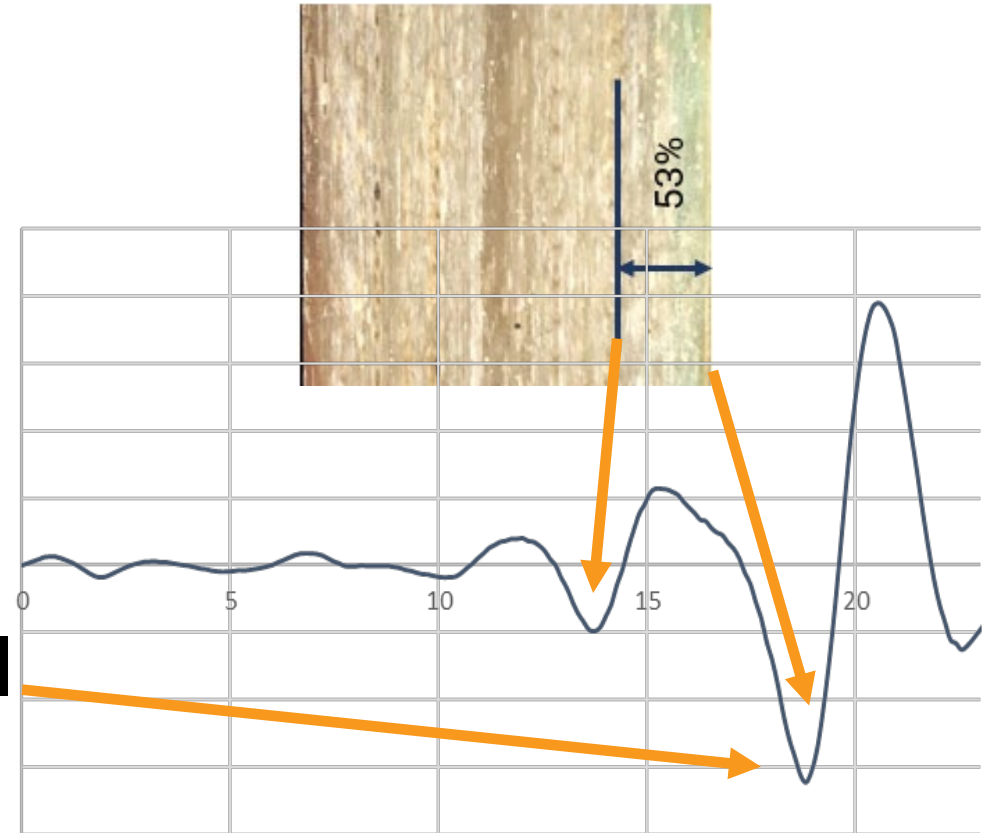
UltraAnalytix®- Analysis

- From the same reading:
 - Corrosion Barrier condition assessment
 - Polymer condition for the full thickness
- Patent pending

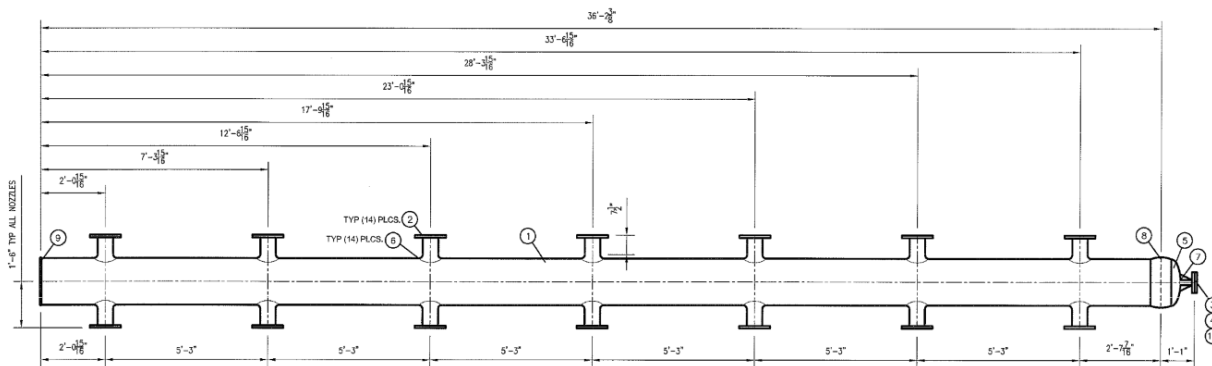
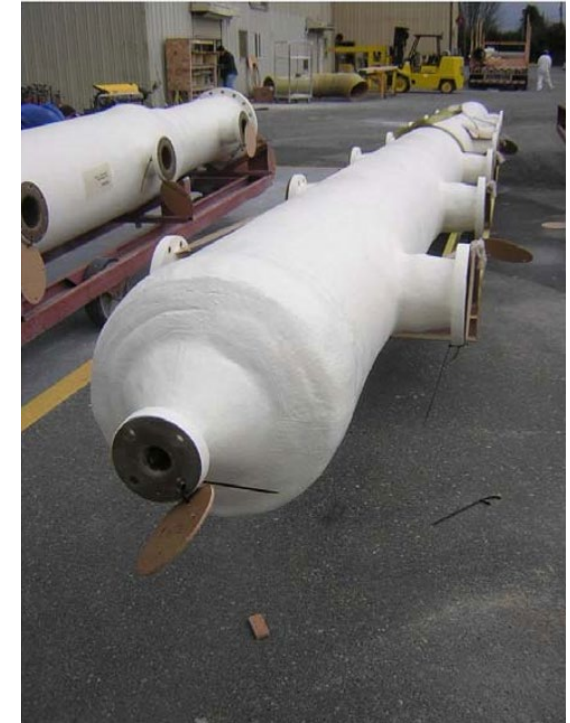
Chlorine Collectors Thickness

- New Headers in 2008.
- Design Thickness: 1.04" Nom.
 - 0.5" Sacrificial Corrosion Barrier
 - 0.54" Structural
- Owner is concerned about current status

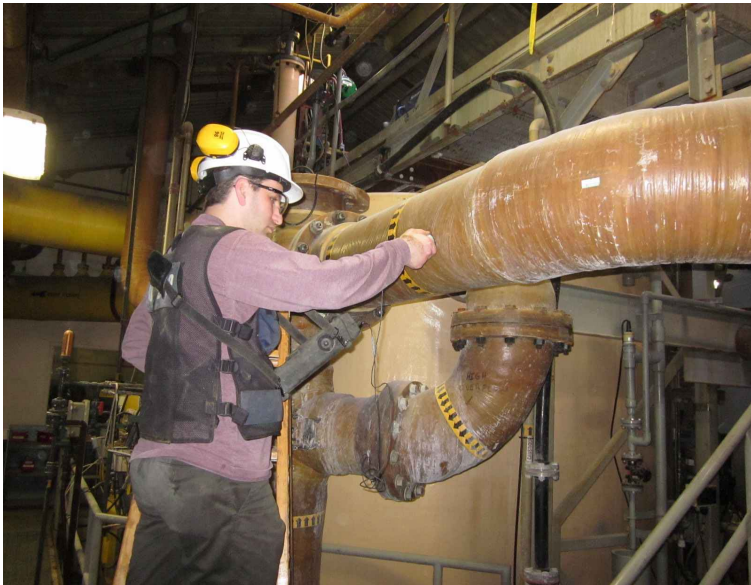
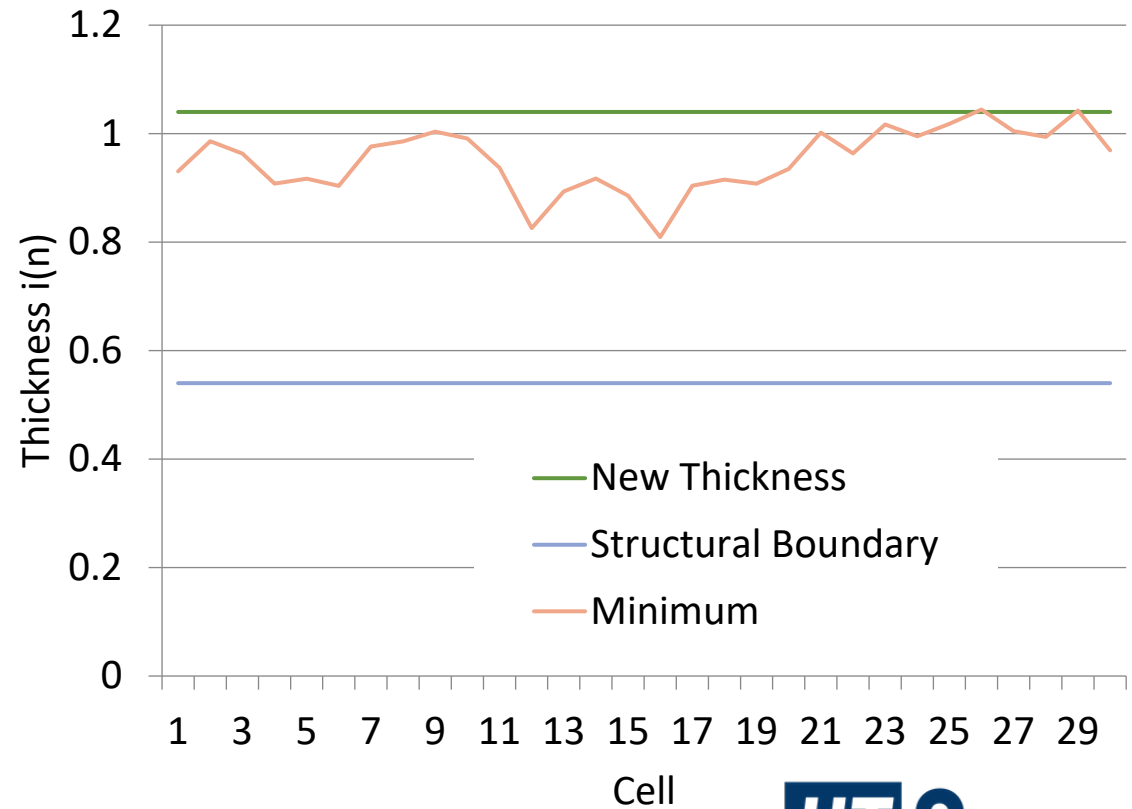
Chlorine Collectors Thickness

- Thickness survey for material loss

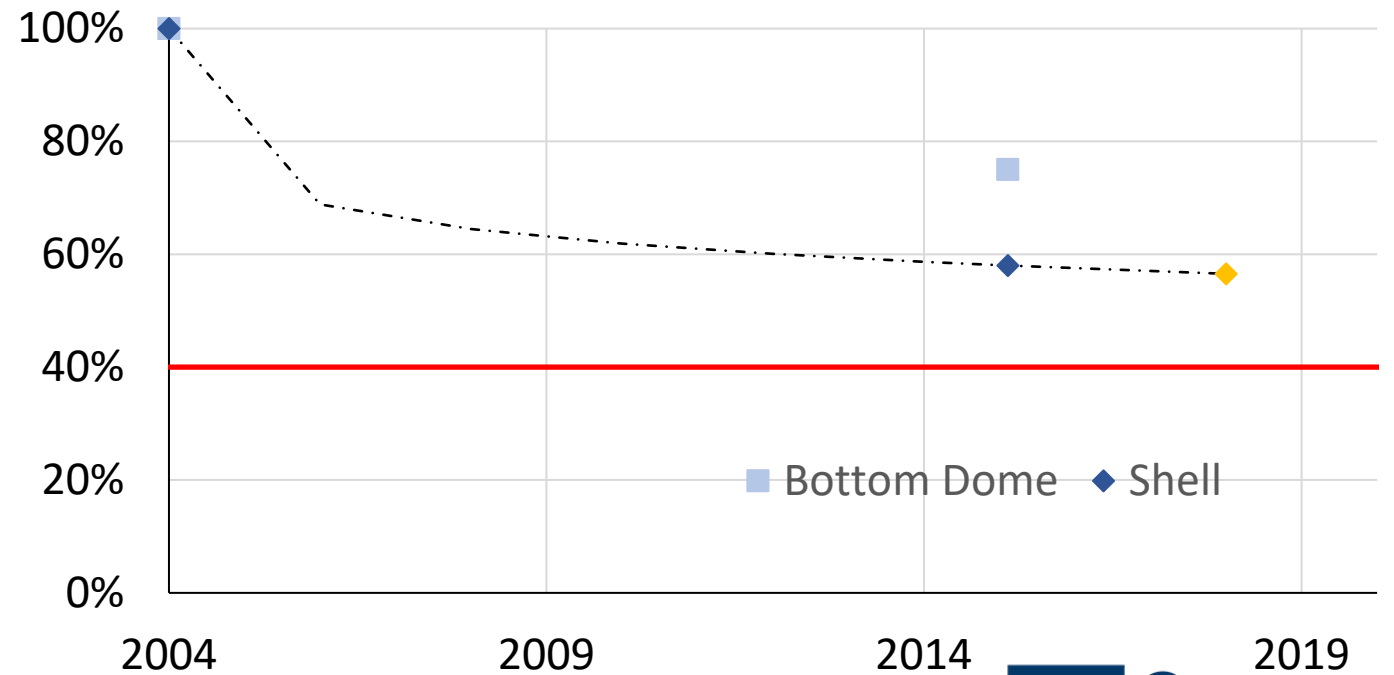
Hypo Tower with PVC Corrosion Barrier

- Results:
 - No defects in PVC-FRP bonds
 - Fit for Service
 - Re-inspect in 2018
