# SPRING25 +21<sup>ST</sup> GCPS

A Joint AIChE and CCPS Meeting

**Non-Intrusive Fit-for-Service  
(FFS) Evaluation for Critical Non-  
Metallic Aboveground Storage  
Tanks (ASTs)**

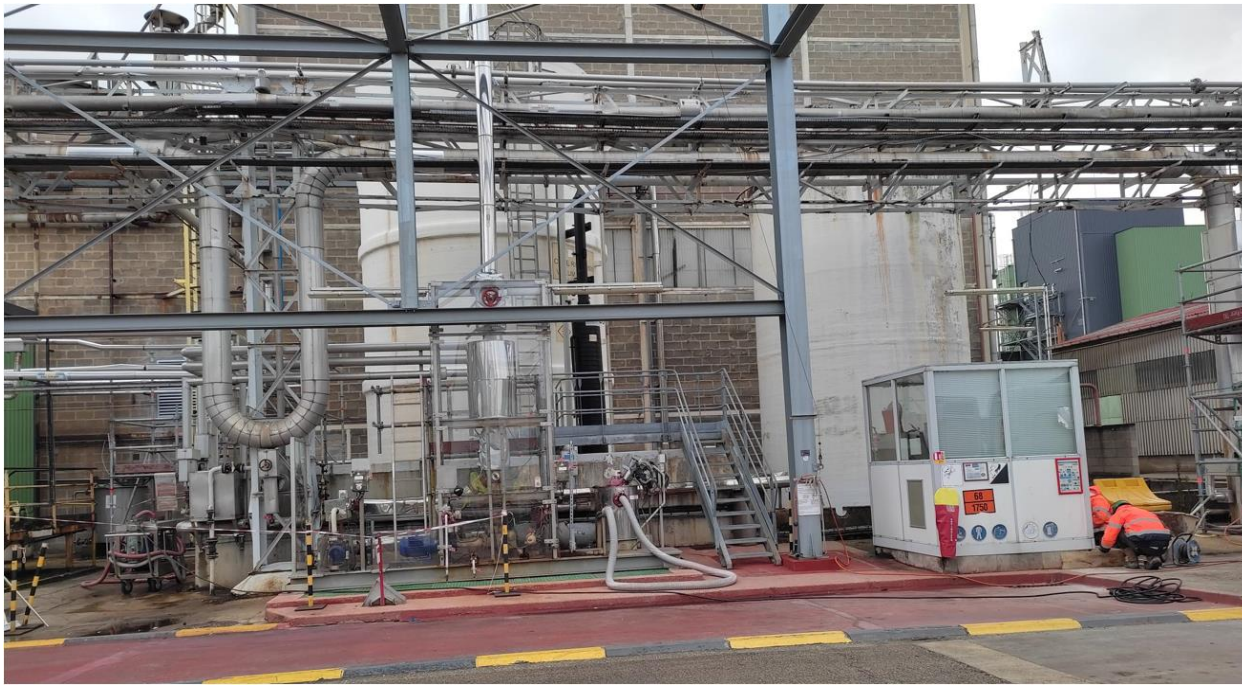
MCA Stored on-site in 5 m x 8.5 m FRP composite AST.  
Challenges associated with:

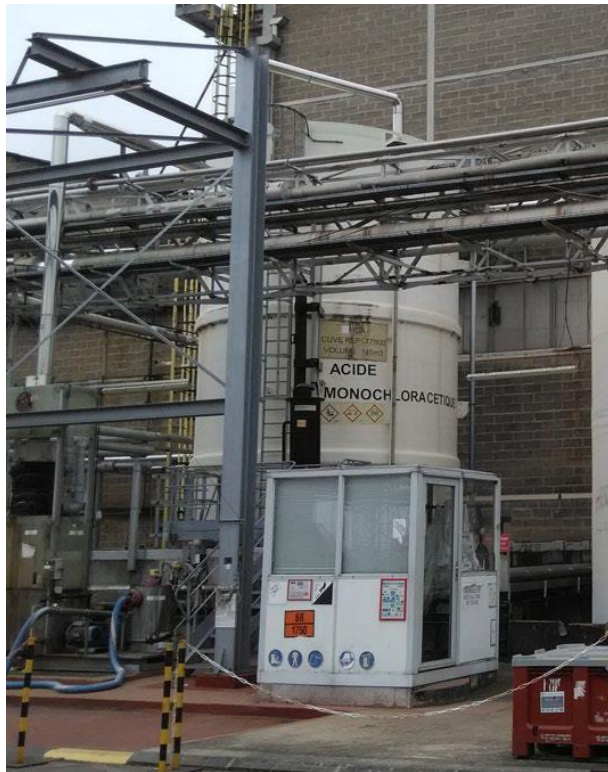
Designed & Constructed in 2002 in accordance with “Reservoirs et Appareils en Matieres Plastiques Renforces – Code de Construction” standard

Code includes quality assurance tests & inspections to ensure vessel complies with these standards, namely:

- Continual inspections during fabrication
- Spark-testing of welds in the PVC liner
- Hydrostatic testing

Following fabrication/installation, MI inspections for the tank have primarily relied on visual external inspections.

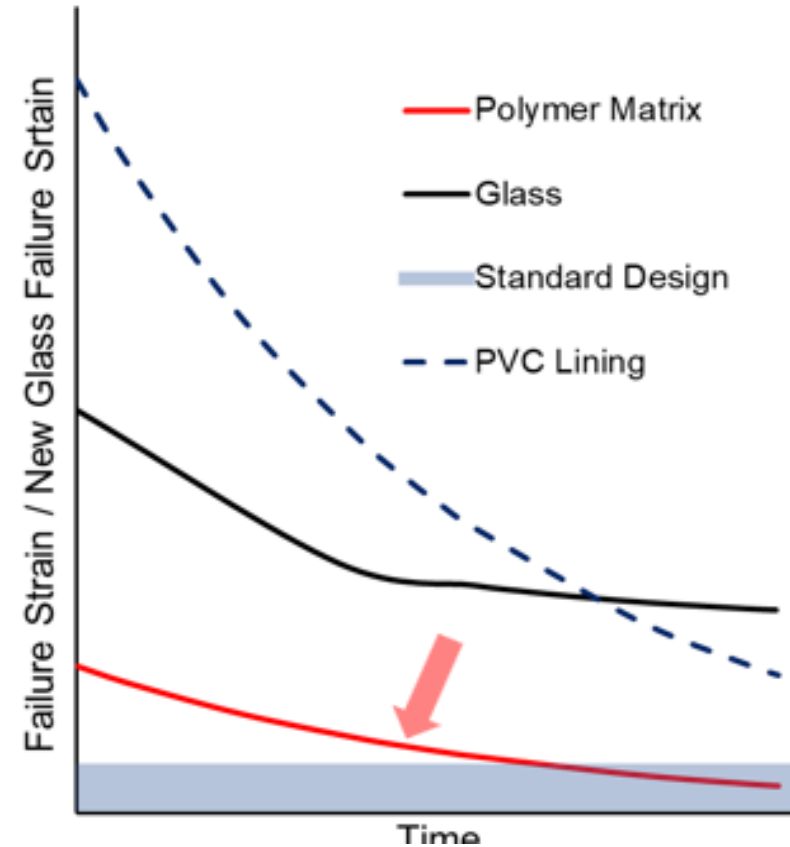
Mechanical properties are changed by all of chemicals, stress and strain.

FRP resin leads the way to crack 1<sup>st</sup>

Cracks in FRP resin will lead to more damage to reinforcement.

PVC is not a structural component.

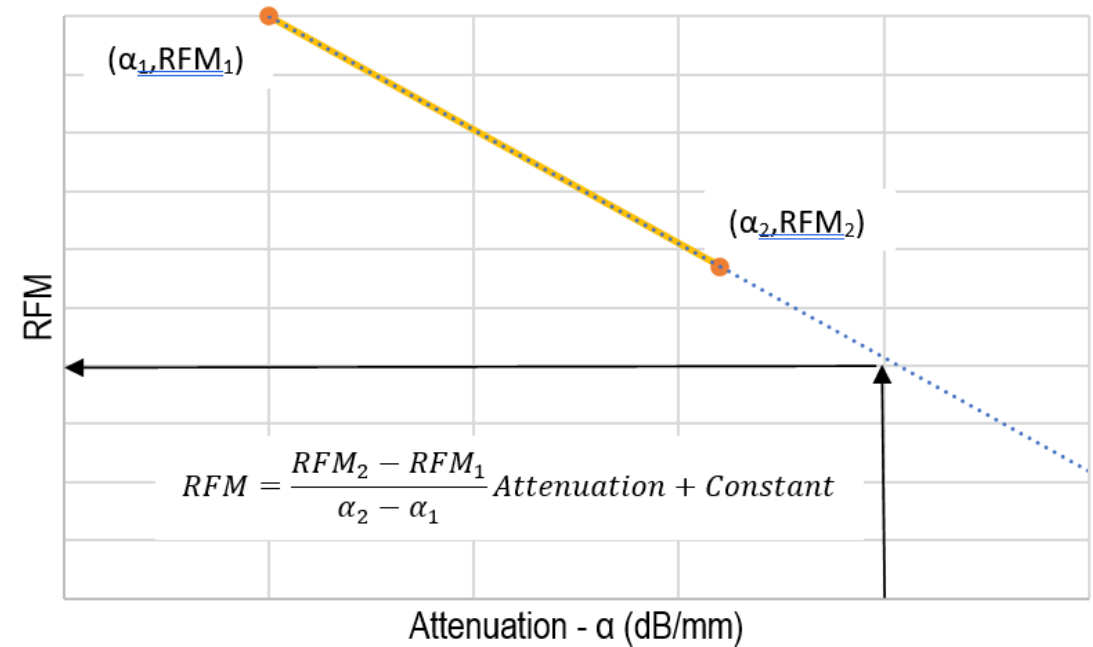
Changes in Flexural Modulus are a proxy.

$$RFM = \frac{\text{Current Flex Modulus}}{\text{New Flex Modulus}}$$

*Polymer Damage Status = PDS*

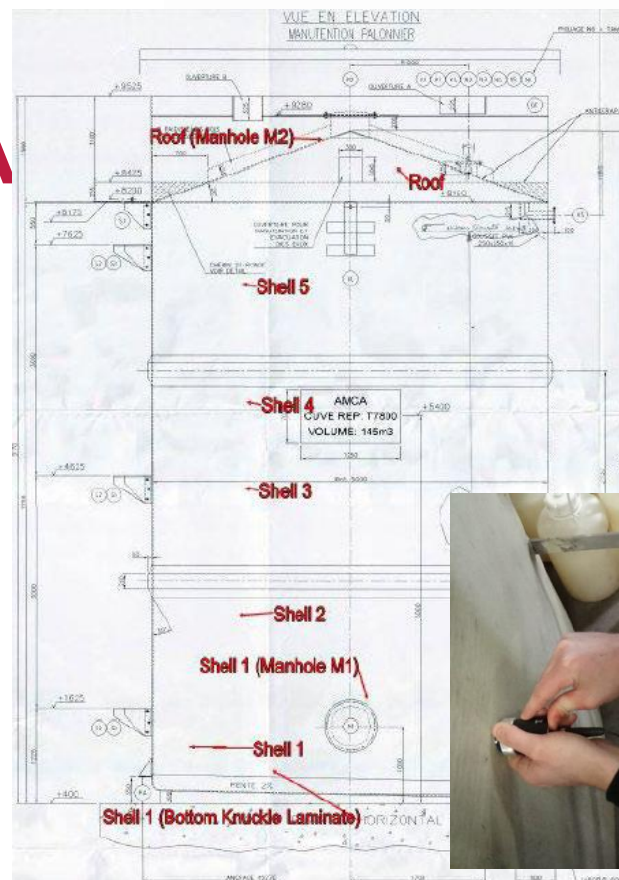
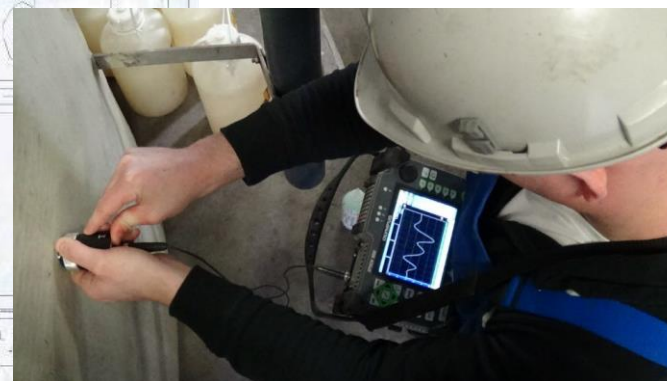
Systematic inspection of areas

At least 30 UT readings per.

Focus on highest stress,  
chemical exposure, PVC weld  
vulnerabilities

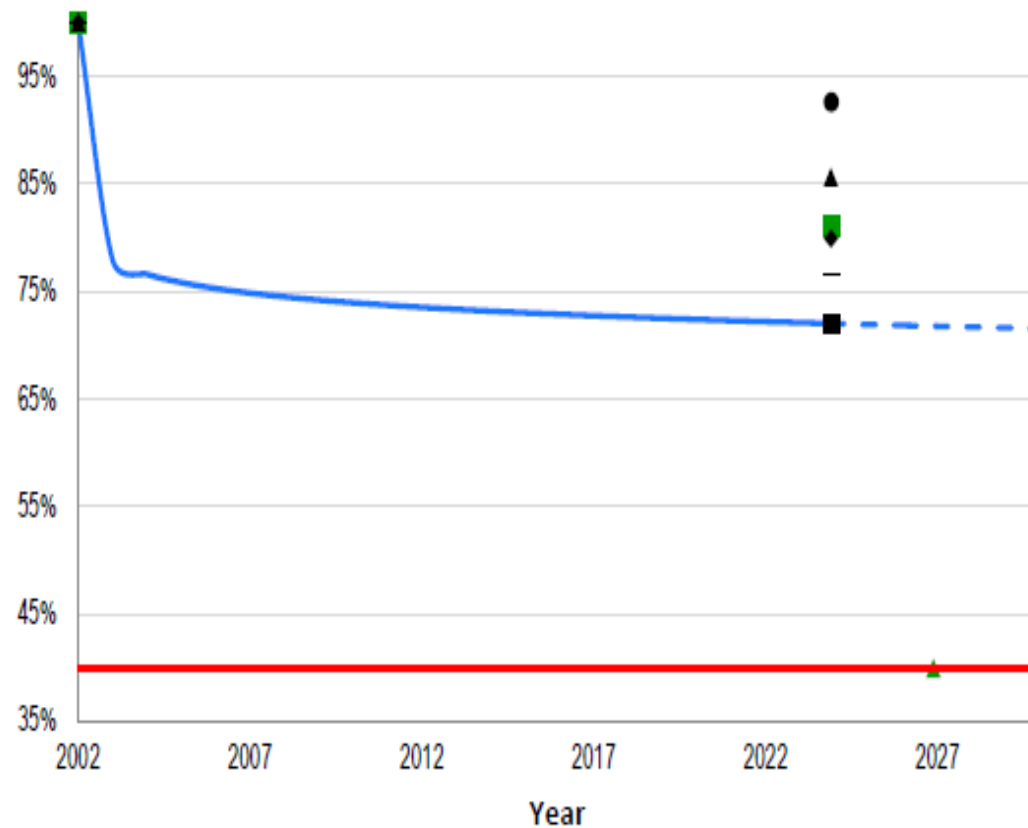
MCA Tank is Fit for continued service.  
Remaining Life can be estimated.

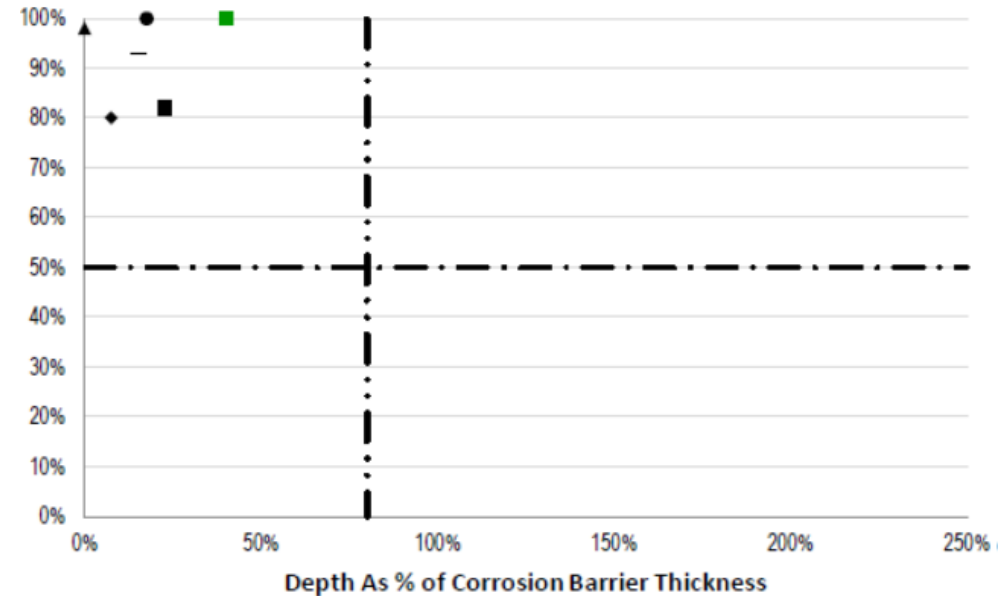
Minor chemical damage to PVC is also detected from the same UT readings.
