Wastewater Pumping Station

Municipal Wastewater
Treatment System

Force Mains

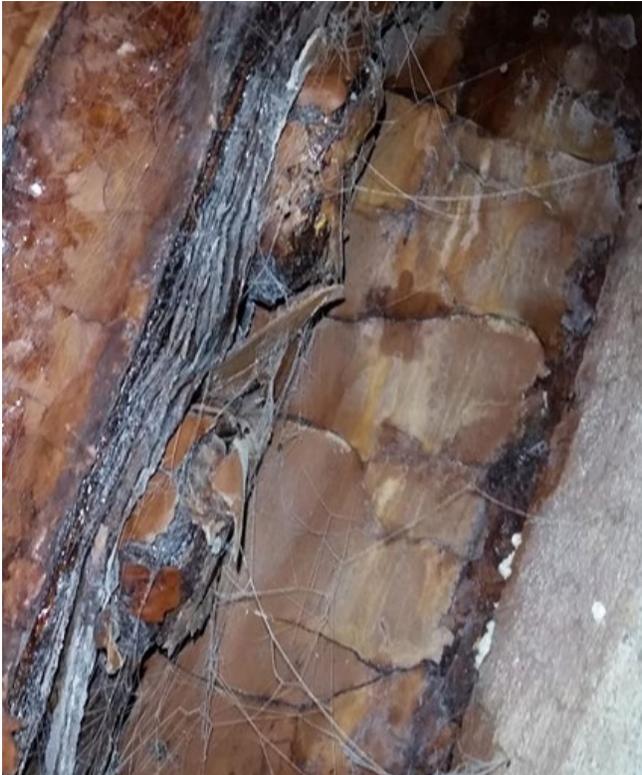
As part of a large collection system, the client operates and maintains a number of wastewater pumping stations throughout a populated city in Ontario. UTComp was requested to inspect and assess the integrity of a certain pumping station's force mains. Steel force mains used to transfer wastewater from the pumps were inspected by ultrasonic thickness measurement, and found to be corroded internally and externally, with low remaining thickness posing an immediate risk of loss of containment. These

Corrosion of exposed steel.

The City began investigating options to repair the corroded force mains while leaving the force mains in service. After considering several repair options, it settled on using UTComp® to design and oversee FRP repair of the corroded force mains.

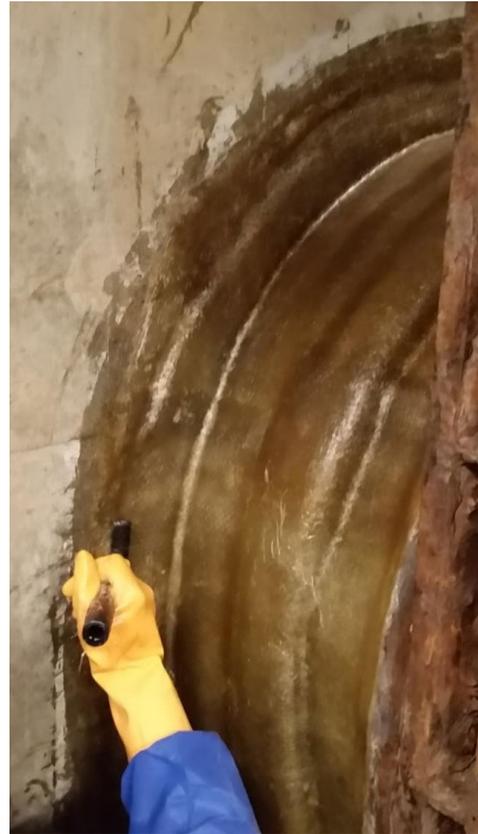
Applying FRP stages.

A UTComp® Engineer visited the site to perform an initial site assessment and gather information on the layout and dimensions of the corroded force mains. The FRP repair was designed on the assumption that the corroded steel pipe would ultimately fail, and fluid containment and structural strength would be supplied solely by the FRP repair with no contribution from the underlying steel.

The repair was designed with no surface preparation of the corroded steel to avoid accelerating the reduction of the thickness causing a potential breach. The corroded pipe was treated as a laminating mold rather than as a bonding substrate. The surfaces of the adjacent concrete at the wall penetration and the butterfly valve and intact piping upstream were prepared for bonding to the new FRP laminate.

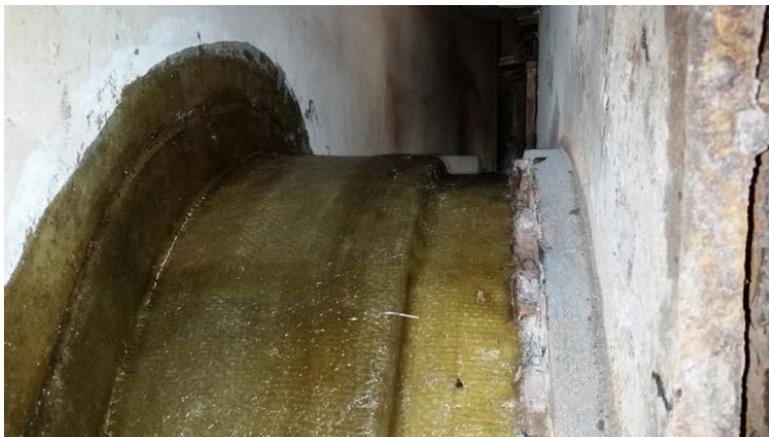
First stage has been applied. When cured, this stage provided a sound surface over pipe and concrete to support lamination.

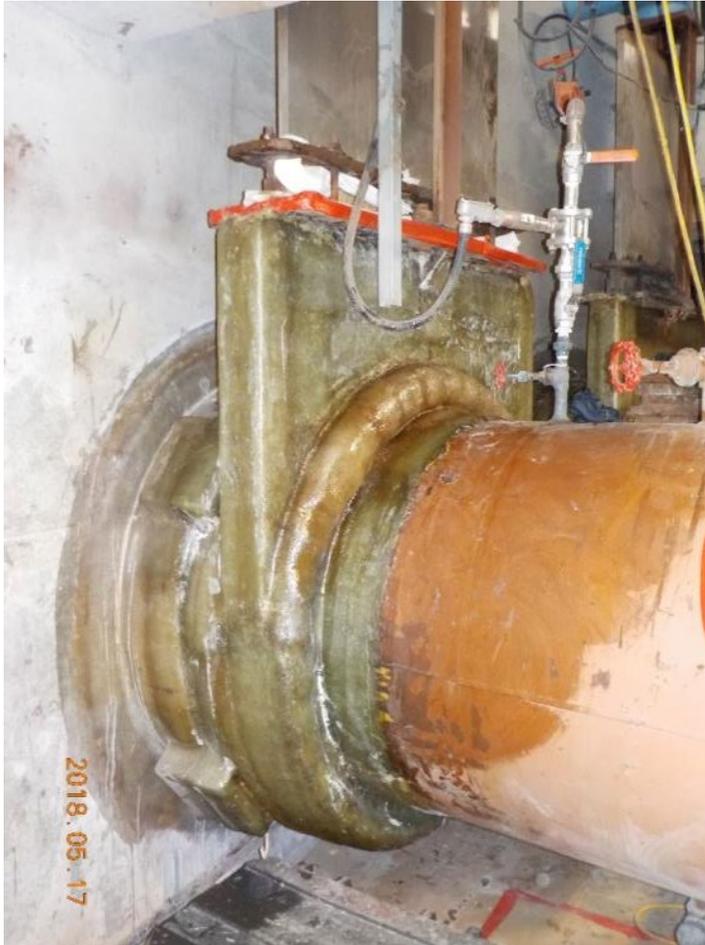
Installation of laminate on the force main pipe and valve

UTComp® prepared design calculations and drawings, supervised the successful installation of the repair, and inspected the repair in several stages.
