## NON-INTRUSIVE FRP INSPECTION FOR AVOIDING PREMATURE ASSET RETIREMENT

GEOFF CLARKSON, *CEO and Founder at UTComp Inc.*

**VOLUME 23, ISSUE 6**

NOVEMBER | DECEMBER 2017

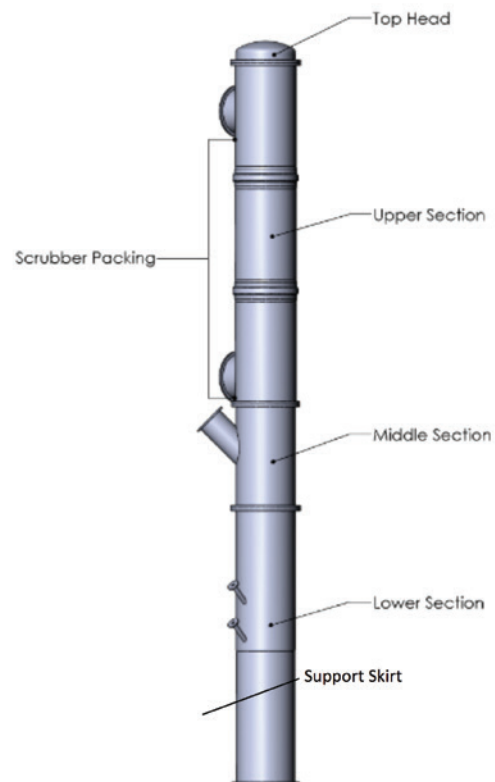
Figure 2. Scrubber Configuration

The FRP equipment inspected was a vent scrubber at large chemical facility. The scrubber was used to neutralize hazardous gas with sodium hydroxide solution in a countercurrent flow. The configuration is shown in **Figure 2**.

The scrubber was new in 1995. In 2002, the lower section was replaced. All sections of the scrubber were manufactured by the same manufacturer. In 2015, the scrubber was replaced because the structural integrity was suspect based on visual inspection of the corrosion barrier. The scrubber that was removed in 2015 is the subject of this investigation, since it was no longer in service and could be made available for comparison of non-destructive and destructive evaluation.
