## **Using Ultrasonic Technique to Determine Fitness for Service of FRP Equipment for Chemical Handling Applications**

Pradip Khaladkar  
PECT Consulting  
Hockessin,  
Delaware  
USA

Geoffrey Clarkson  
UTComp Inc.  
Cambridge, ON, N1R 8C8  
Canada

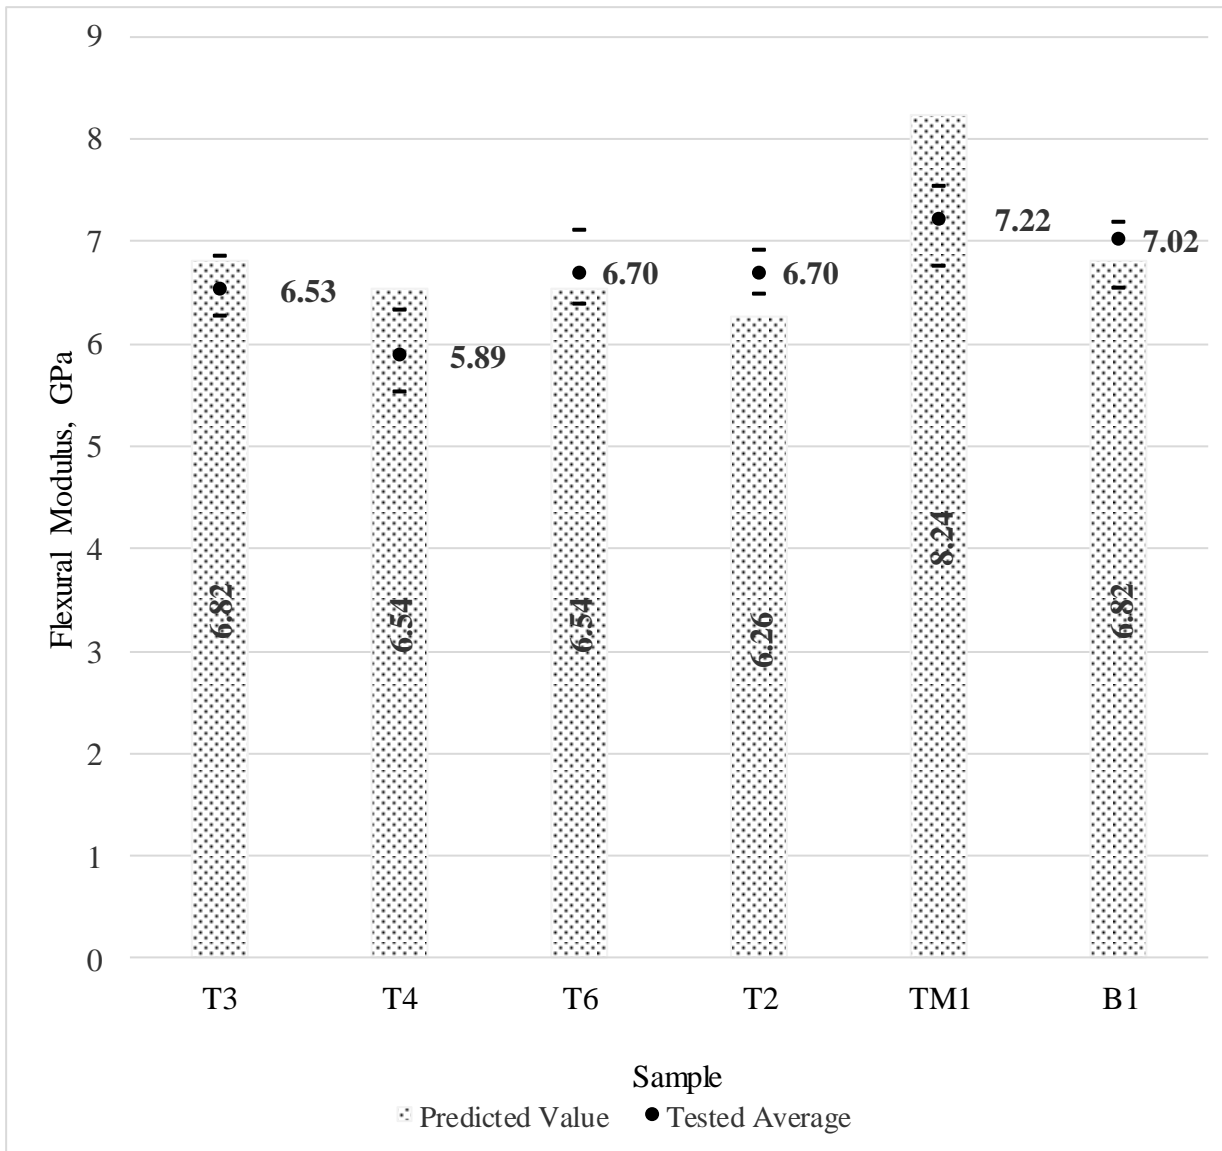
**Figure 5: Chart of Stiffness Results Comparison**

Another illustration of the results is given by the chart in Figure 5. This chart also shows the range of the individual flexural modulus results from the D 790 test.

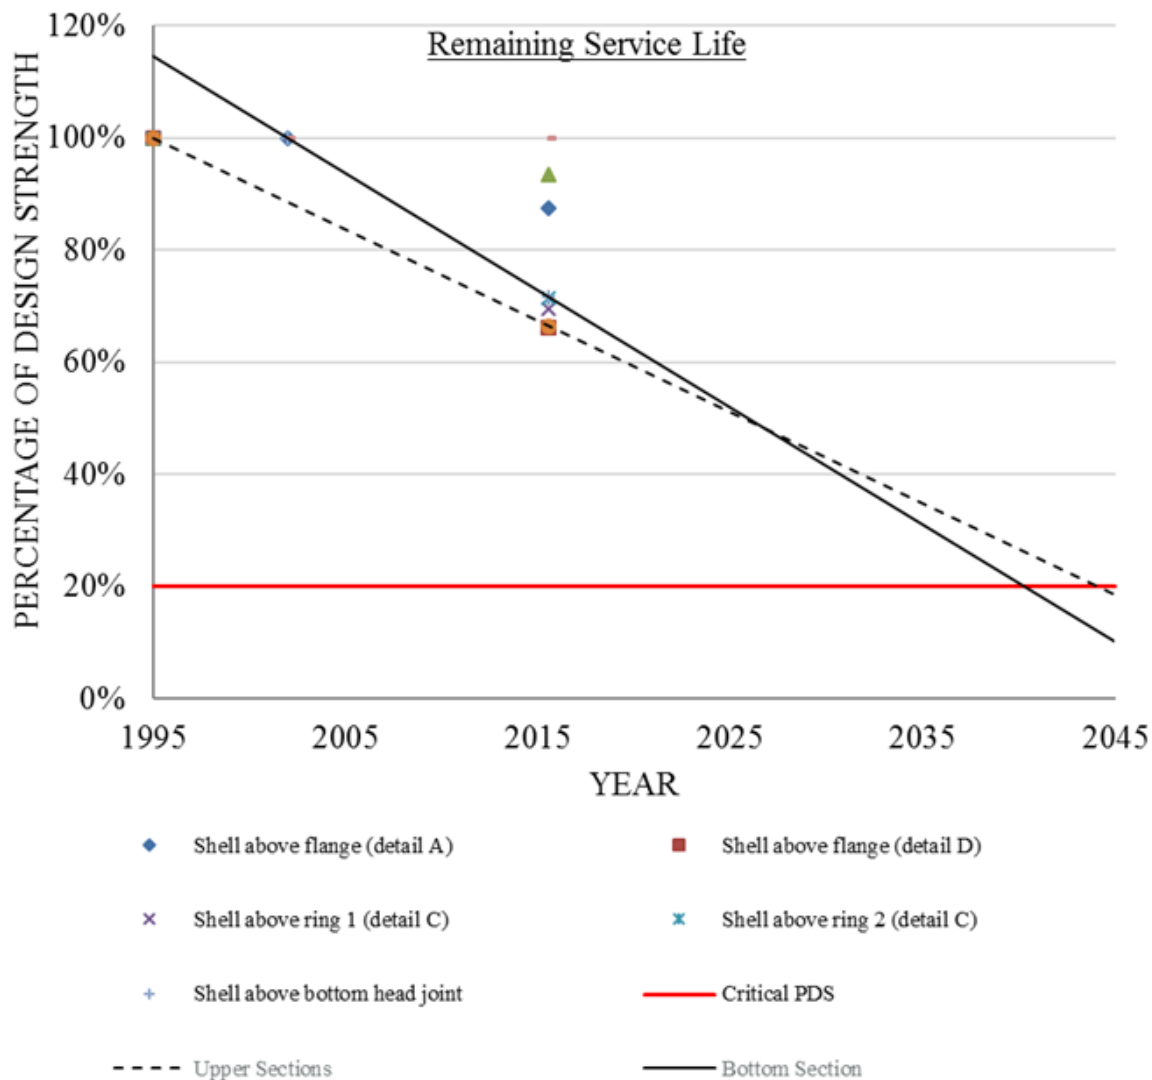
**Figure 7: Chart Showing Remaining Service Life**

This is illustrated graphically in Figure 7.

Remaining service life could also be determined on the basis of the corrosion barrier damage detected in this case using the damage depth and criteria for end of corrosion barrier service life.
