## NON-INTRUSIVE FRP INSPECTION FOR AVOIDING PREMATURE ASSET RETIREMENT

GEOFF CLARKSON, *CEO and Founder at UTComp Inc.*

**VOLUME 23, ISSUE 6**

NOVEMBER | DECEMBER 2017

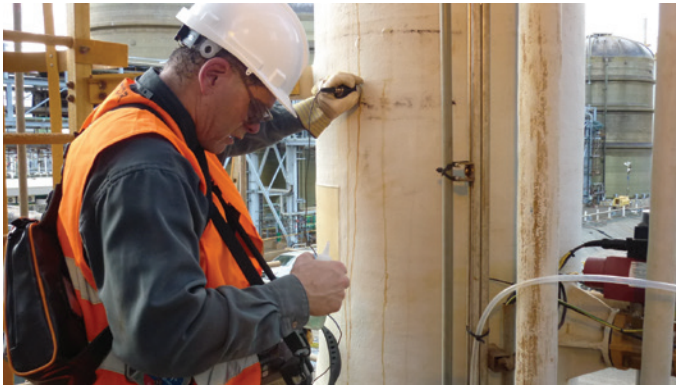
Figure 5. Non-Intrusive FRP Inspection

Figure 5 shows an image of a typical FRP inspection using the technique.

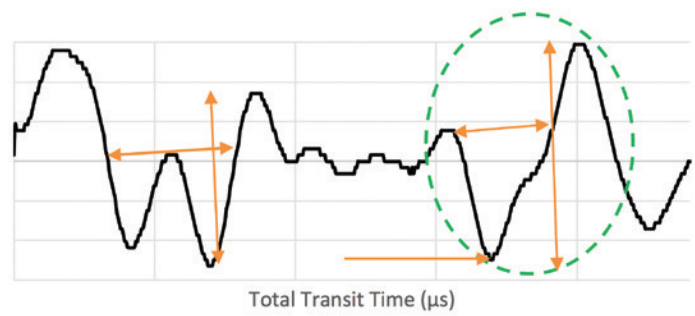
Figure 6. Reading Processing

When the computer file is evaluated, the SME integrates all of the information provided to assist with computer analysis of the readings. The SME uses a computer program to process each reading for environmental and transducer application conditions. Some of the environmental conditions that are considered include ambient temperature during the inspection, surface temperature of the FRP and high magnetic fields from equipment nearby. Application conditions include surface condition of the FRP, UV damage to the resin of the outer surface, and coupling defects due to contaminants on the surface of the FRP. From each processed reading, data is extracted that provides information on the condition of the FRP. Figure 6 shows an example of a reading
