Using Ultrasonic Technique to Determine Fitness for Service of FRP Equipment for Chemical Handling Applications

Pradip Khaladkar,

Geoffrey E. Clarkson,

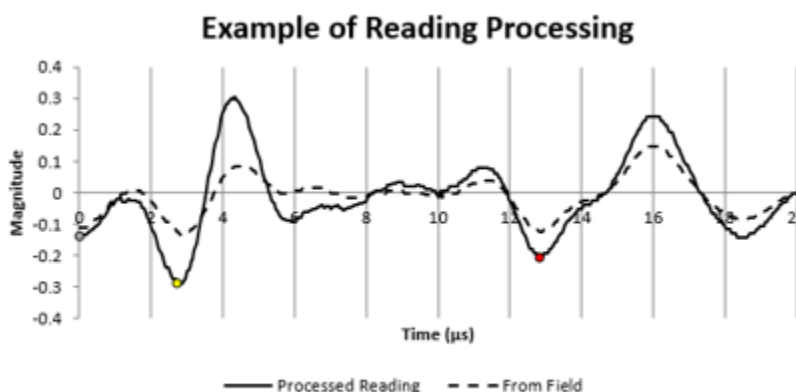
Figure 5: Reading Processing

Before the ultrasonic readings can be used to calculate quantitative values such as PDS and the depth of corrosion barrier damage, the readings are processed using a proprietary computer algorithm to compensate for coupling variations with the FRP, accommodate instrument variations and employ statistical tools to determine 95% confidence intervals. An example of the end result of this processing is shown in Figure 5. The reading shown is the same as in Figure 2.
