FRP IMPELLER FAILURE CASE STUDY

Carbon Fiber Reinforced Polymer
Fan Impeller Blade

SUMMARY

The UTCOMP® engineering investigation of an impeller failure during commissioning identified that operation of the impeller at high temperatures led to the failure.

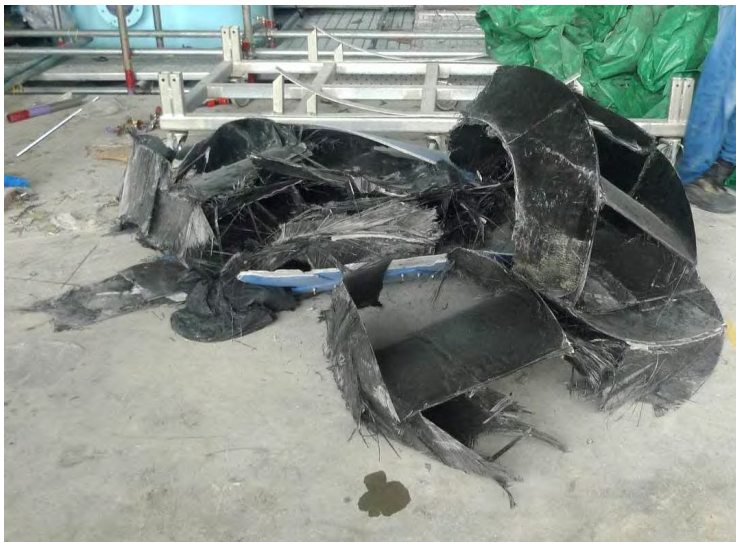
An impeller is a component that rotates around a hub to increase the pressure and flow of a gas or liquid using centrifugal force. It typically consists of several angled blades mounted on a backplate. The backplate is then attached to a driveshaft which is turned by a motor. When its encased in a housing like a centrifugal fan, it can move the outgoing air in a certain direction. Air enters from the side of the impeller, changes direction with the impeller blades, accelerates, then exits the housing with a higher pressure. There are all types and blade angles for impellers for different applications. Impeller fans are typically used in constant high-pressure applications such as HVAC systems and air pollution control systems.
